**Figure 2**  
**Site & Sample Location Map**  
**BOPCO, L.P.**  
**Poker Lake Unit #59 Battery**  
**Eddy County, New Mexico**

**TABLE 1**  
**CONCENTRATIONS OF BENZENE, BTEX, TPH & CHLORIDE IN SOIL**

BOPCO, LP  
 PLU #59 TANK BATTERY  
 EDDY COUNTY, NEW MEXICO  
 NMOCD REFERENCE #: 2RP-\_\_\_\_\_

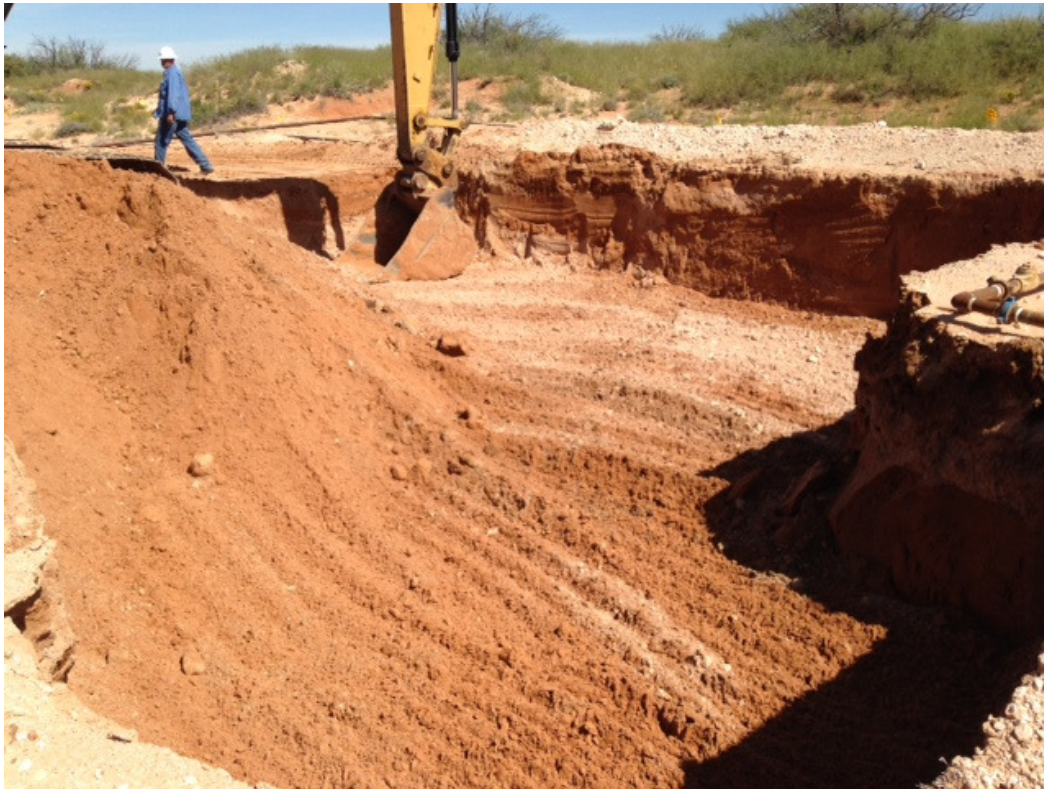
Photograph of excavation activities at the PLU #59 Tank Battery.

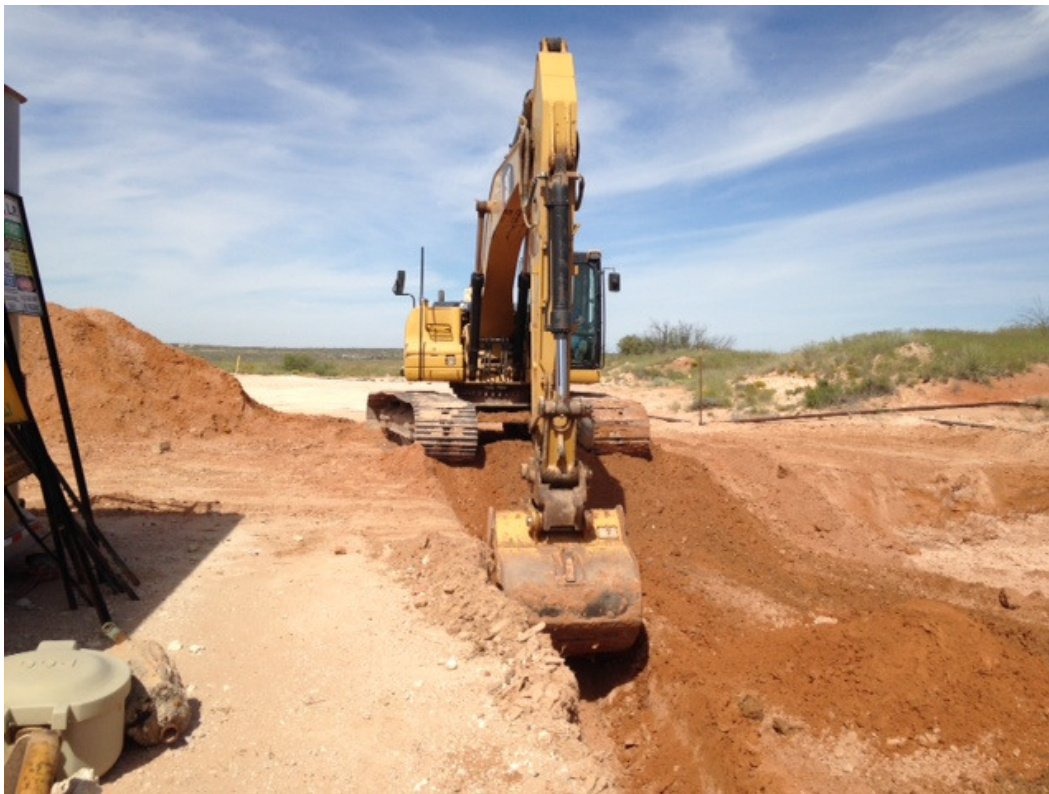
Photograph of excavation activities at the PLU #59 Tank Battery.

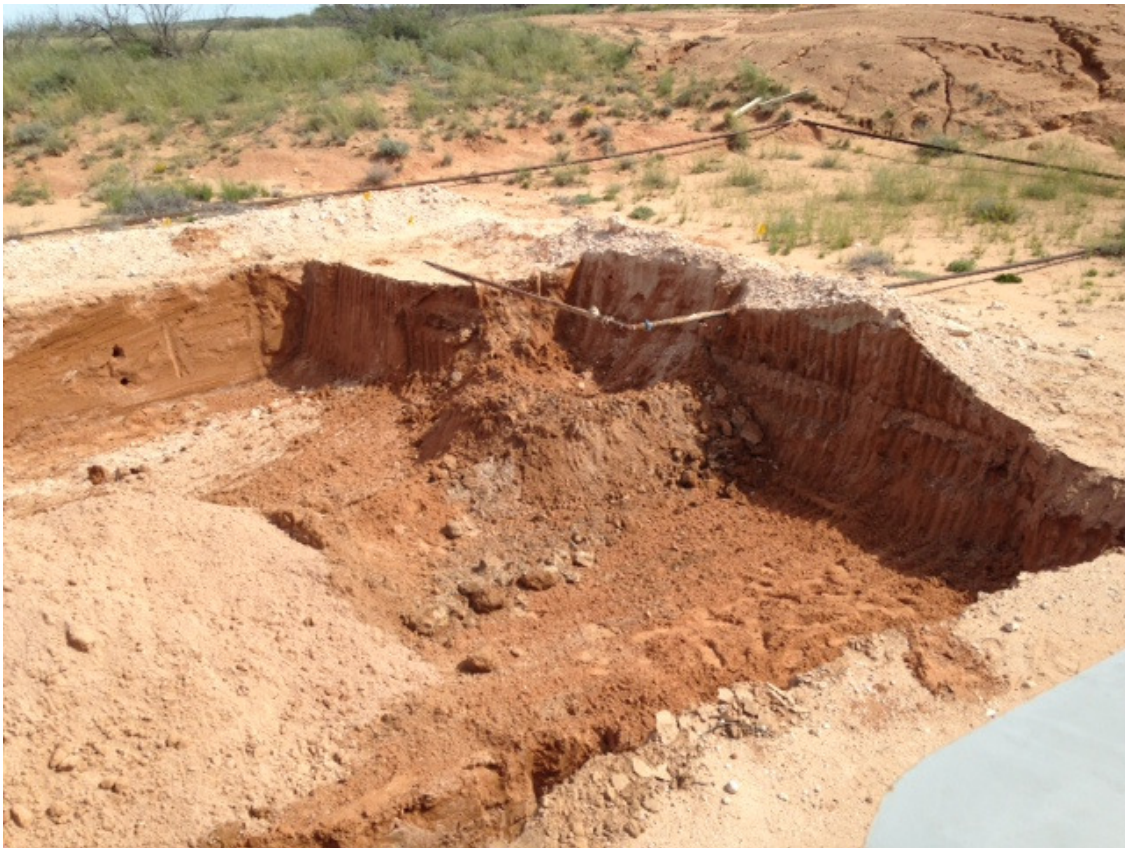
Photograph of excavation activities at the PLU #59 Tank Battery.

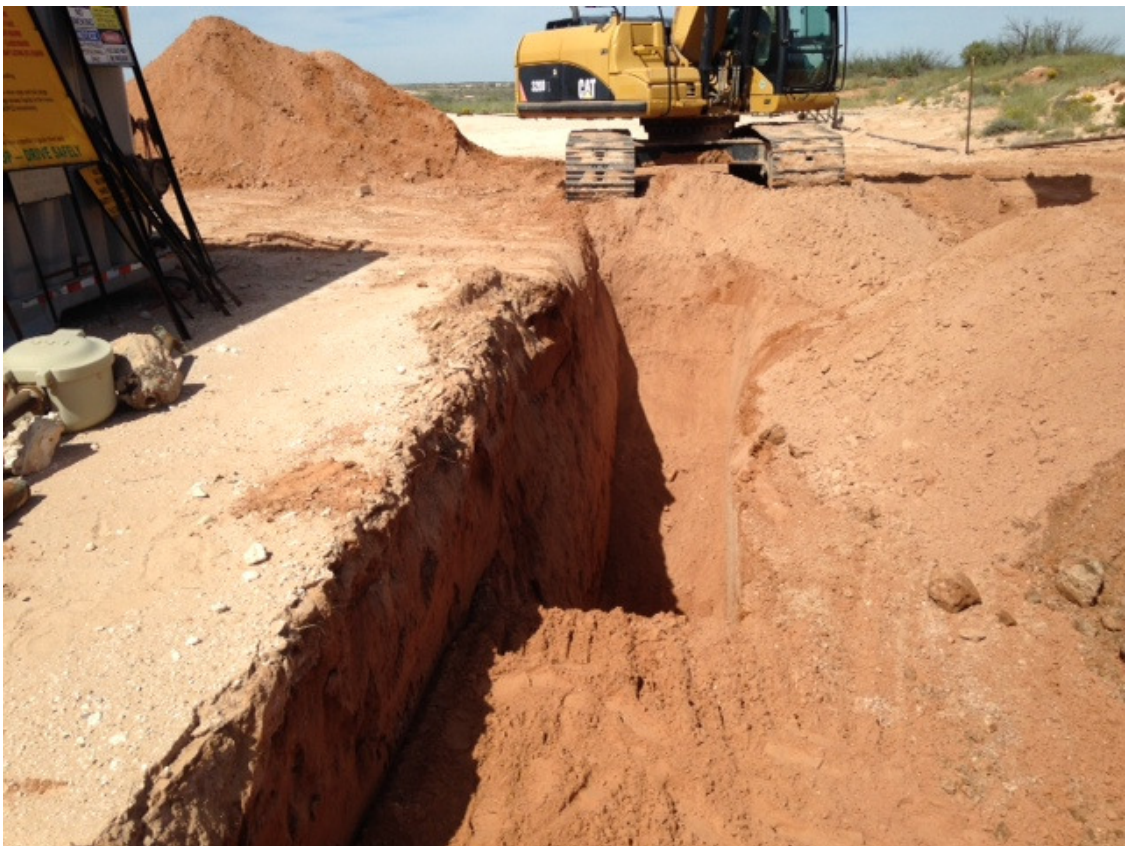
| SAMPLE LOCATION | SAMPLE DEPTH (BGS) | SAMPLE DATE | SOIL STATUS | METHOD: EPA SW 846-8021B, 5030 | | | | | METHOD: 8015M | | | TOTAL | 4500 Cl-B<br>CHLORIDE (mg/Kg) |
|---|---|---|---|---|---|---|---|---|---|---|---|---|---|
| WSW @ 10' (Conf) | 10' | 10/7/2014 | In-Situ | - | - | - | - | - | Pending | Pending | Pending | Pending | 556* |

Photograph of the collection of soil sample WSW @ 10'.
