J.L. Keel A #10

Corrective Action Plan

API No. 30-015-05098

April 4th, 2014

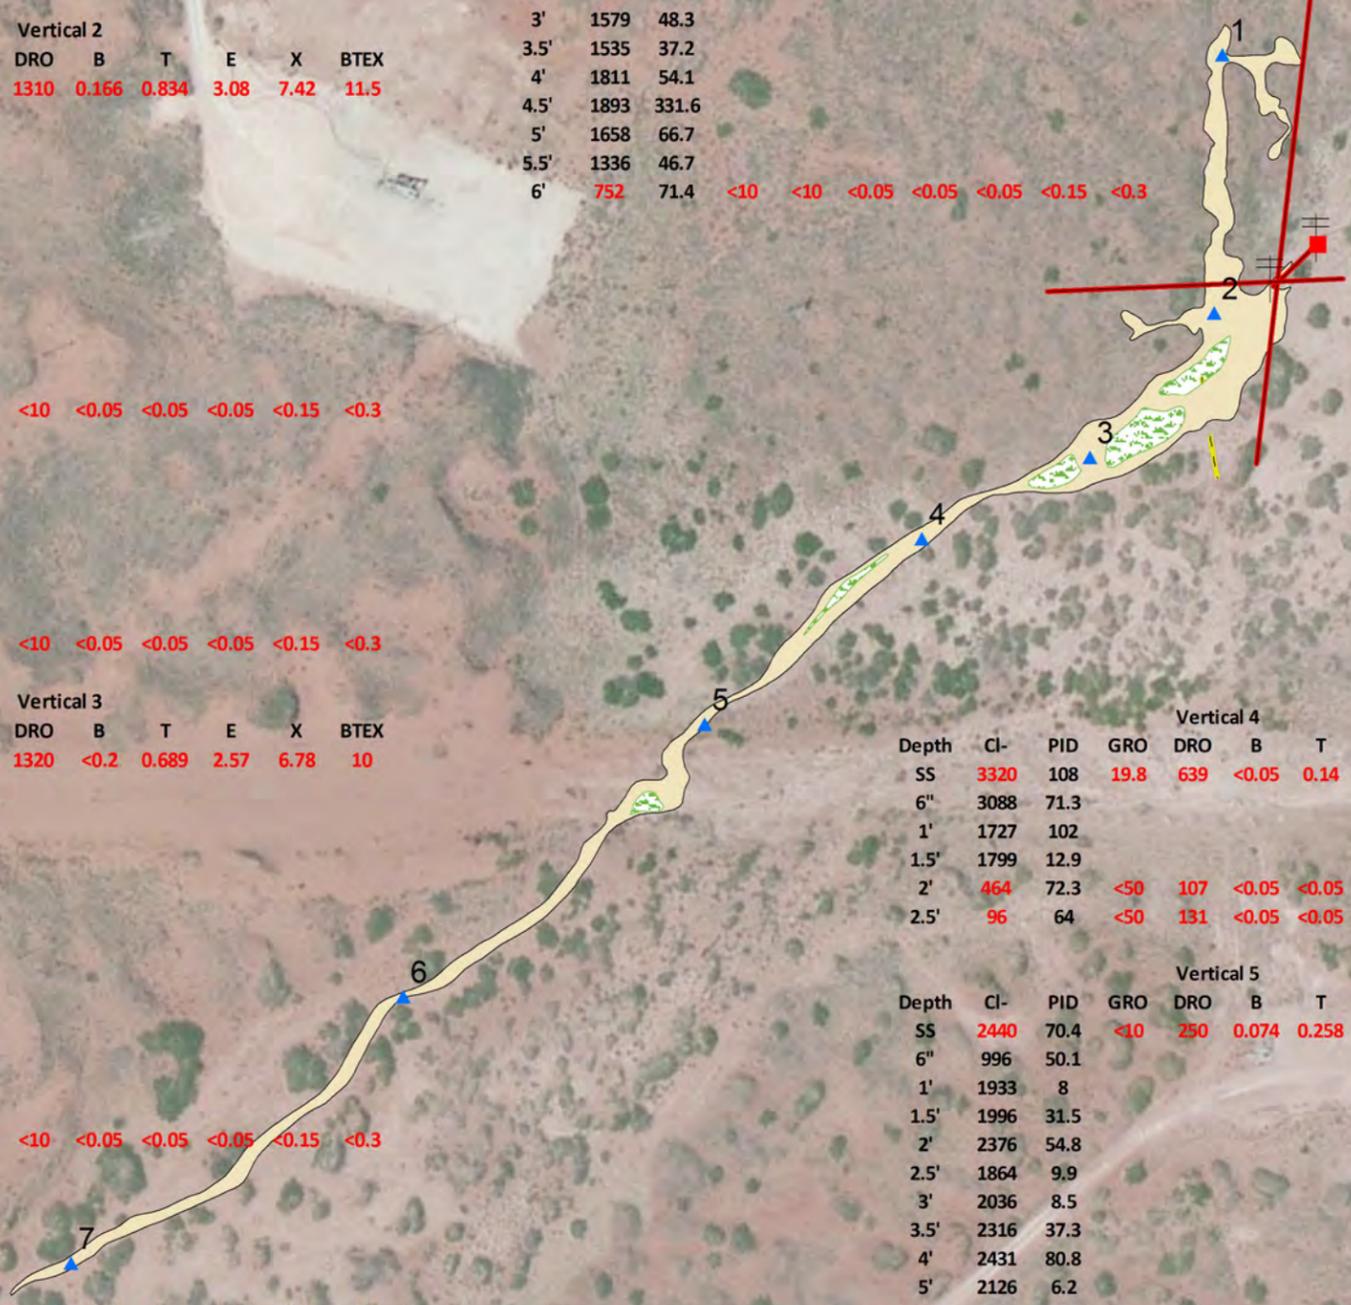
Figure 1

RECS personnel were on site beginning on December 31st, 2013 to assess the release. Seven points from within the release were sampled at the surface and with depth (Figure 1). All samples were field tested for chlorides and organic vapors, and representative samples were taken to a commercial laboratory for analysis (Appendix B). Vertical 1 was installed by hand augur and then backhoe to a depth of 12 ft bgs. At 12 ft bgs, the laboratory chloride concentration returned a result of 1,230 mg/kg. Vertical 3 was installed by hand augur and then backhoe to a depth of 15 ft bgs. At 15 ft bgs, the laboratory chloride concentration returned a result of 1,440 mg/kg. The remainder of verticals installed at the site achieved chloride values below regulatory standards at the bottom of each vertical.

Vertical 1									
Depth	Cl-	PID	GRO	DRO	B	T	E	X	BTEX
SS	1720	2030	7850	31500	16.1	170	208	336	729
6"	2775	1445							
1'	3265	478							
1.5'	3087	363							
2'	3058	391							
2.5'	3754	123							
3'	3493	253							
3.5'	4249	112							
4'	5907	216							
4.5'	4052	197							
5'	5679	176							
5.5'	6354	231							
6'	5932	169							
7'	5680	3.1	<10	<10	<0.05	<0.05	<0.05	<0.15	<0.3
8'	3460	2.9							
9'	1470	2.3							
10'	1234	1.1							
11'	1136	0.6							
12'	1230	0.4	<10	<10	<0.05	<0.05	<0.05	<0.15	<0.3

Vertical 2									
Depth	Cl-	PID	GRO	DRO	B	T	E	X	BTEX
SS	20000	316	60	1310	0.166	0.834	3.08	7.42	11.5
6"	5515	481.5							
1'	2441	179.2							
1.5'	3313	104.3							
2'	3784	57.7							
2.5'	3569	442.8							
3'	3500	30.2							
3.5'	2414	68.7							
4'	2250	371.2							
5'	3170	3.2							
6'	3575	3.4							
7'	4320	4.1	<10	<10	<0.05	<0.05	<0.05	<0.15	<0.3
8'	3299	1.7							
9'	2612	1.4							
10'	3611	1.8							
11'	2913	1.3							
12'	1619	0.8							
13'	854	0.7							
14'	1858	0.9							
15'	336	0.6	<10	<10	<0.05	<0.05	<0.05	<0.15	<0.3

Vertical 3									
Depth	Cl-	PID	GRO	DRO	B	T	E	X	BTEX
SS	8800	434	215	1320	<0.2	0.689	2.57	6.78	10
6"	2971	121.3							
1'	1331	57.1							
1.5'	1470	7.8							
2'	1566	7.4							
2.5'	1532	13.3							
3'	1430	15.1							
3.5'	1947	10.3							
4'	1452	4.8							
5'	1416	3.5							
6'	1977	1.7							
7'	2053	2.1							
8'	2558	3.2							
9'	2520	1.1	<10	<10	<0.05	<0.05	<0.05	<0.15	<0.3
10'	1896	1.2							
11'	2399	0.8							
12'	2192	1							
13'	1679	1.7							
14'	1358	1.5							
15'	1440	1.2	<10	<10	<0.05	<0.05	<0.05	<0.15	<0.3

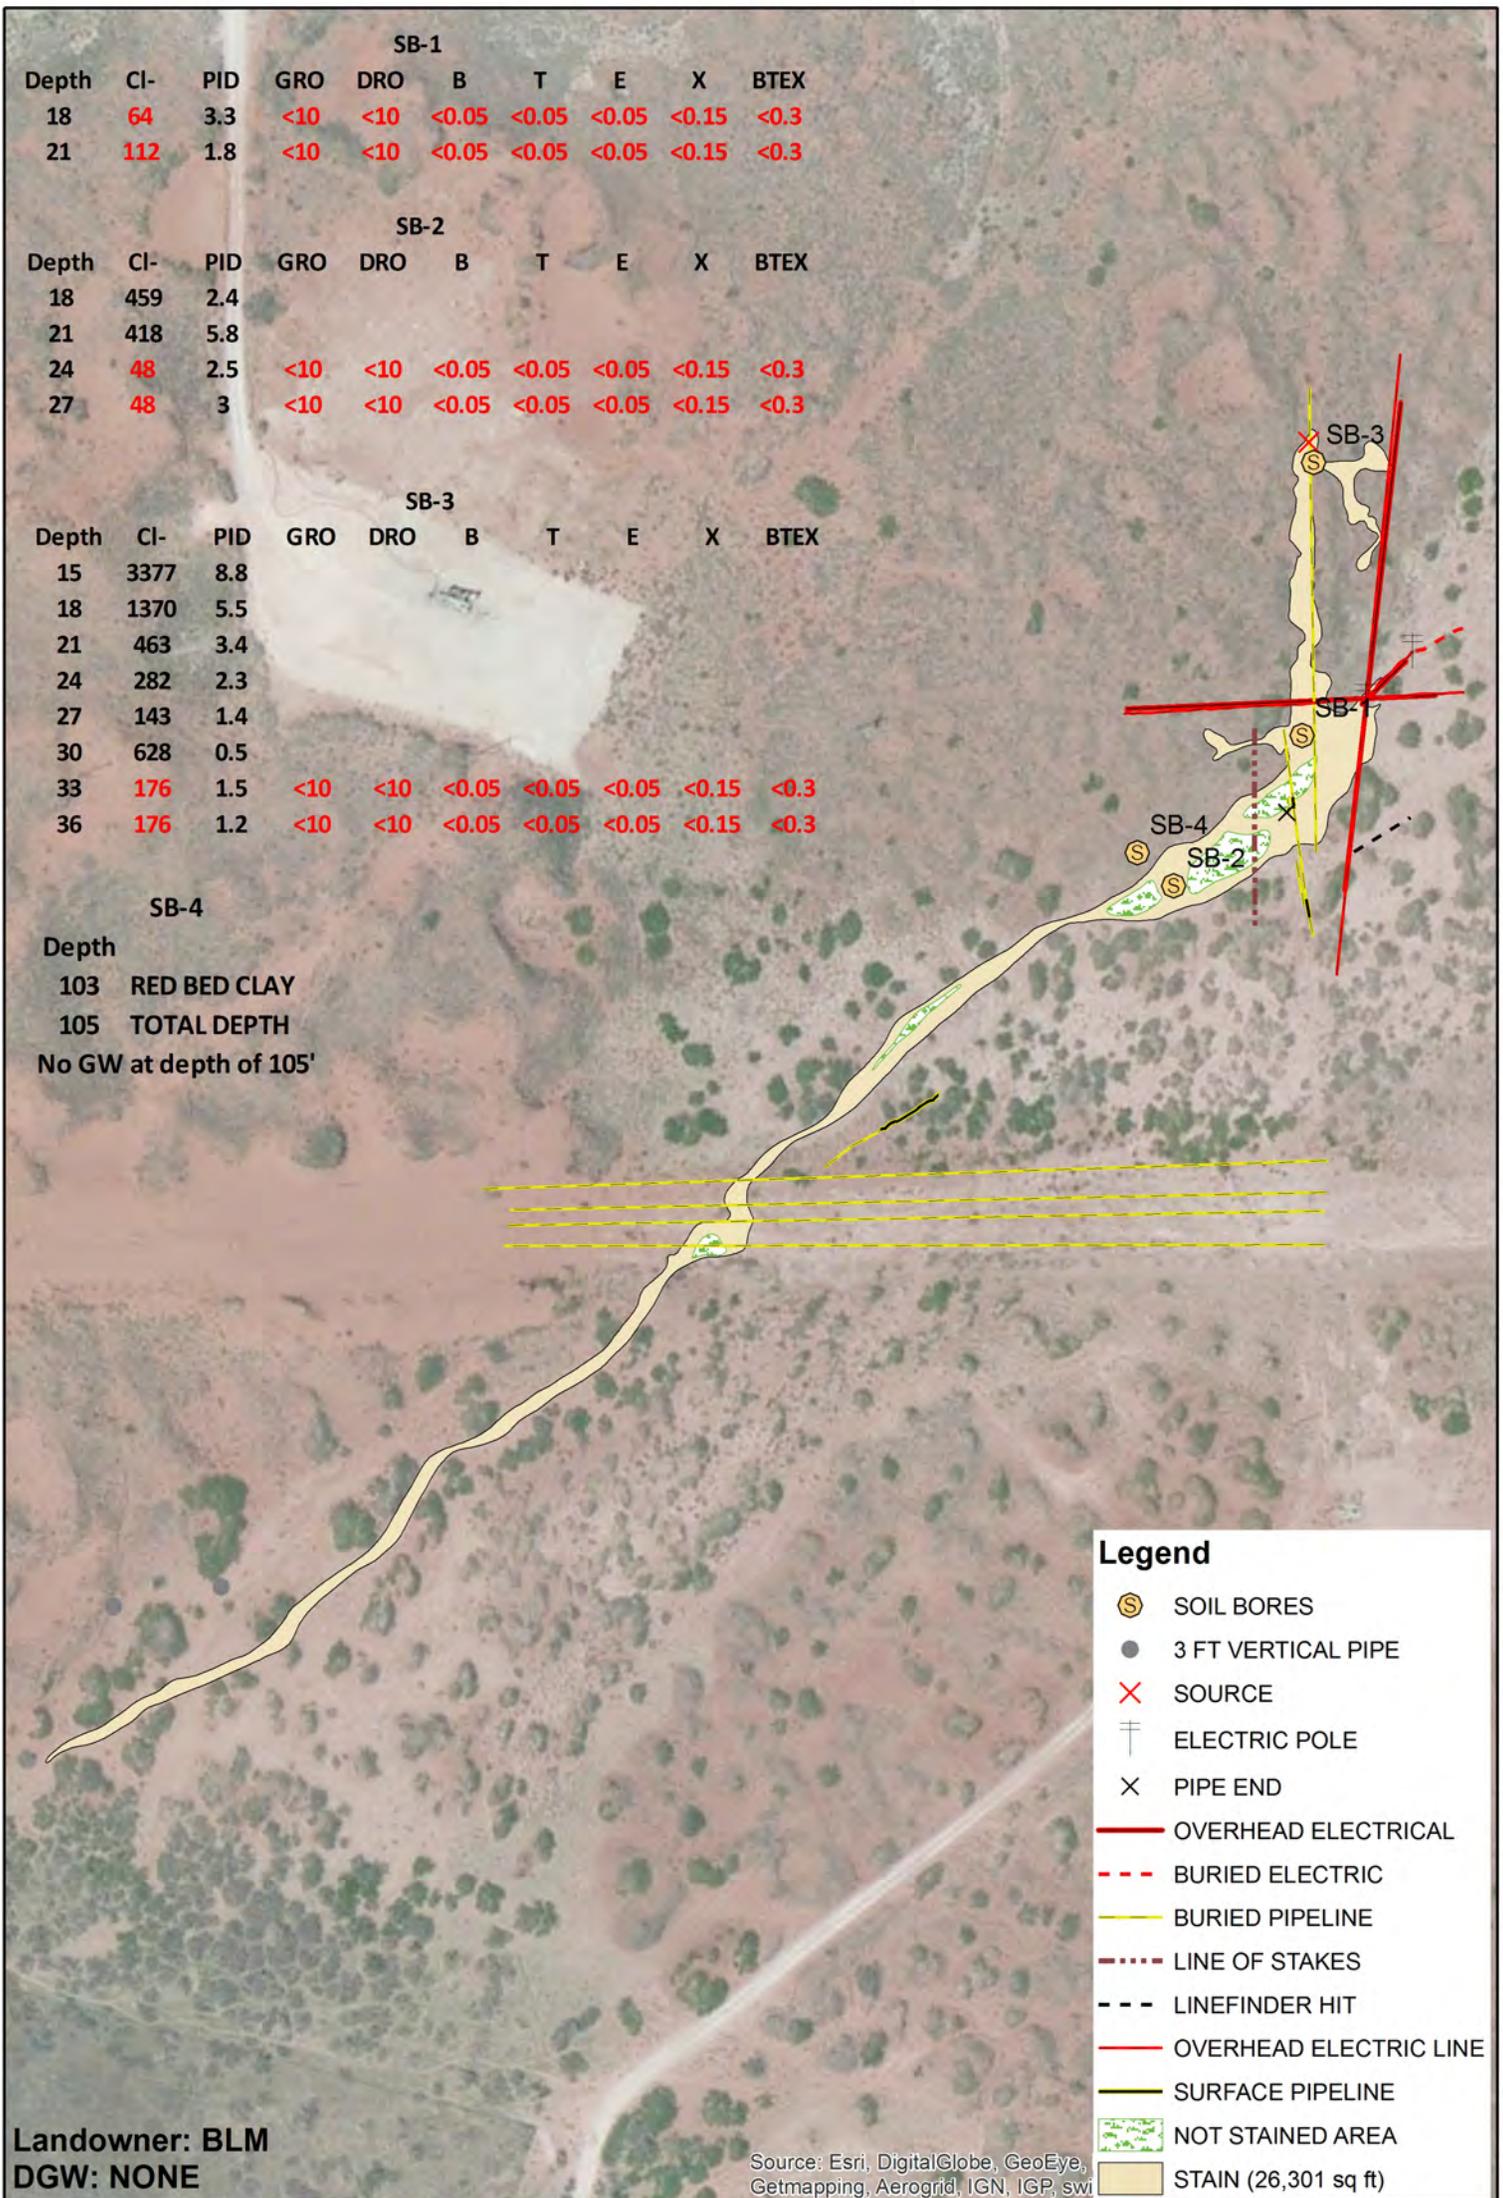
Figure 2

In order to further delineate the chloride concentrations in the vadose zone, three soil bores were installed on February 19th, 2014 (Figure 2). The soil bores were installed over Verticals 1-3. As the bores were advanced, samples were taken at regular intervals and field tested for chlorides and hydrocarbons. Representative samples from each bore were taken to a commercial laboratory for analysis. SB-1 returned laboratory chloride readings of 64 mg/kg at 18 ft bgs and 112 mg/kg at 21 ft bgs. SB-2 returned laboratory chloride readings of 48 mg/kg at 24 and 27 ft bgs. SB-3 returned laboratory chloride readings of 176 mg/kg at 33 and 36 ft bgs. GRO, DRO and BTEX results were non-detect (Appendix C).

SB-4 was installed outside the release area to confirm that groundwater was not present at the site. The bore was installed to a depth of 105 ft bgs. At 103 ft bgs, red bed clay was encountered that indicated the bottom of the aquifer. The bore was left open for over 48 hours and on February 25th, 2014, the bore was gauged to determine depth to groundwater. No groundwater was discovered in the bore to a depth of 105 ft bgs.
