Russell Turner Water Station

CLOSURE REPORT

Release Date: June 6, 2014

RP# 2RP-2338

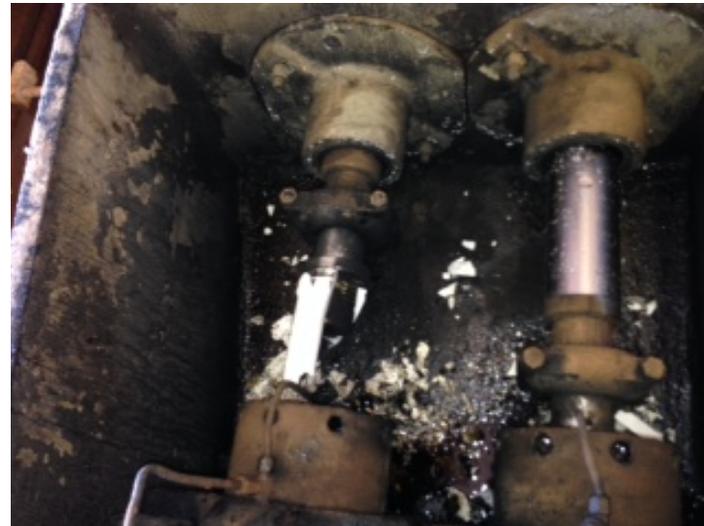
Describe Cause of Problem and Remedial Action Taken.*: Pulled up to water station doing my daily routine, triplex pump had water shooting up inside waterstation. Plunger on triplex Pump broke completely off, causing water to shoot out, swamp pump inside water station sucked all water and pumped into fiberglass swamp tank, causing it to overflow and spill over.

Source of leak 06/09/14

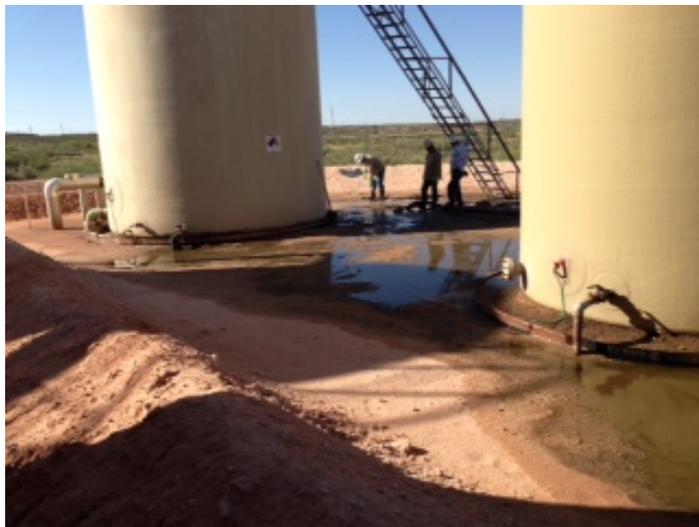
Describe Area Affected and Cleanup Action Taken.* : Area affected was 66ft ong X 51 ft Wide, all inside the dike. Water truck was used on leak site and picked 60barrels/BSG roustabout gang helped pick up water.

Impacted area inside berm 06/09/14

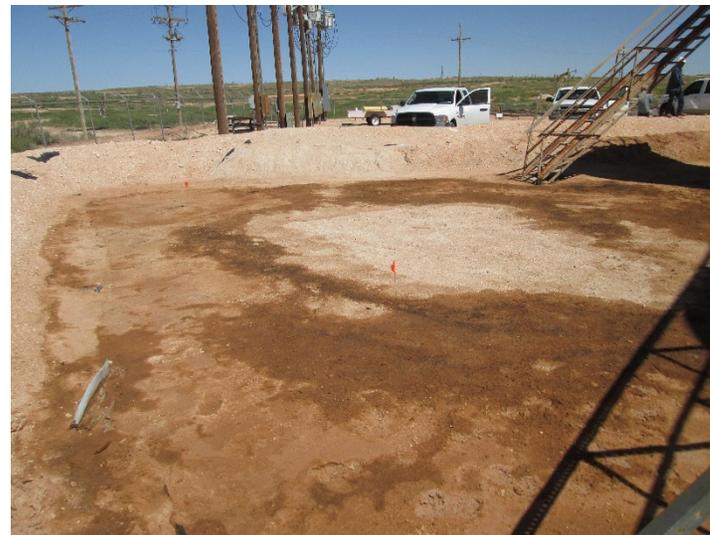
Site after fluid recovery 06/09/14

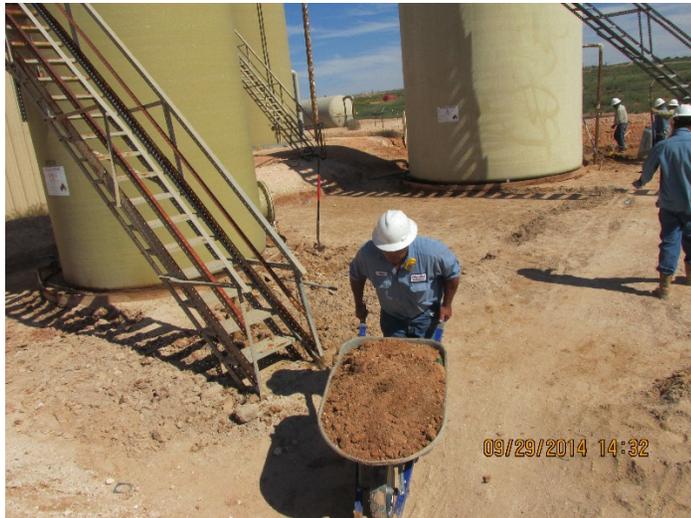
Digging out contaminated soil, hauling 09/29/14

Visually impacted soils were excavated throughout the entire leak area and removed to a NMOCD approved disposal facility.

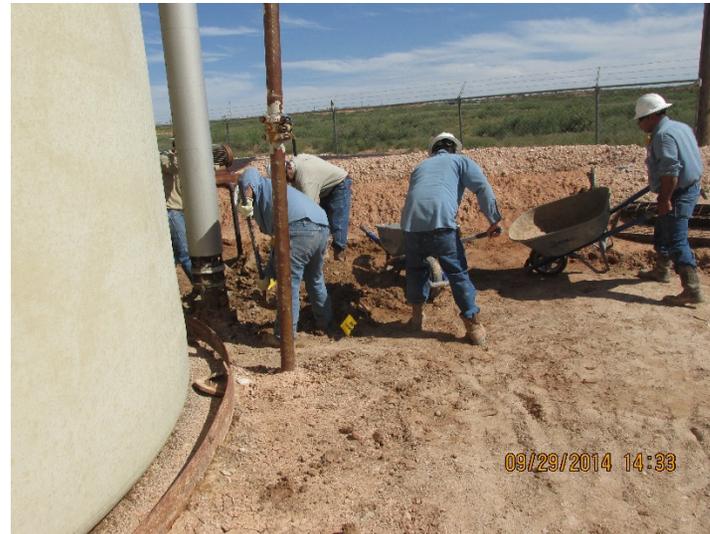
Hand-digging contaminated area 09/29/14

On September 26, 2014, DFSI personnel visited the site to begin excavation. DFSI personnel returned on September 29, and on October 7 to hand-dig out the area to 1' below ground surface (bgs).

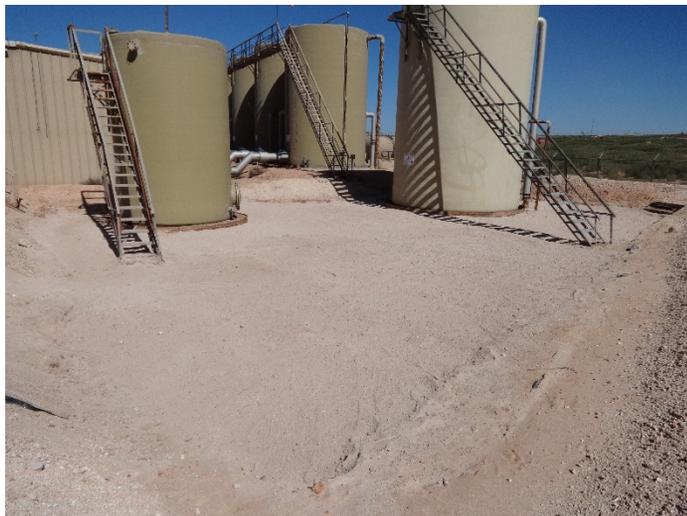
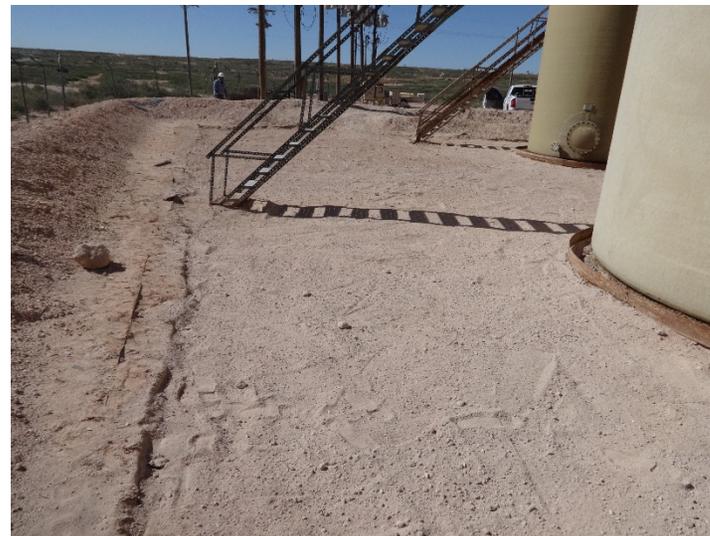
Area fully excavated before backfill 10/07/14

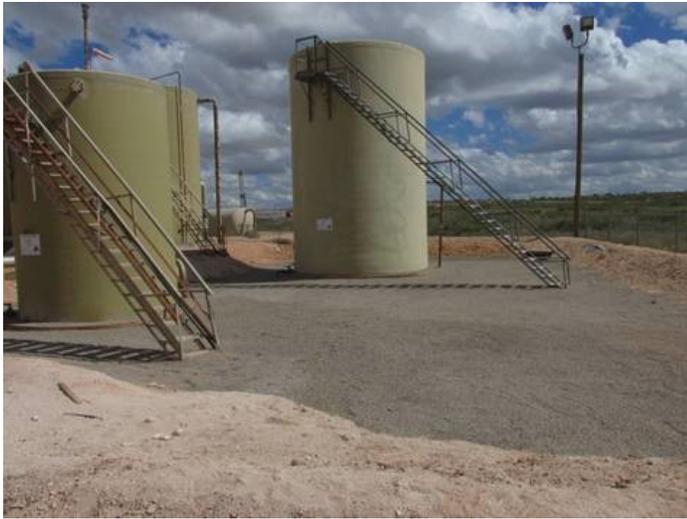
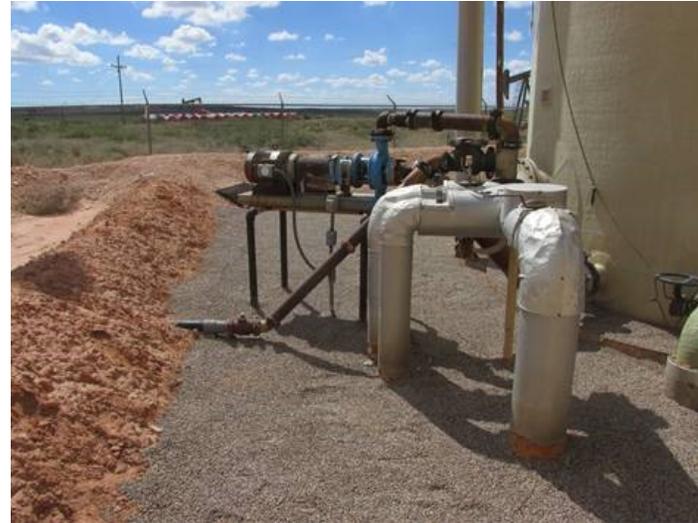
Site with backfill completed 10/10/14

On October 10, pea gravel was brought in to backfill the excavated area. Photographs of site activities can be viewed in Appendix II.

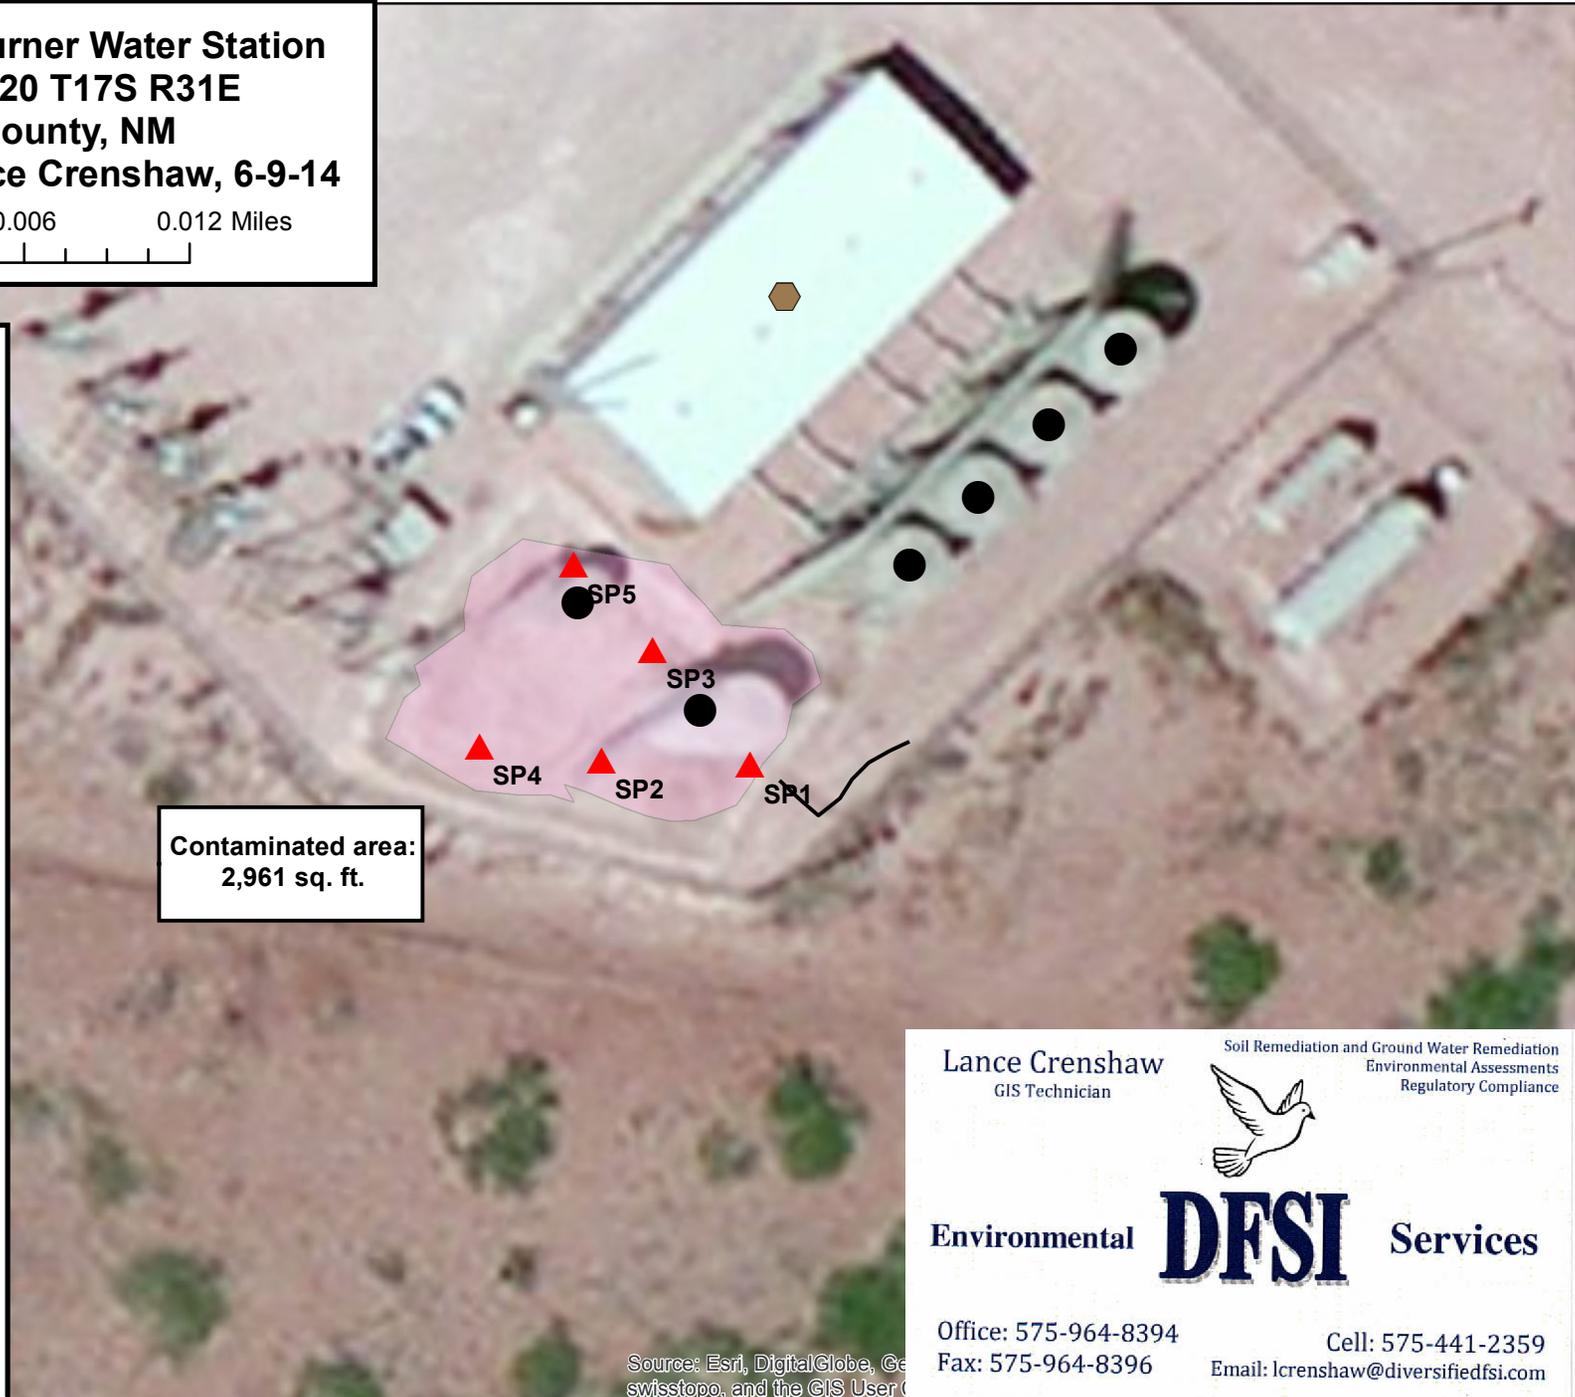
Site Diagram

Contaminated area:
2,961 sq. ft.
