SUBJECT: SOIL REMEDIATION WORKPLAN FOR INCIDENT 2RP-2918 SCARED HAWK STATE COM #1, EDDY COUNTY, NEW MEXICO

# SOIL REMEDIATION WORKPLAN FOR INCIDENT 2RP-2918

SCARED HAWK STATE COM #1
API# 30-015-35102
SECTION 4, T25S R28E, NMPM
EDDY COUNTY, NM

June 22, 2015 SMA Reference 5B23978 BG6

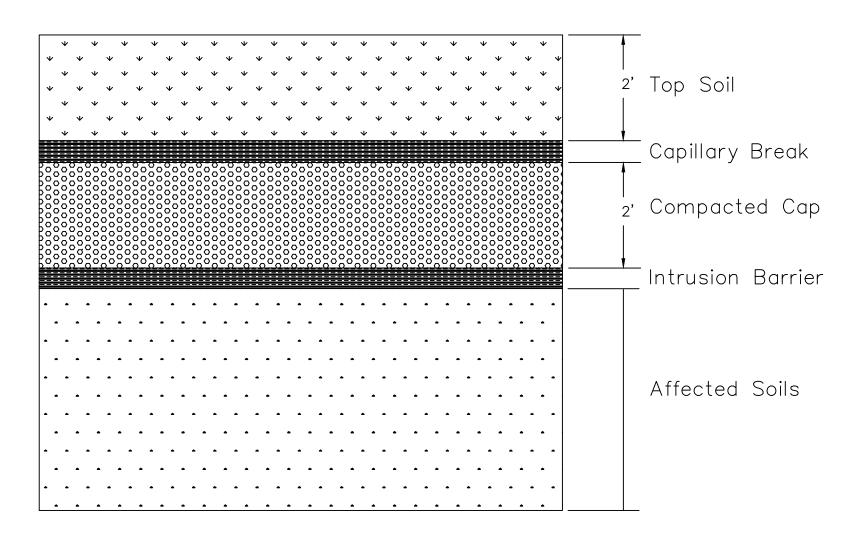
# FIGURE 3 IN-SITU CAP AND BIO BARRIER DESIGN

Figure 3: Proposed In—situ Cap and Biobarrier Design

have been removed in the horizontal extent. Closure samples will be collected at the final depth of excavation. Excavation will be conducted to three feet bsg in the spill area to remove the soils affected by the release. An in-situ cap will be constructed within the excavation. The construction of the in-situ cap (Figure #3) has been designed to prevent both capillary and leaching movement of the brine affected soils contained beneath. Starting from three feet below surface grade, a plastic liner will be added as a capillary break between the affected soils and the proposed caliche cap. The cap will consist of two feet of contaminant-free caliche material placed, and compacted. Then, a geo-synthetic liner will be added above the compacted caliche cap to form an intrusion barrier. This barrier will prevent leaching and formation of deep root systems into the cap itself. Topsoil will then be placed on top of the cap. The plastic liner on both sides of the caliche cap will effectively break the communication of precipitation through the compacted cap. After excavation, installation of in-situ cap, and backfill, a minimum of 18 inches of topsoil will be added to help with contouring of the area and to promote vegetation growth. Approximately 1,444 cubic yards of contaminated soil will be removed and replaced with the cap and clean backfill material to bring the excavated area to surface grade. The contaminated soil will be transported for disposal at Lea Land, near Carlsbad, NM.
