Report Type: Work Plan

Site:	Honey Graham 29 State Com #6H					
Company:	COG Operating LLC					
Section, Township and Range	Unit C	Sec 29	26S	28E		
Lease Number:	(API#) 30-015-38488					
County:	Eddy County					
GPS:	32.01908° N			104.11124° W		
Surface Owner:	State					
Mineral Owner:						
Directions:	From Malaga NM drive south 11.3 miles to County Rd 724. Turn West and drive 3 miles. Turn South and drive 3.1 miles. Turn East and drive 0.3 miles.

RE: Work Plan for the COG Operating LLC., Honey Graham 29 State Com. #6H, Unit C, Section 29, Township 26 South, Range 28 East, Eddy County, New Mexico.

Mr. Mike Bratcher
Work Plan for the COG Operating LLC.
Project Name: Honey Graham 29 State Com #6H

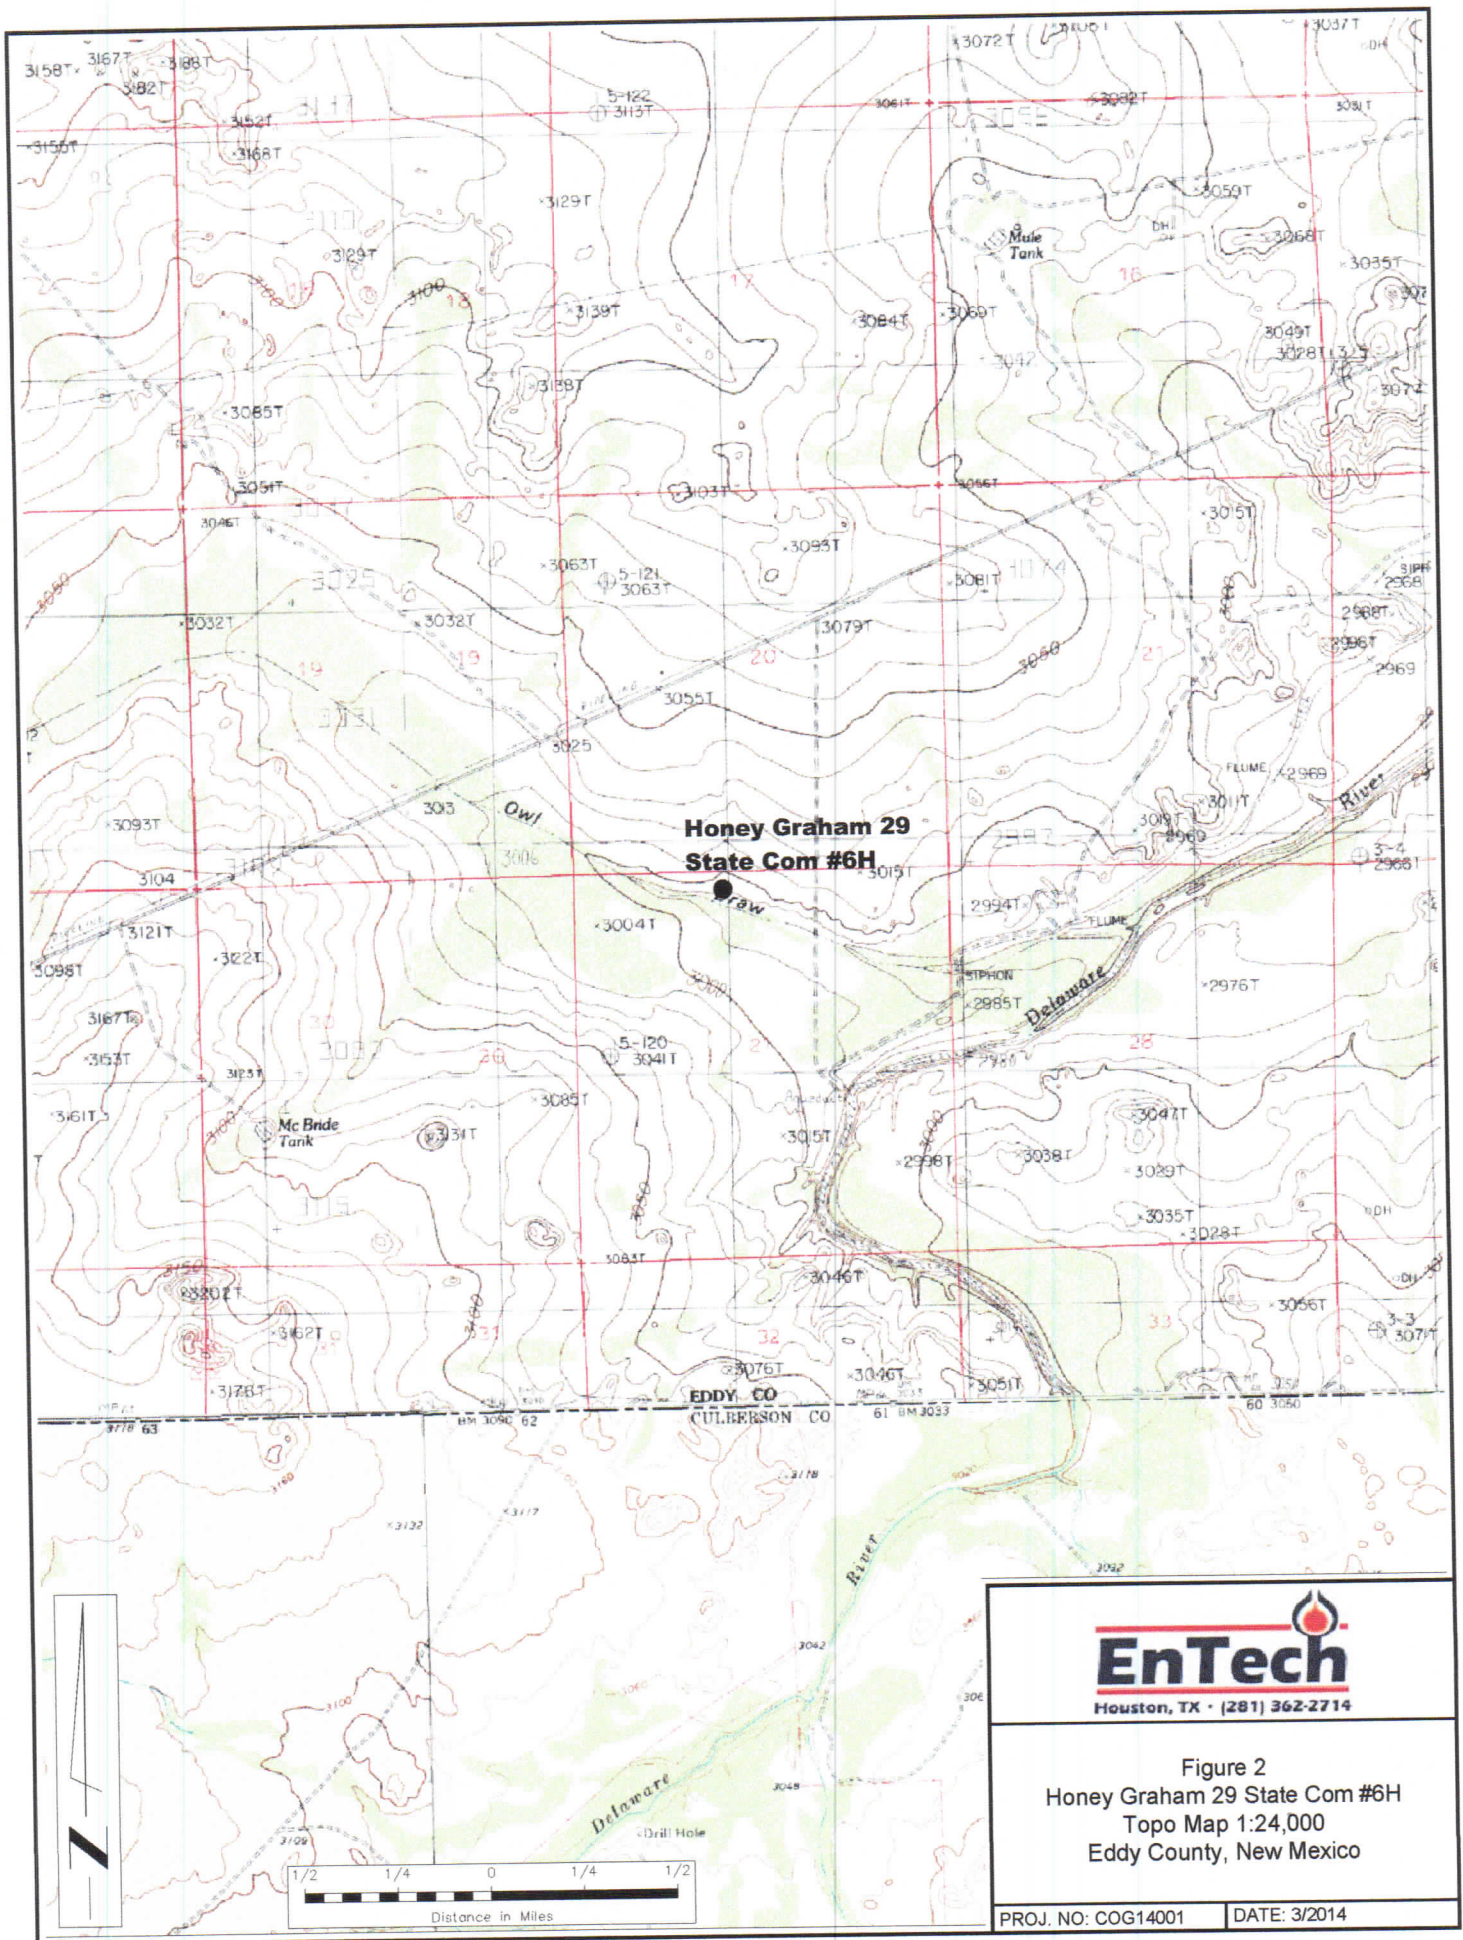
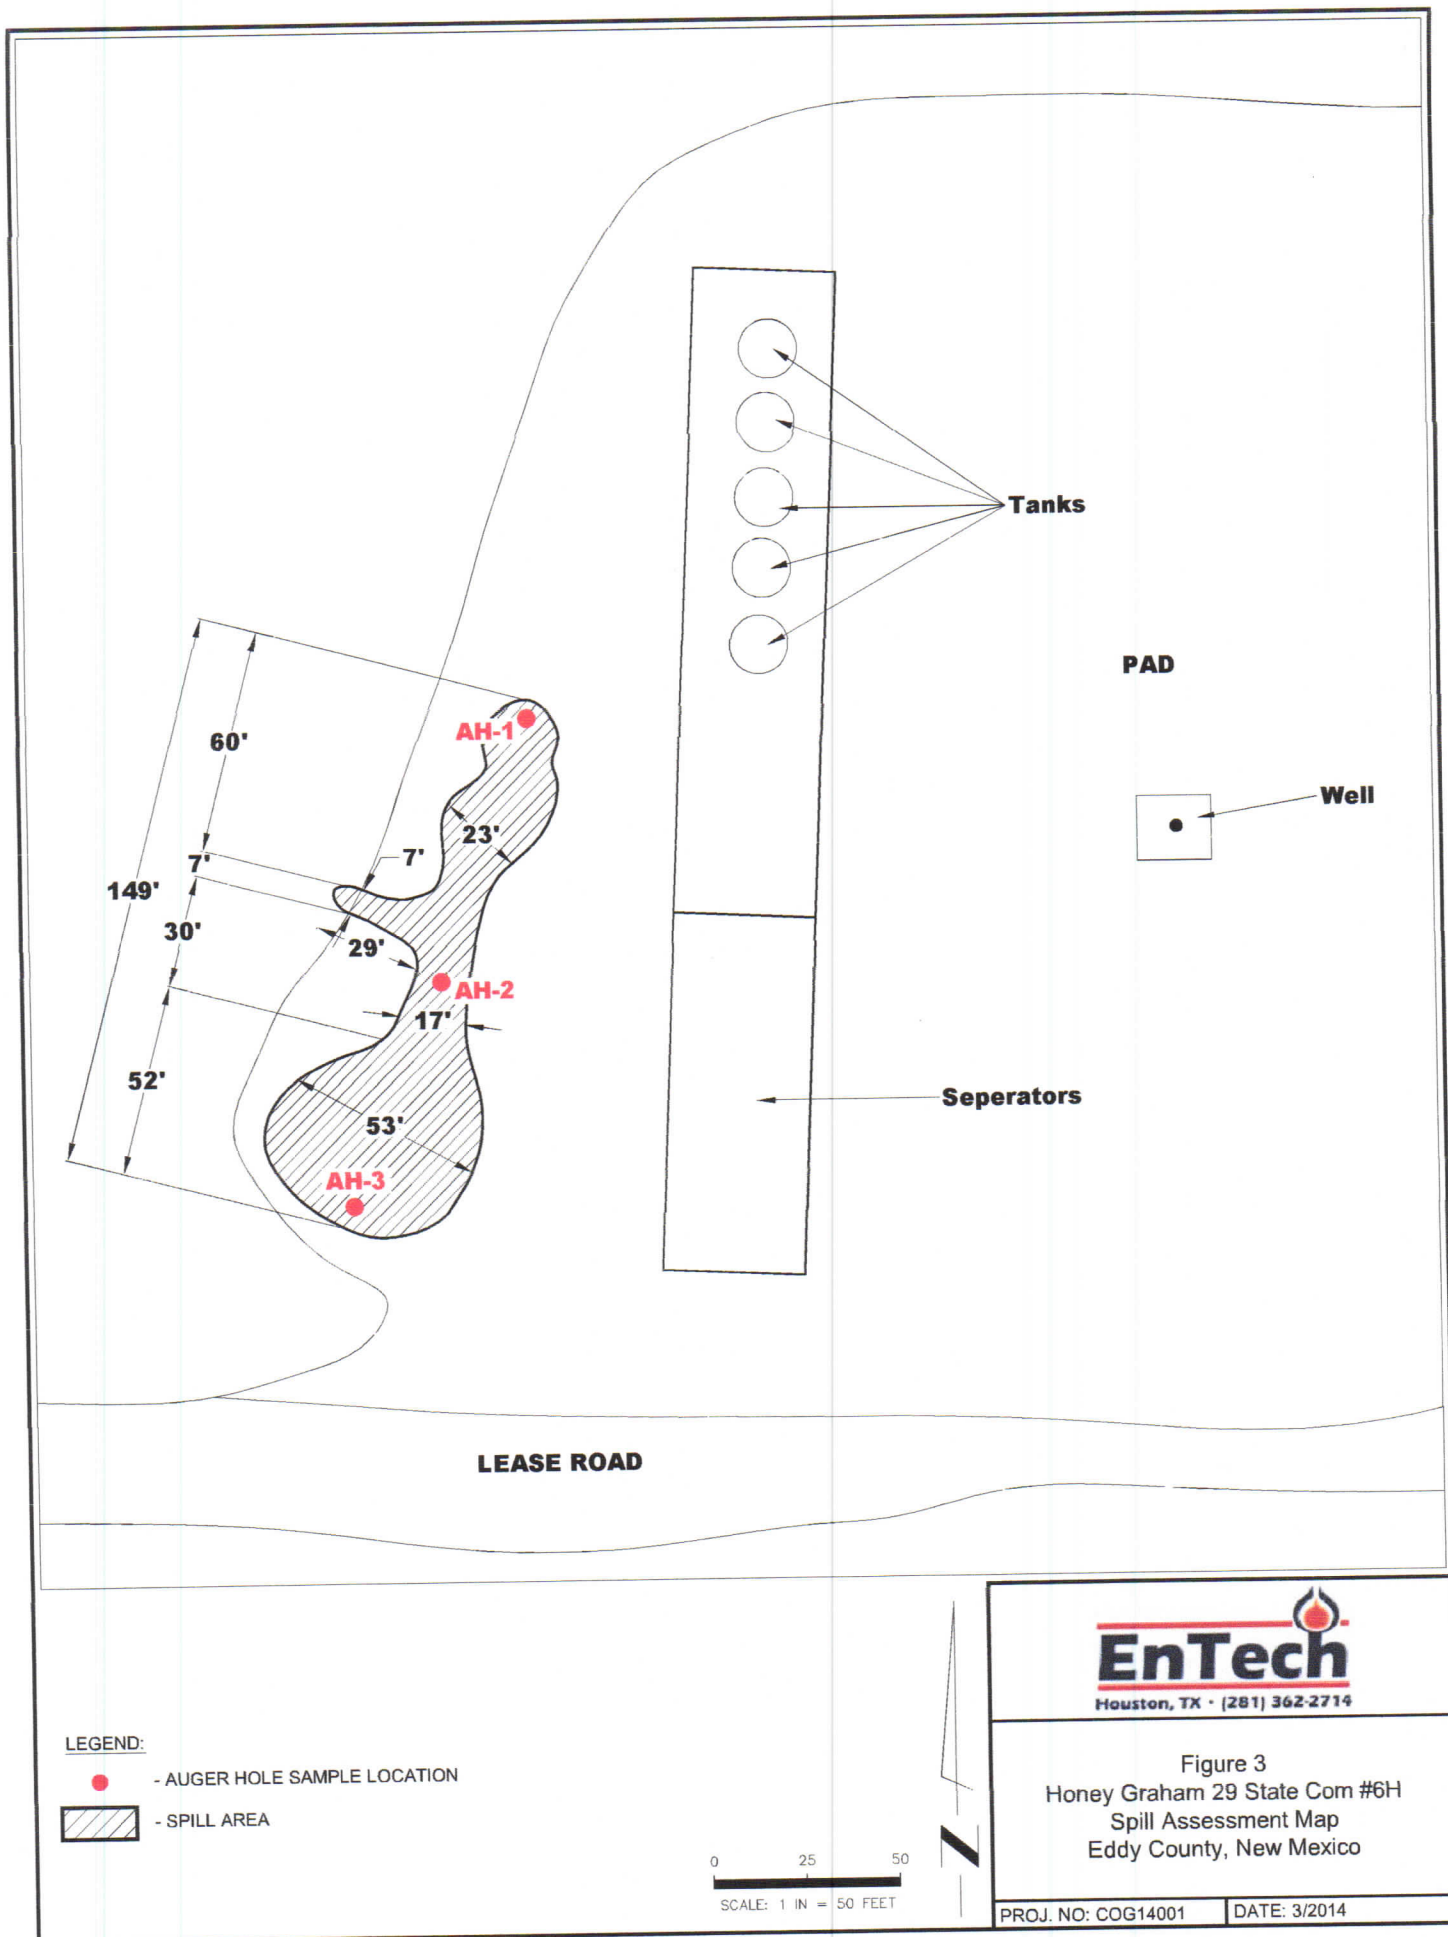
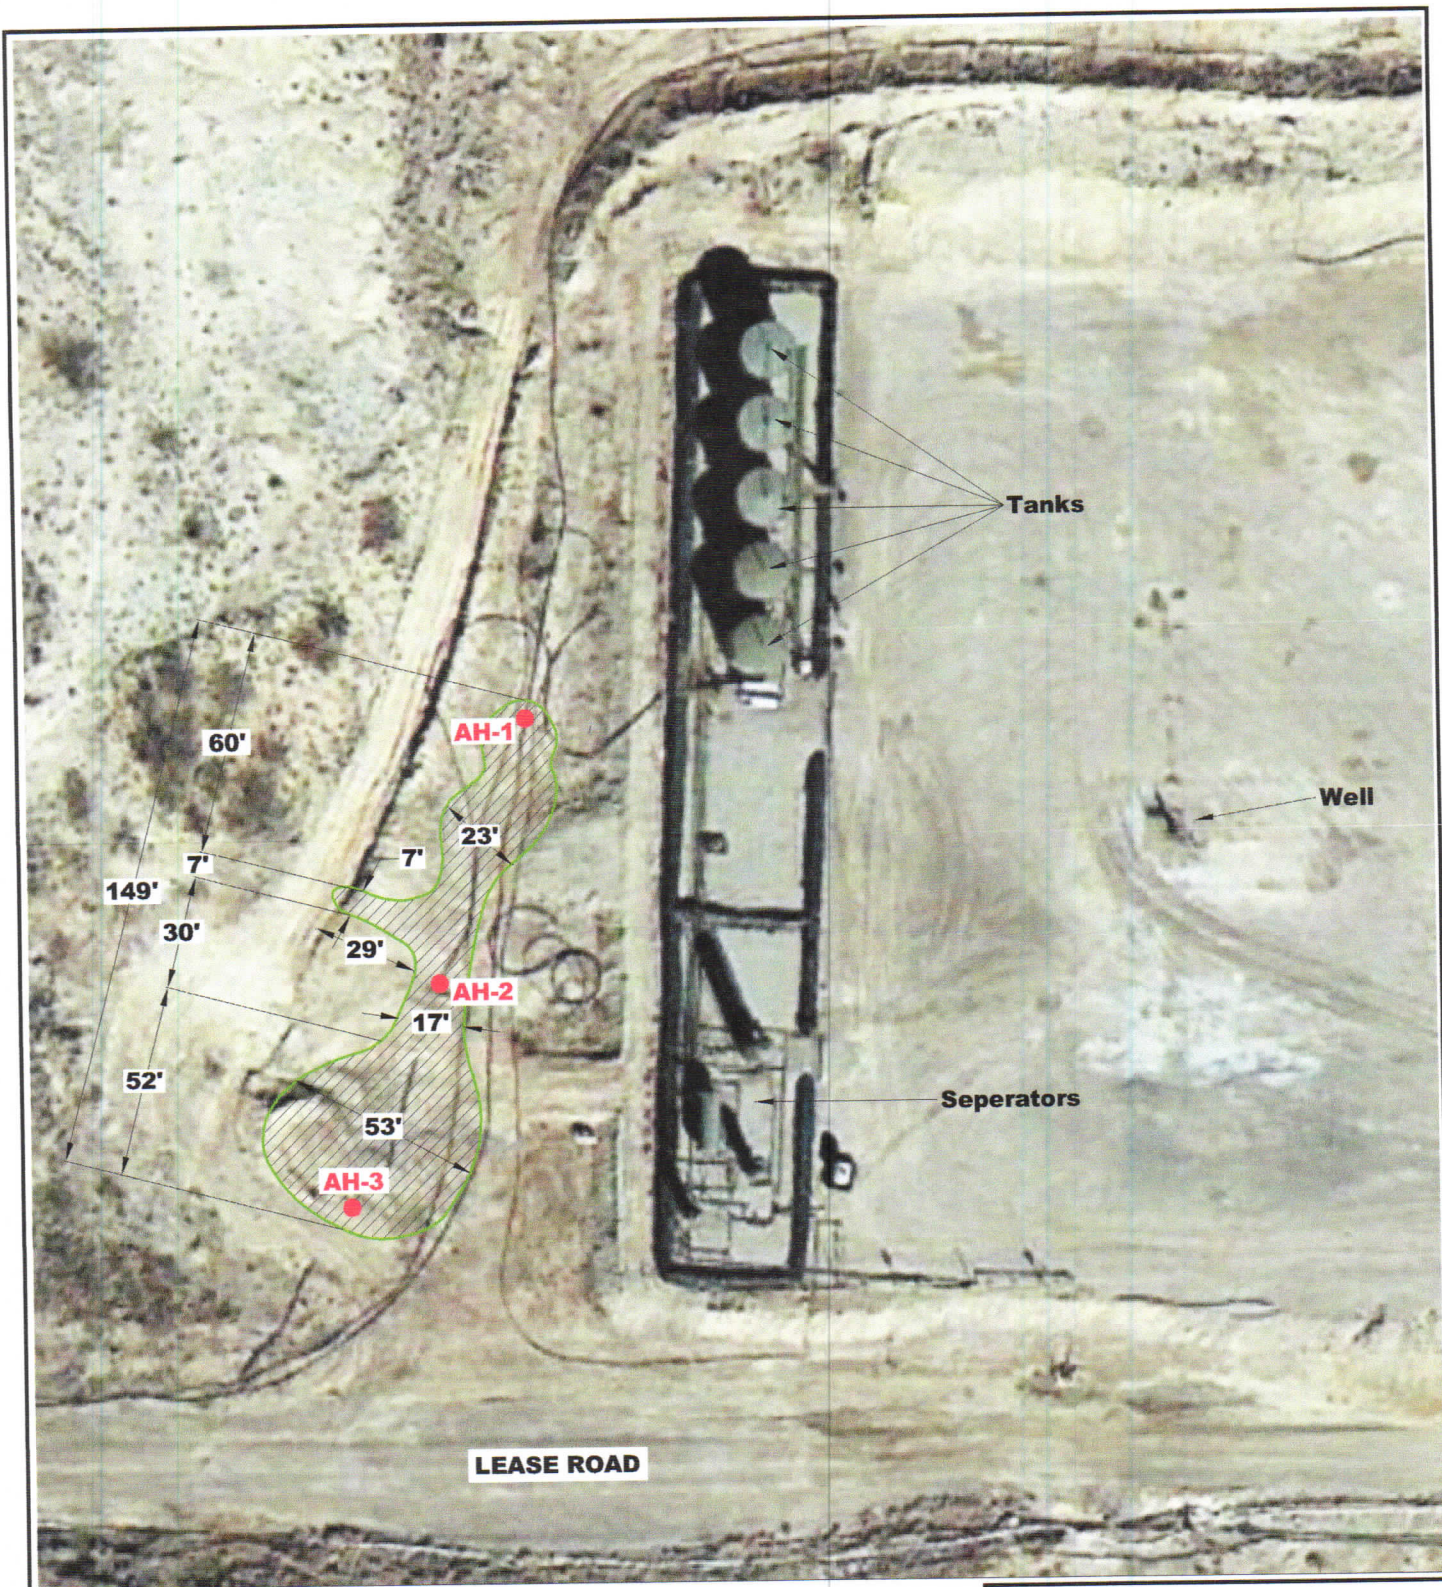
Figure 3
Honey Graham 29 State Com #6H
Spill Assessment Map
Eddy County, New Mexico

On February 20, 2014, EnTech personnel inspected and sampled the spill area. Three (3) auger holes (AH-1, AH-2 and AH-3) were installed using a stainless steel hand auger to assess the impacted soils (**Figure 4**). Samples were analyzed for TPH analysis by EPA Method 8015 modified, BTEX by EPA Method 8021B and chloride by EPA Method 300.0. The sampling results are summarized in **Table 1**. Copies of laboratory analysis and chain-of-custody documentation are included in **Appendix C**.

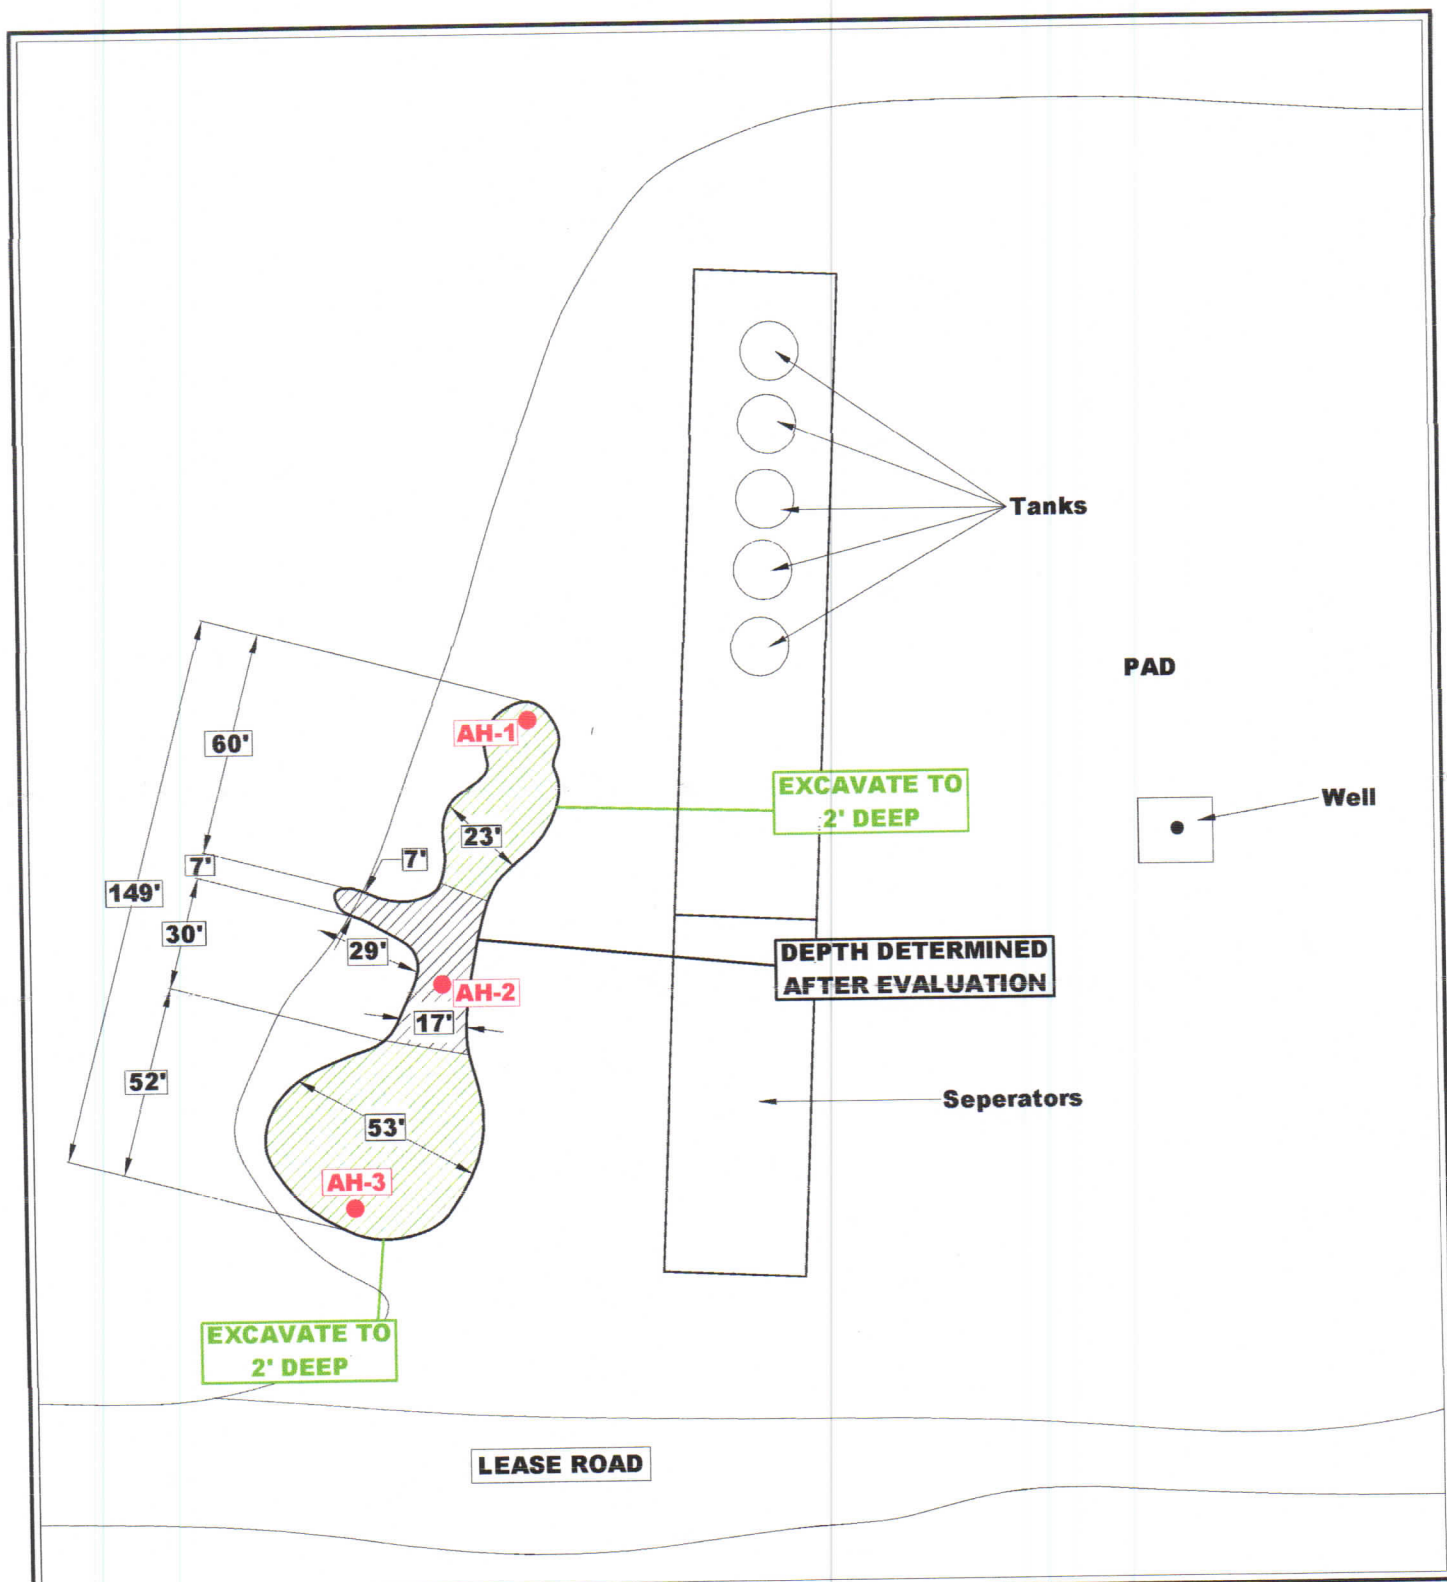
Figure 4
Honey Graham 29 State Com #6H
Proposed Excavation Areas & Depths Map
Eddy County, New Mexico

Referring to Table 1, none of the samples exceeded the TPH, BTEX, and benzene RRAL. However, elevated chloride concentrations were detected in all of the auger holes. Auger holes 1-3 showed shallow chloride impacts in the top foot ranging from 5790 mg/kg to 13,800 mg/kg. Chloride content declined with depth in each auger hole and virtually disappeared in AH #1 and AH #3 by 3.5 feet. AH #2 still shows a chloride concentration of 1,220 mg/kg at 3.5 feet below surface.

COG proposes to remove impacted material as highlighted (green) in **Table 1** and shown in **Figure 4**. The proposed excavation depth is estimated at 2' below surface in the vicinity of AH #1 and AH #3. In the area of AH #2, excavated depth will be determined during excavation based on chloride titrations done in the field. However, the excavation will be guided by visual evidence and chloride titration samples. Once the contaminated soils have been excavated and confirmation samples have confirmed the clean-up, the excavation will be backfilled with clean soil. The excavated soil will be transported to proper disposal.

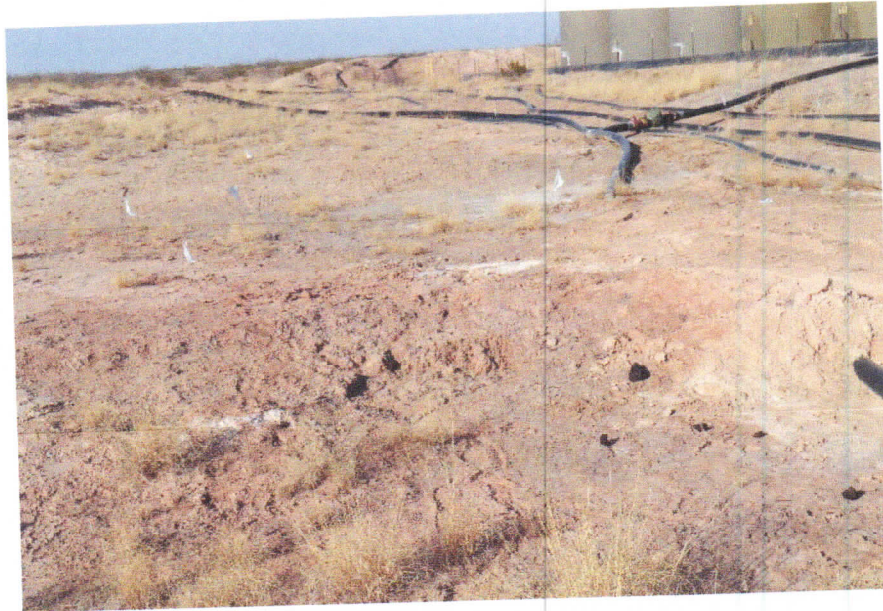
View looking North AH #1

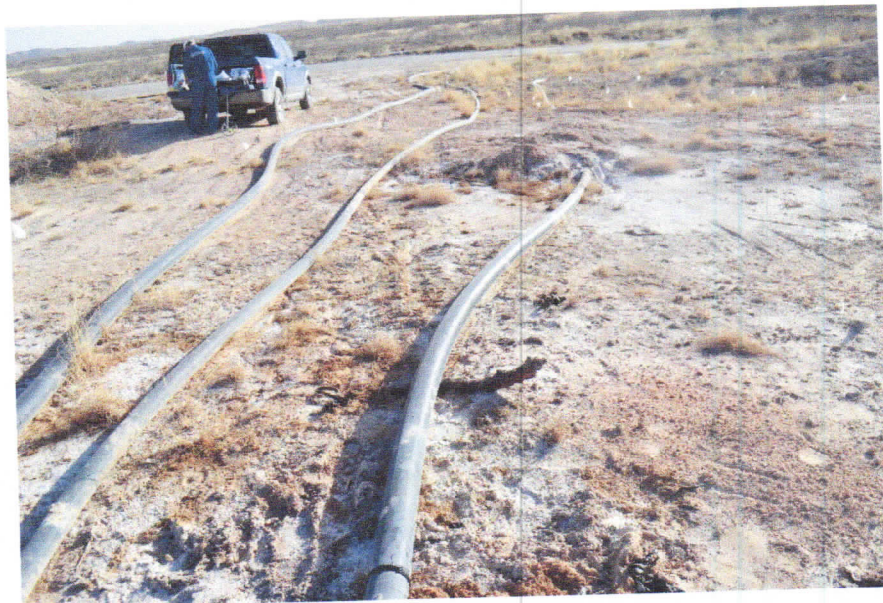
View looking South AH #2 and AH #3

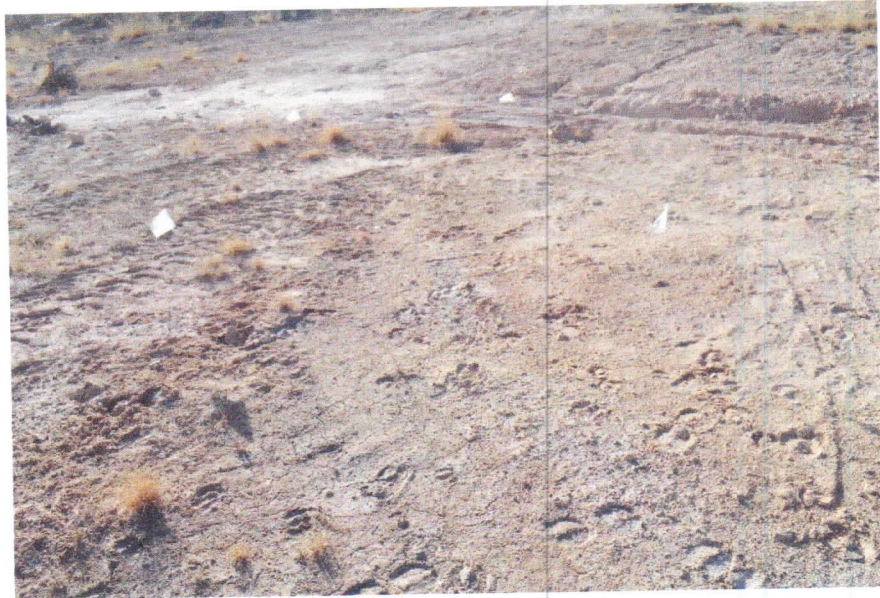
View looking West

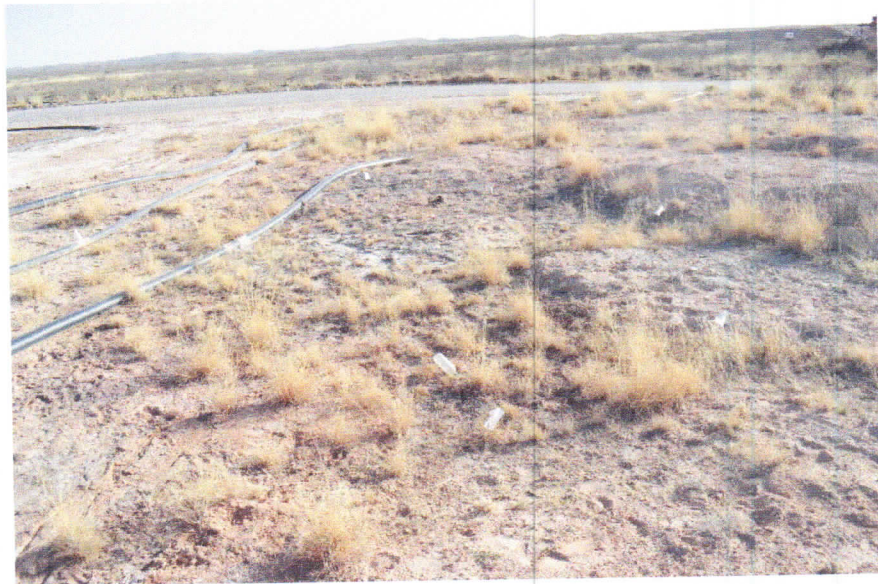
View looking South at low spot on South end near AH #3
