Remuda Basin Fed #2 SWD

REMEDIATION WORK PLAN

API No. 30-015-28901

July 14, 2015

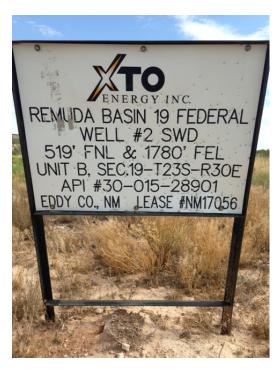
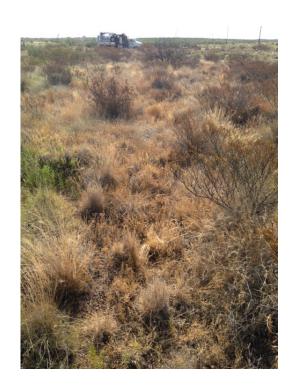
The site is located east of Loving, NM, in Eddy County. The leak site resulted from a hole, which developed in the injection line approximately 900' southwest of the well location. The impacted area is approximately 900' southwest of the well location in the pasture and ran west for approximately 300 yards. Approximately 160 bbls of produced water was released, and 0 bbls recovered. A C-141 was submitted to the NMOCD on July 14, 2015. The C-141 is attached.

Remove 3' to 4' bgs of the contaminated soil in the pasture. Lab samples can be obtained when the site is excavated. Haul all contaminated material to an approved NM state disposal. We will backfill with clean native soil around the injection line and use surrounding terrain the backfill the rest. We will re-seed using a BLM approved seed mix.
