**Devon Energy Production Co LP
Todd 24 Fed 2 Battery
API 30-015-27691
Delineation Report and Work Plan**

**Unit Letter B, Section 24, T23S, R31E
Eddy County, New Mexico
2RP-3051
2RP-1686
2RP-1391**

July 13, 2015

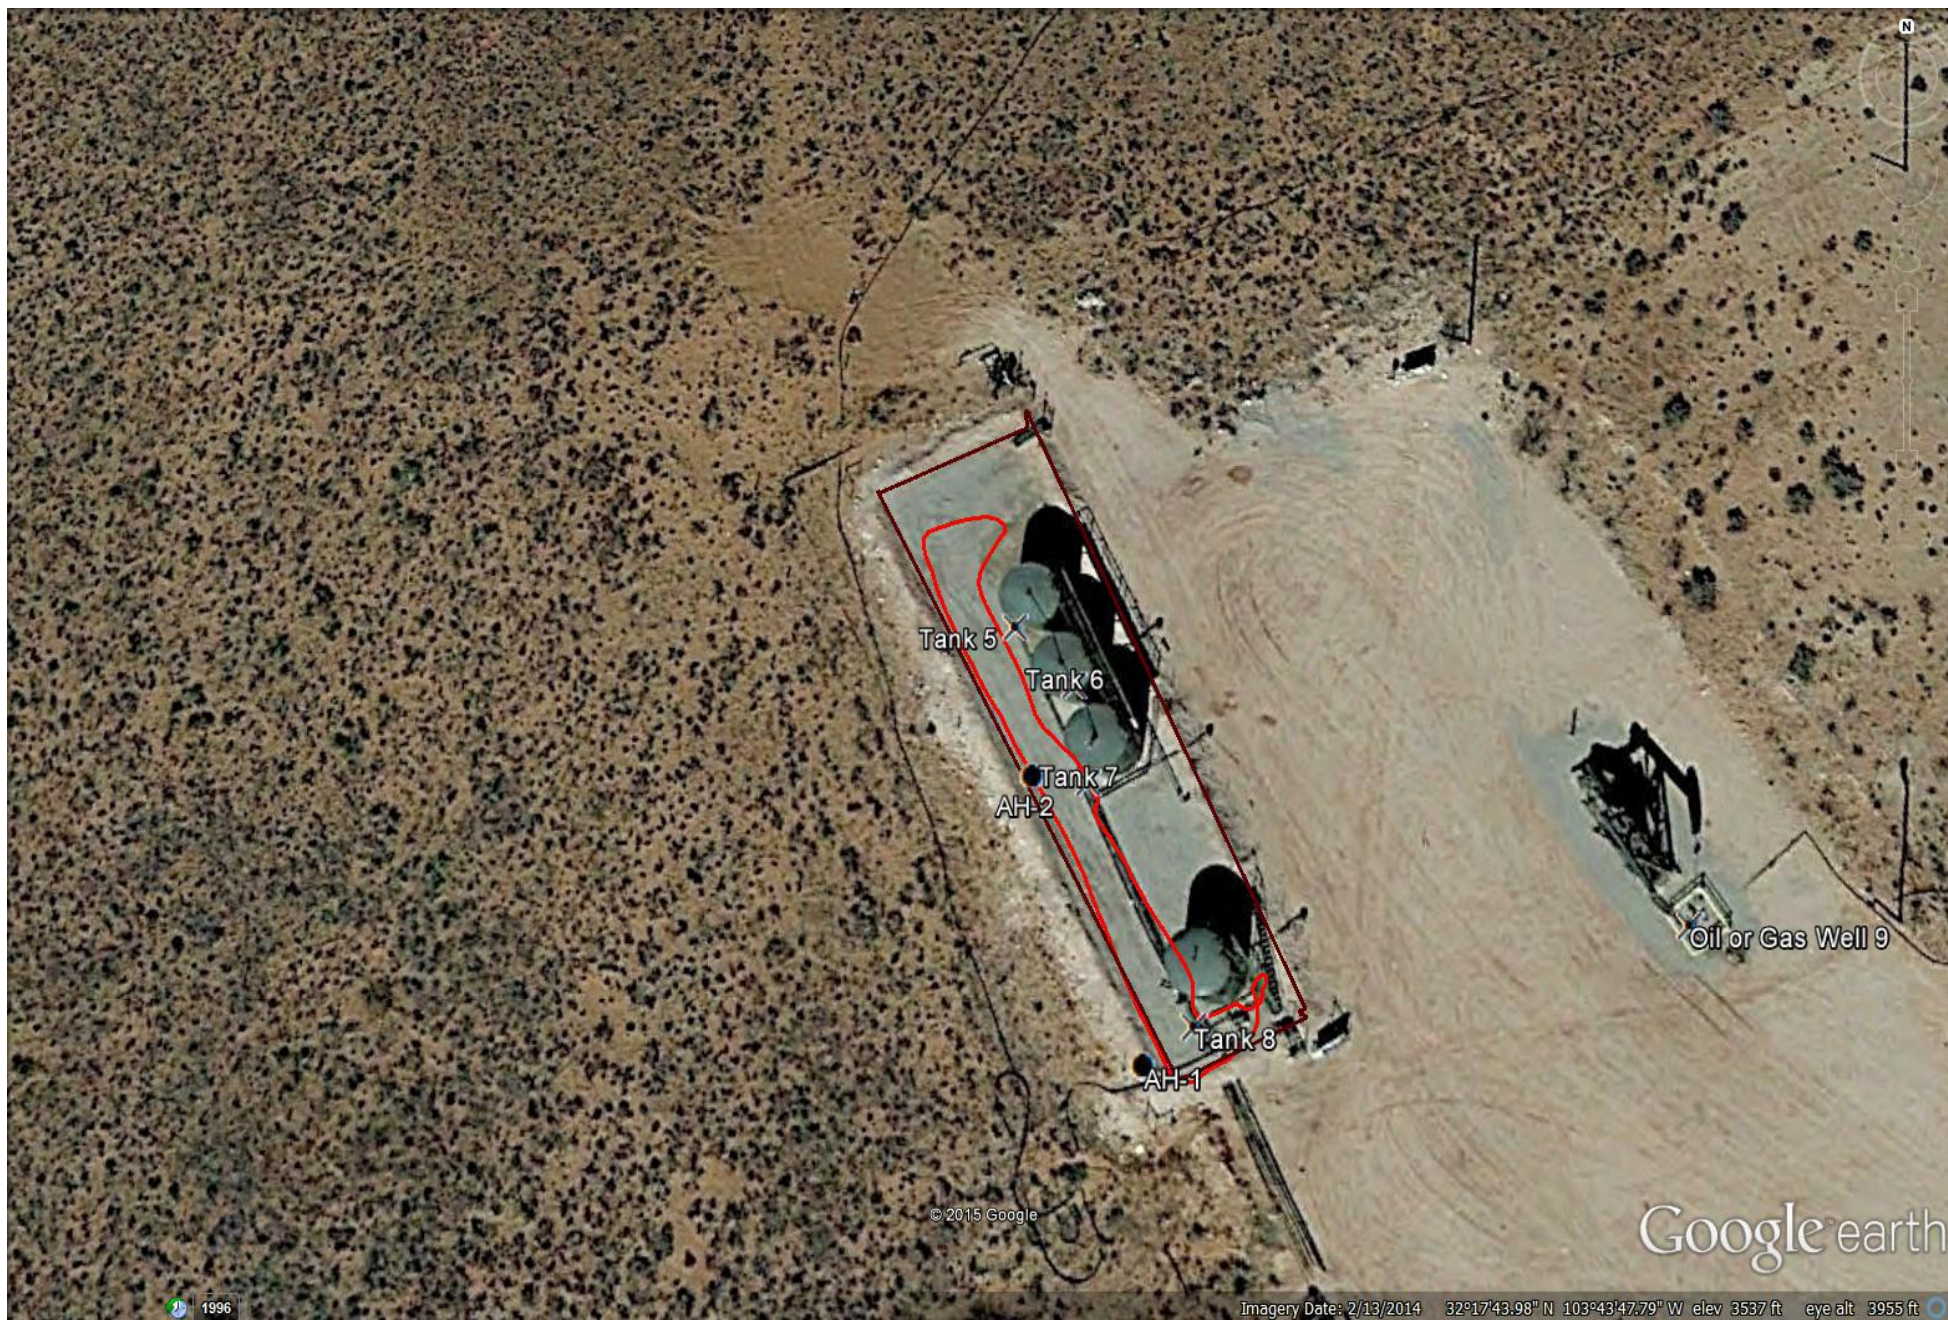
Figure 2 Site Plan

On June 17, 2015, SESI personnel visited the site to conduct a vertical and horizontal delineation of the impacted area. Whereby, it was determined that two (2) sample point positions would be sufficient given the dynamics and outlay of the area i.e. number of lines and tanks. The two sample point positions were hand augured to depths of 4' and 6', respectively. Representative soil samples were properly packaged, preserved and transported to Cardinal Laboratories, Hobbs New Mexico and analyzed for Chloride (Cl⁻) (Method SM 4500Cl-B). The results of the analysis are presented in the table below:

Sample Date 6/03/15	Chloride (mg/kg)
Depth	
AH-1 @Surface	1460
AH-1 @ 1'	1200
AH-1 @ 2'	1700
AH-1 @ 3'	1730
AH-1 @ 4'	720
AH-1 @ 5'	112
AH-2 @ Surface	3280
AH-2 @ 1'	1660
AH-2 @ 2'	1260
AH-2 @ 3'	799
AH-2 @ 4'	944
AH-2 @ 5'	400
AH-2 @ 6'	144

Due to the spill having been contained inside the bermed area, a decline in chloride constituency, and depth to ground water for this area, a 1' bgs. excavation is proposed. Confirmation samples will be taken from the sides and bottom of the excavation area. The representative soil samples will be taken to a commercial laboratory for final analysis and confirmation. A 30 mil. Liner would be installed, preventing further migration of chlorides, layered with sand, capped with material similar to that presently inside the bermed area. SESI is proposing to remove and transport all impacted soils to an approved NMOCD facility for disposal. The excavated area will be backfilled with material similar to that removed, returning to grade and esthetically restore the pad area. Proper regulatory documentation will be submitted to the NMOCD and BLM respectively.

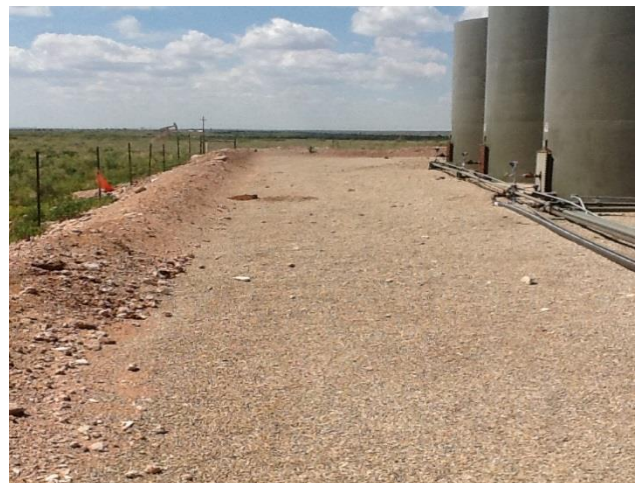
AH2 inside bermed area
