Yates Petroleum Corporation Humidor State Unit #3 Lightning Strike

Section 14, T24S-R27E. Eddy County, NM

New Mexico State Land Office Carlsbad District: Ian Dolly District Resource Specialist
7/17/2015

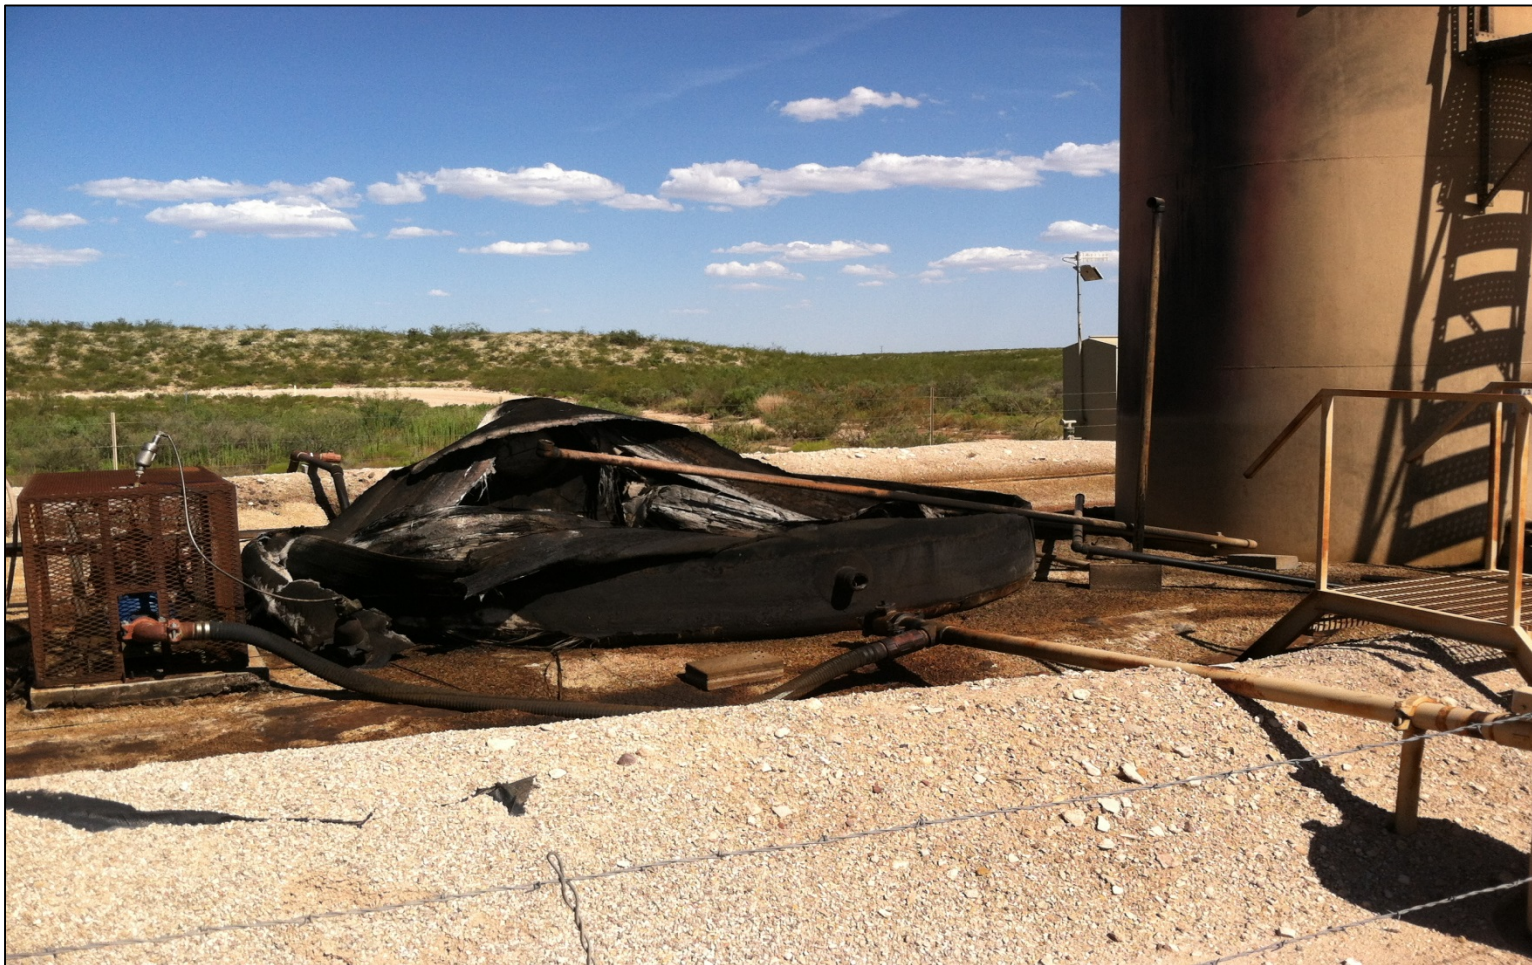
Photo Point 3: View of Spill Site #2 Lat: 32.709307° Lon: -104.199400°

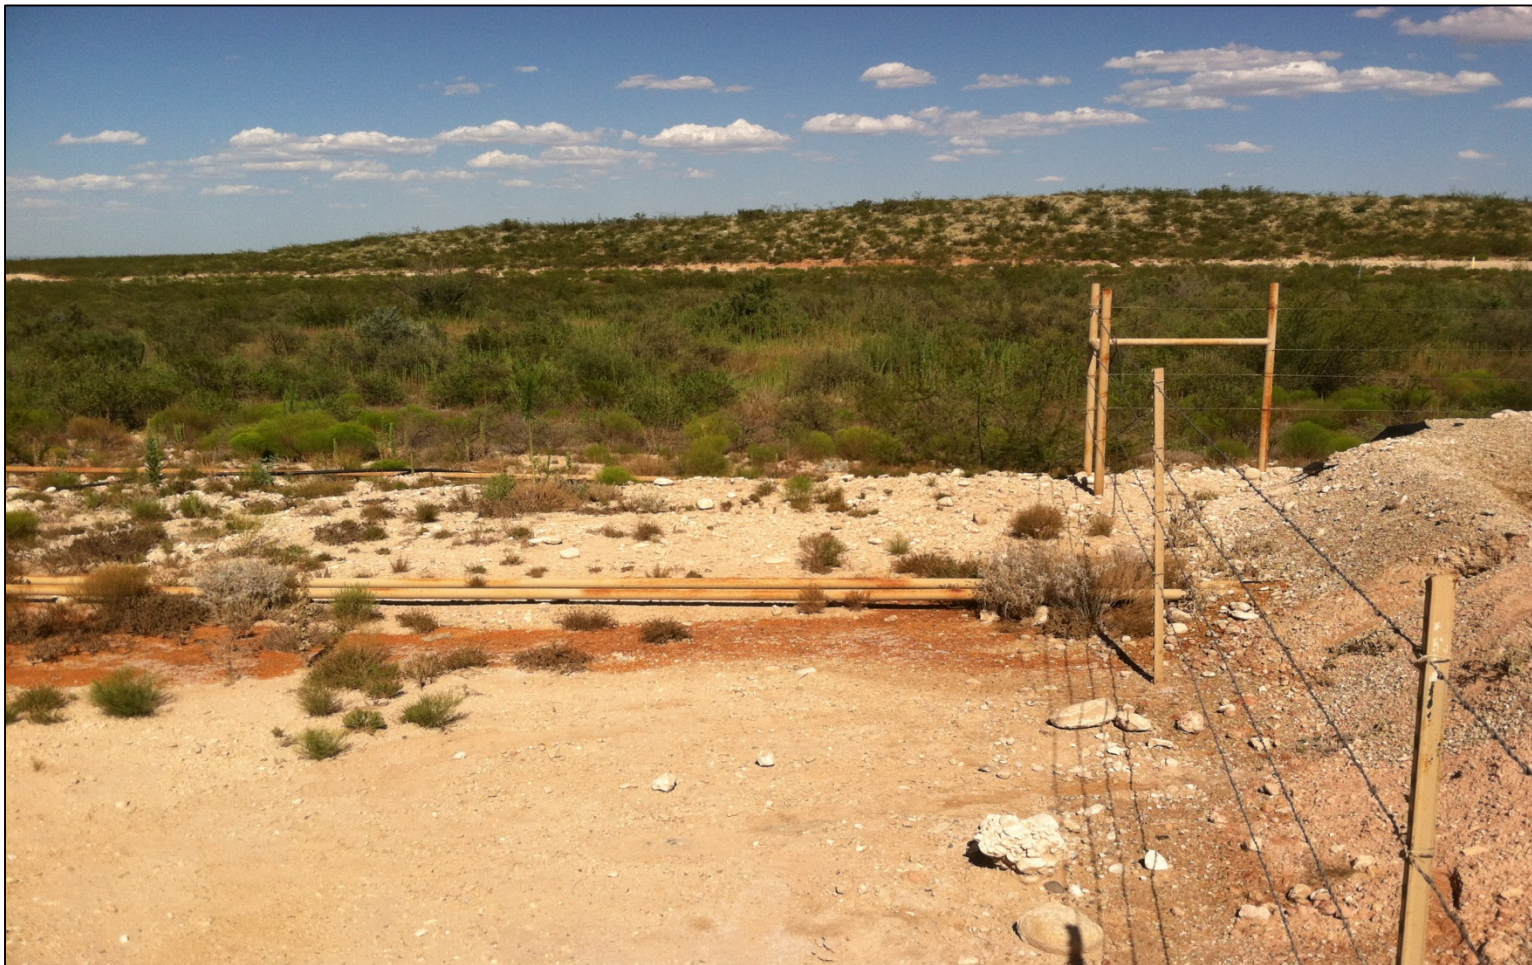
Photo Point 4: View of released water escaping via north side of berm

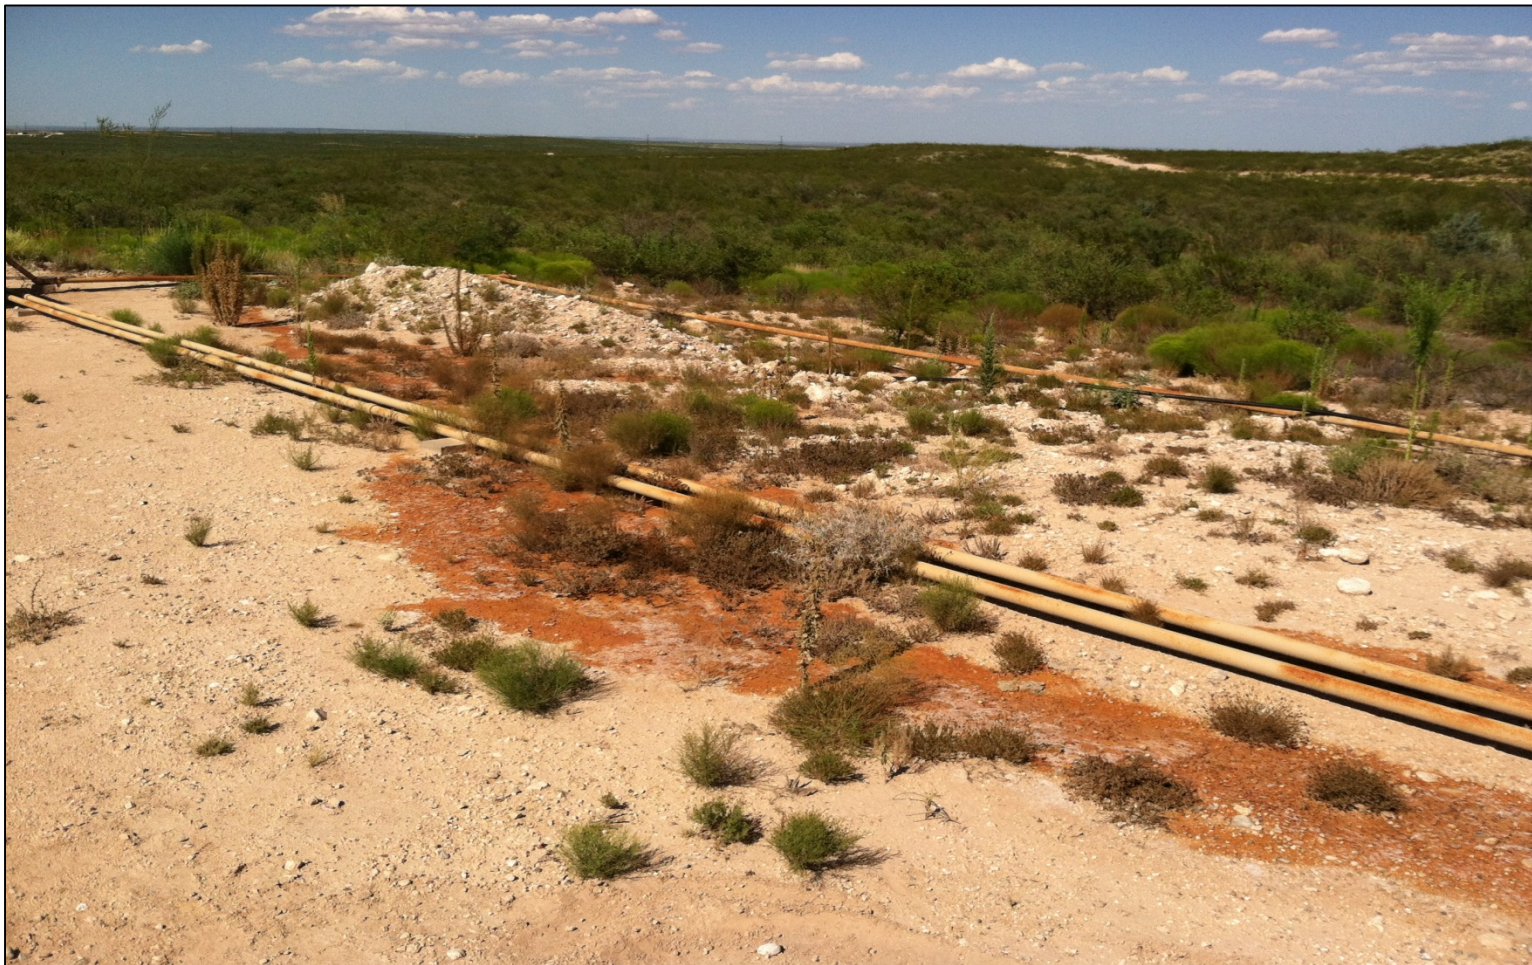
Photo Point 5: View of produced water on northeast corner of pad.

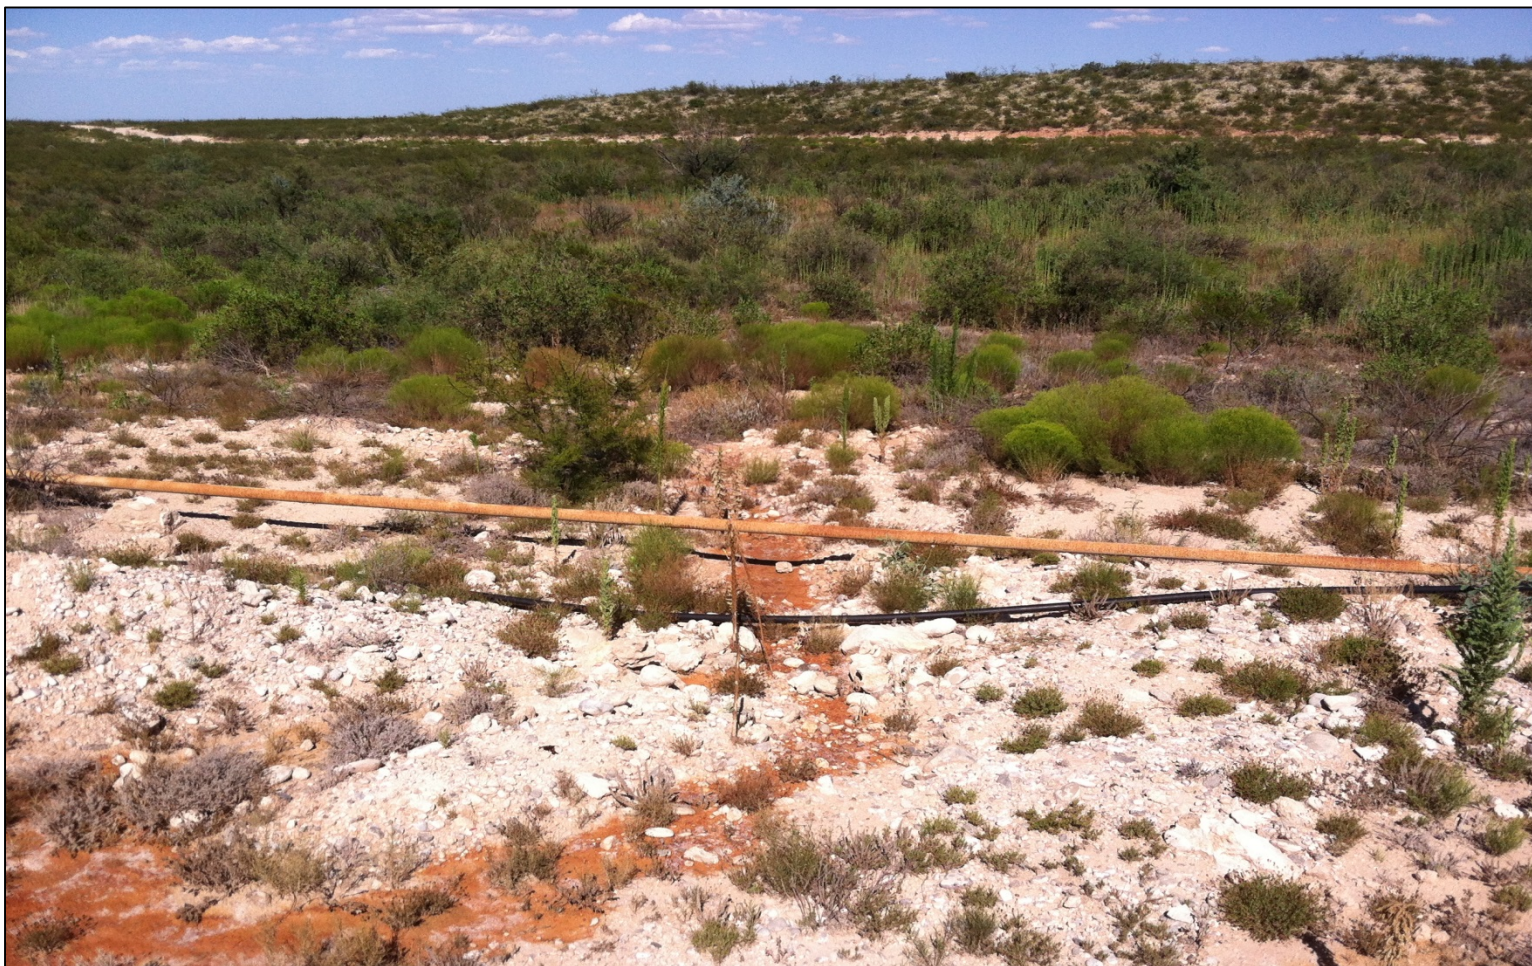
Photo Point 7: View of produced water leaving pad

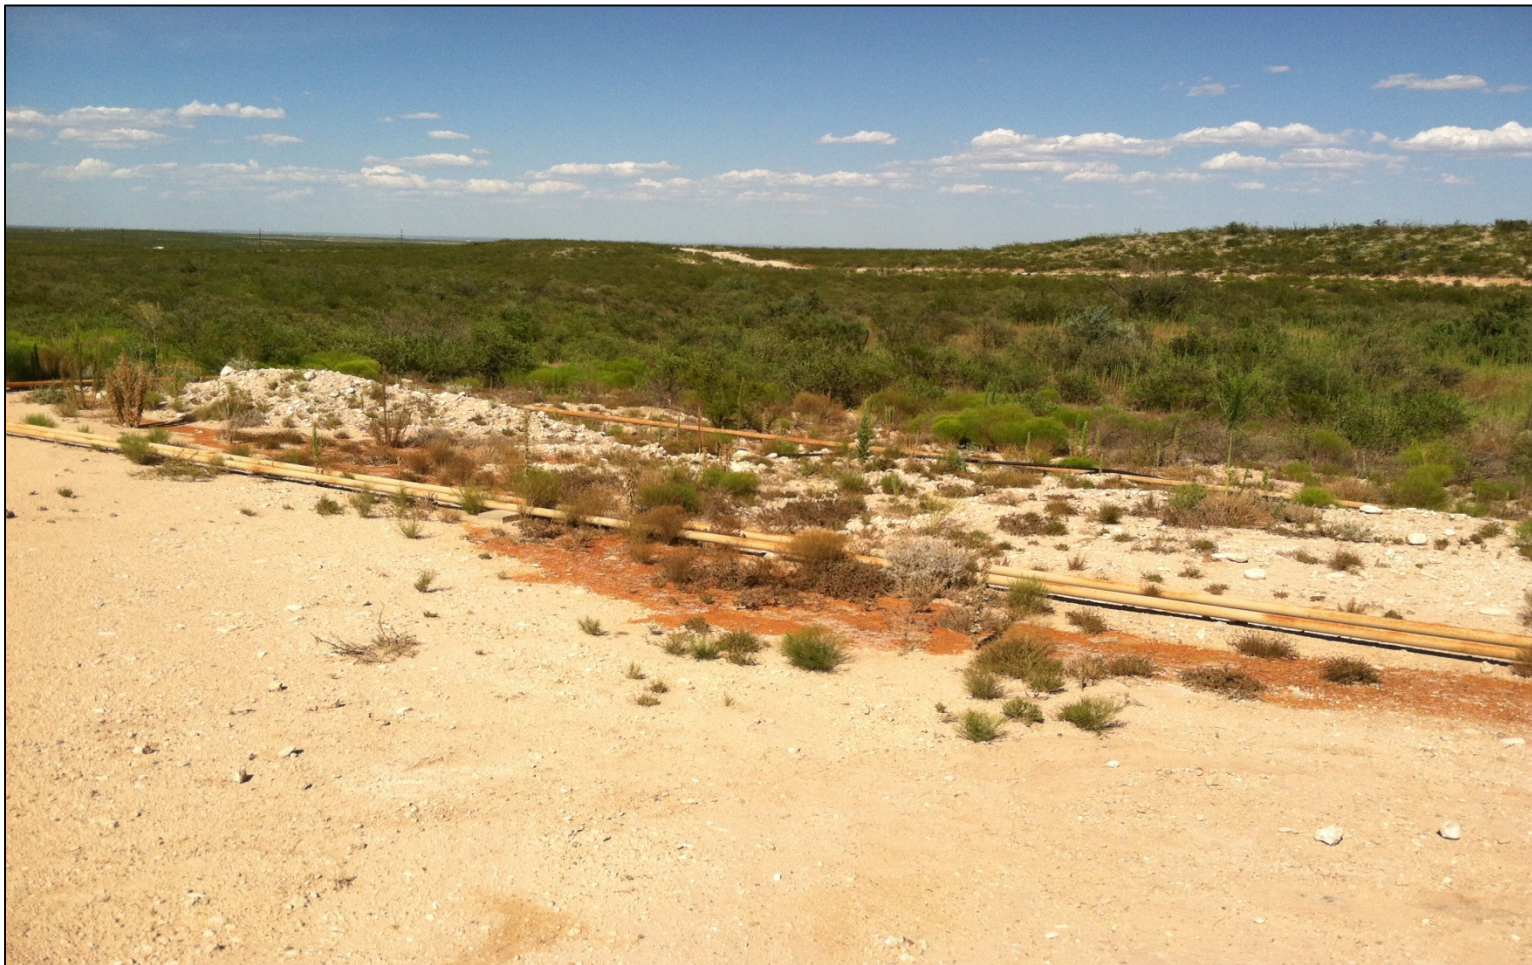
Photo Point 8: View of produced water leaving pad
