# COG Operating, LLC. SRO State Unit #1H Line Break

Section 4, T26S-R28E. Eddy County, NM

**Description:** On Monday, 7/13/2015 I discovered evidence of a produced water release originating from a poly pipeline connected to the SRO State Unit #1H. The line has been repaired.

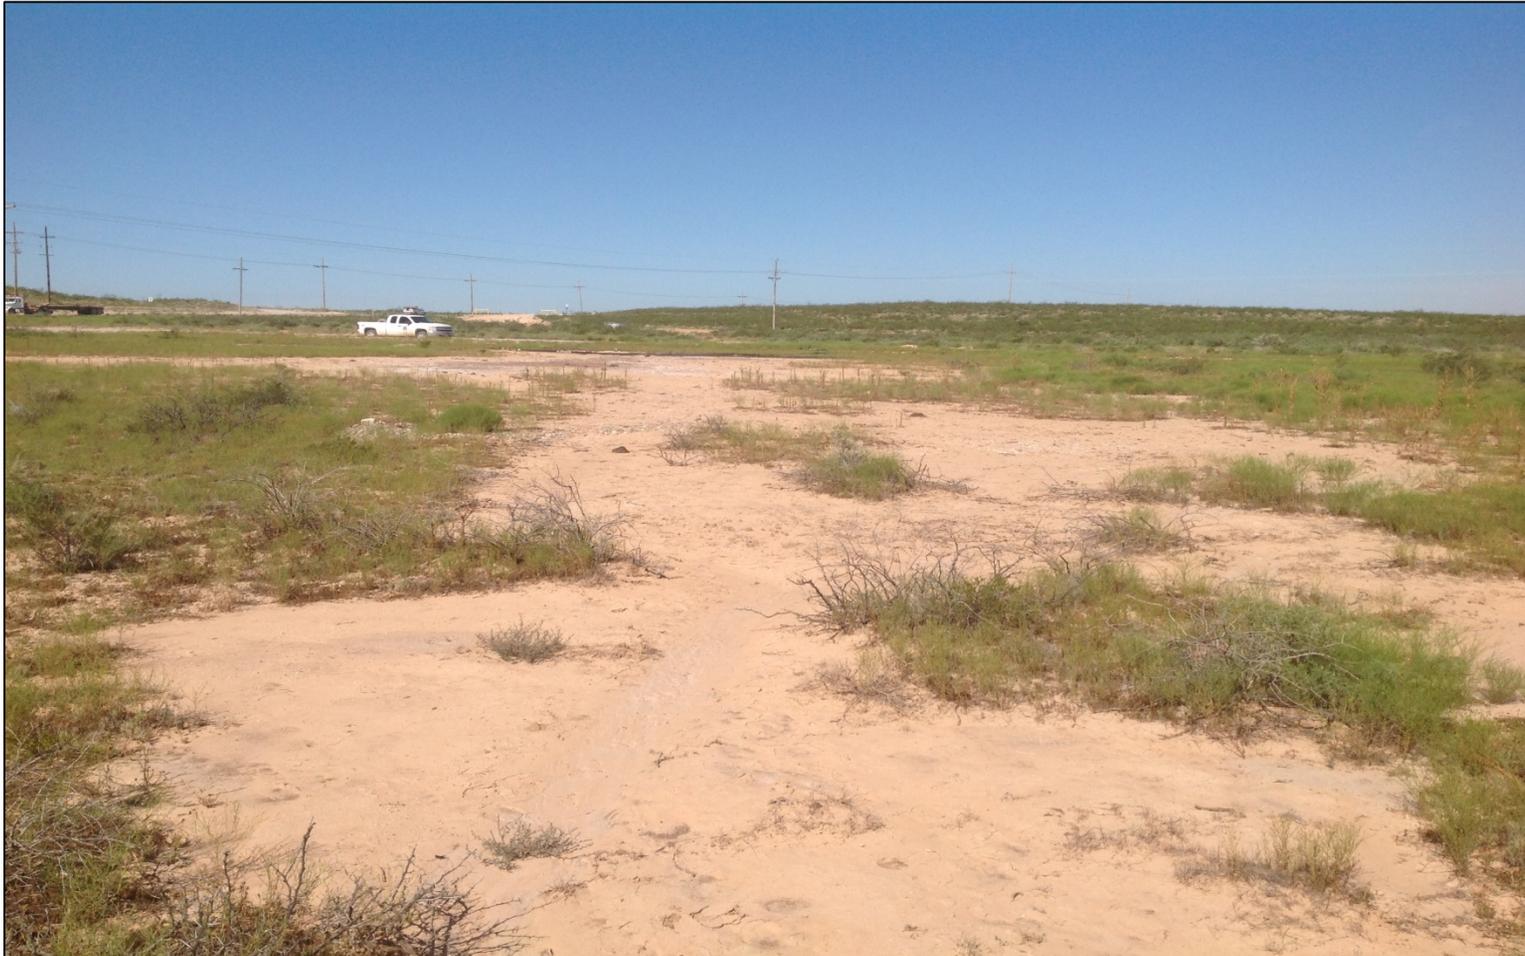
**Photo Point 3: View of Spill Site #2 Lat: 32.709307° Lon: -104.199400°**

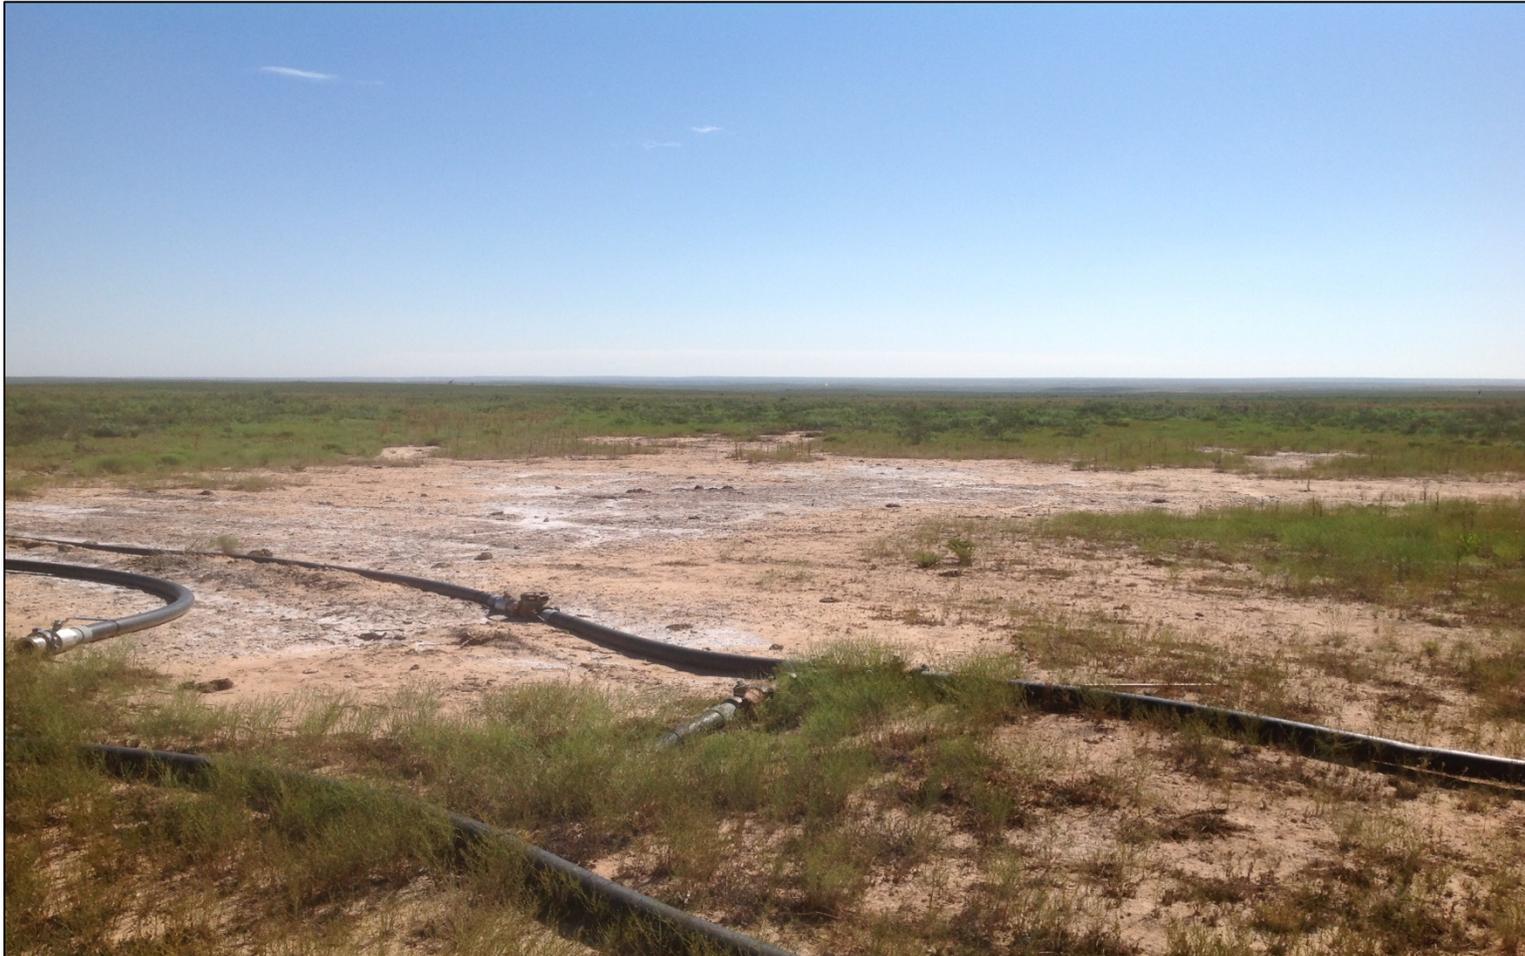
**Photo Point 4: View of released water escaping via north side of berm**
