**REMEDIATION SUMMARY
&
SITE CLOSURE REQUEST**

**BOPCO, L.P.
POKER LAKE UNIT #213 (SWD)
(Spill dated 11/26/05)
API-30-015-33859
Eddy County, New Mexico
UL-P, Section 18, Twns. 24 South, Range 30 East
Latitude N 32.212505° Longitude W 103.914199°
NMOCD Spill reference (N/A)**

**BOPCO, L.P.
522 W. Mermod, Suite 704
Carlsbad, N.M. 88220**

January 2016

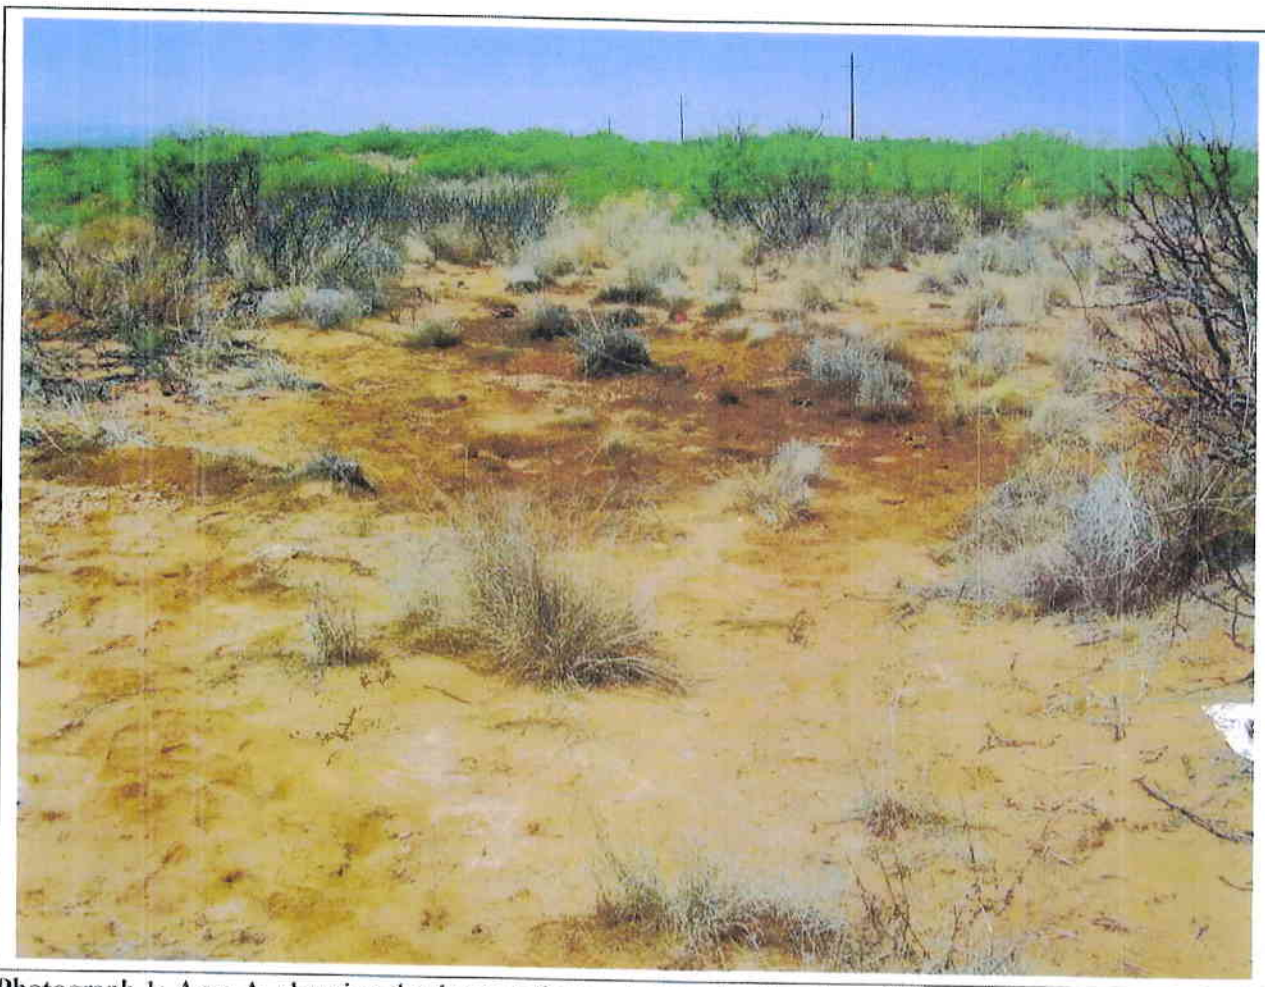
Area A is the largest area contaminated with chlorides and encompasses about 24,000 ft². Four soil sample locations (waypoints 014 through 017) were selected within Area A. Seven samples were collected at depths ranging from ground surface to 2 ft below ground surface (bgs). Samples were collected from areas that were clearly stained (waypoints 015 and 017) to represent "worst case" (Photograph 1) and from areas that appeared undisturbed, but were surrounded by dead vegetation (waypoints 014 and 016).

Photograph 1: Area A, showing dead vegetation and stained soils where fluids ponded.

Area A is the largest area contaminated with chlorides and encompasses about 24,000 ft². Area A is closest to the well pad. Soil samples collected during the site assessment contain chloride concentrations that range from 16 ppm to 3,489 ppm at the surface and in places greater than 2,500 ppm (field test) at a depth of 2 ft bgs. The following approach is recommended for the cleanup of Area A:

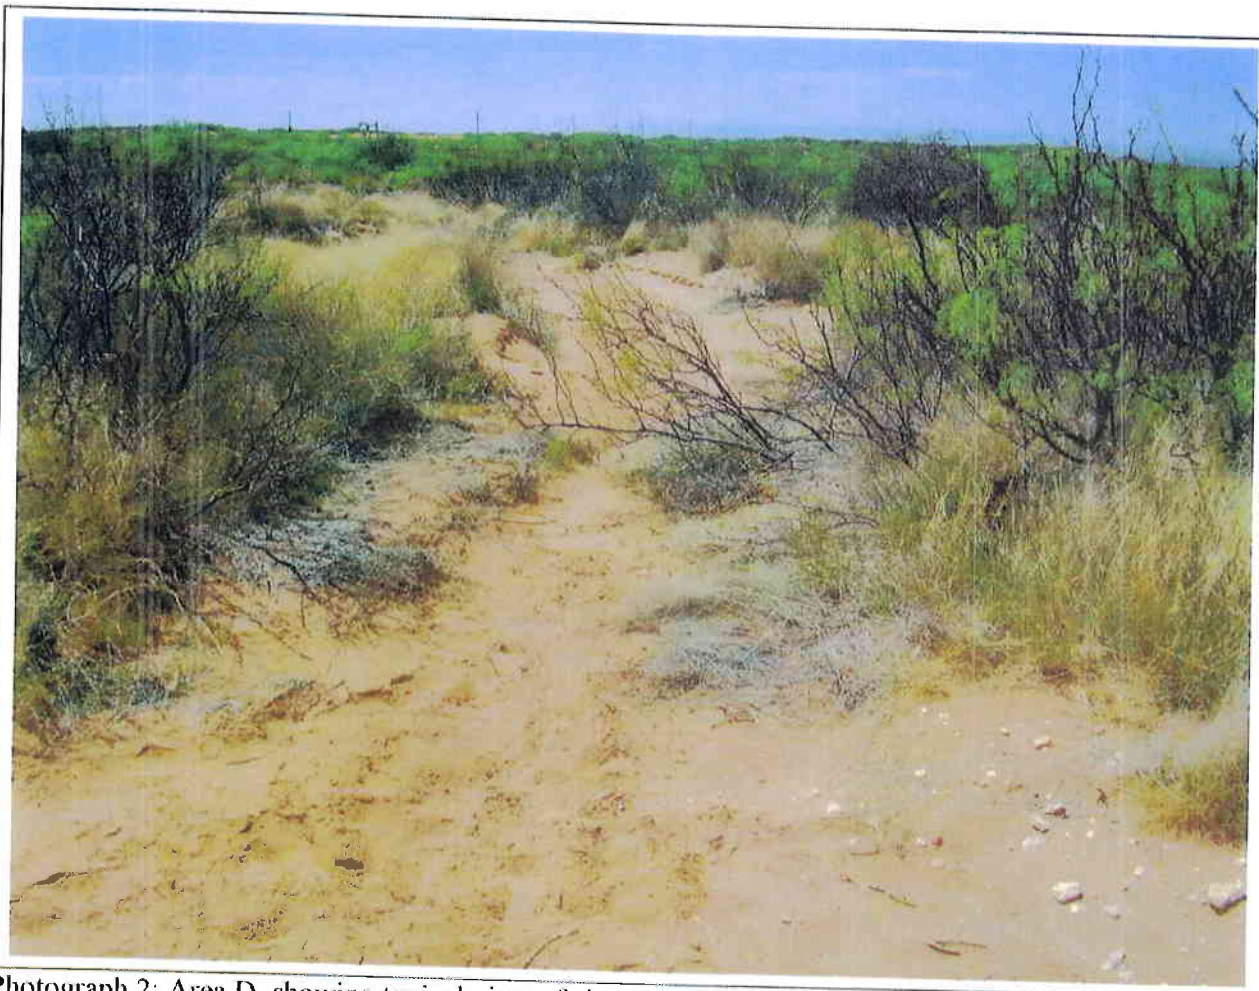
Photograph 2: Area D, showing typical view of channel.

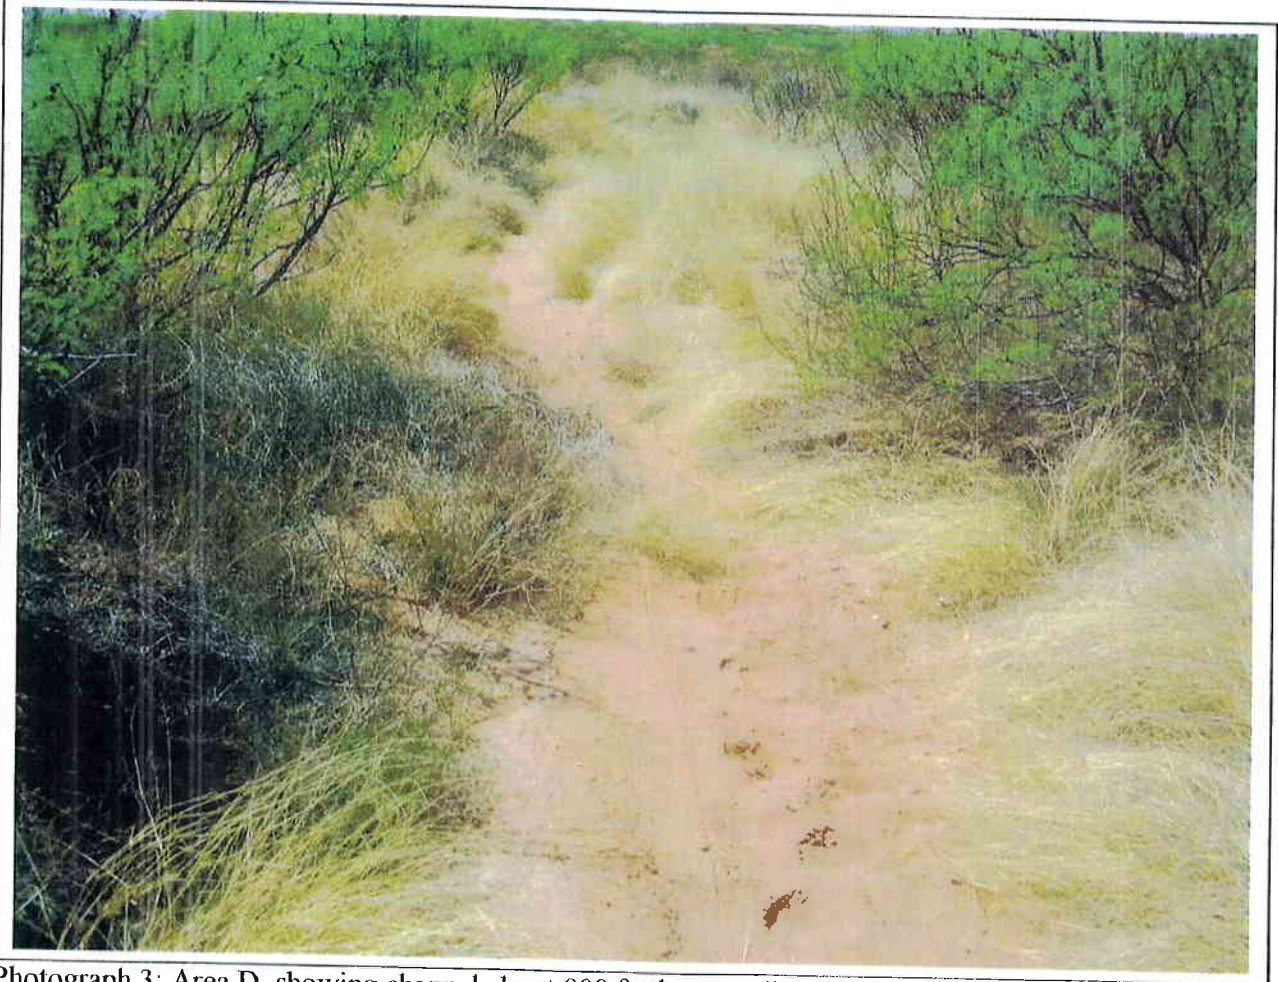
Photograph 3: Area D, showing channel about 900 ft. downgradient where vegetation first reappears.
