**REMEDIATION SUMMARY  
&  
SITE CLOSURE REQUEST**

**BOPCO, L.P.  
POKER LAKE UNIT #213 (SWD)  
(Spill dated 6/23/12)  
API-30-015-33859  
Eddy County, New Mexico  
UL-P, Section 18, Twns. 24 South, Range 30 East  
Latitude N 32.212384° Longitude W 103.914812°  
NMOCD Spill reference #2RP-1221**

January 2016

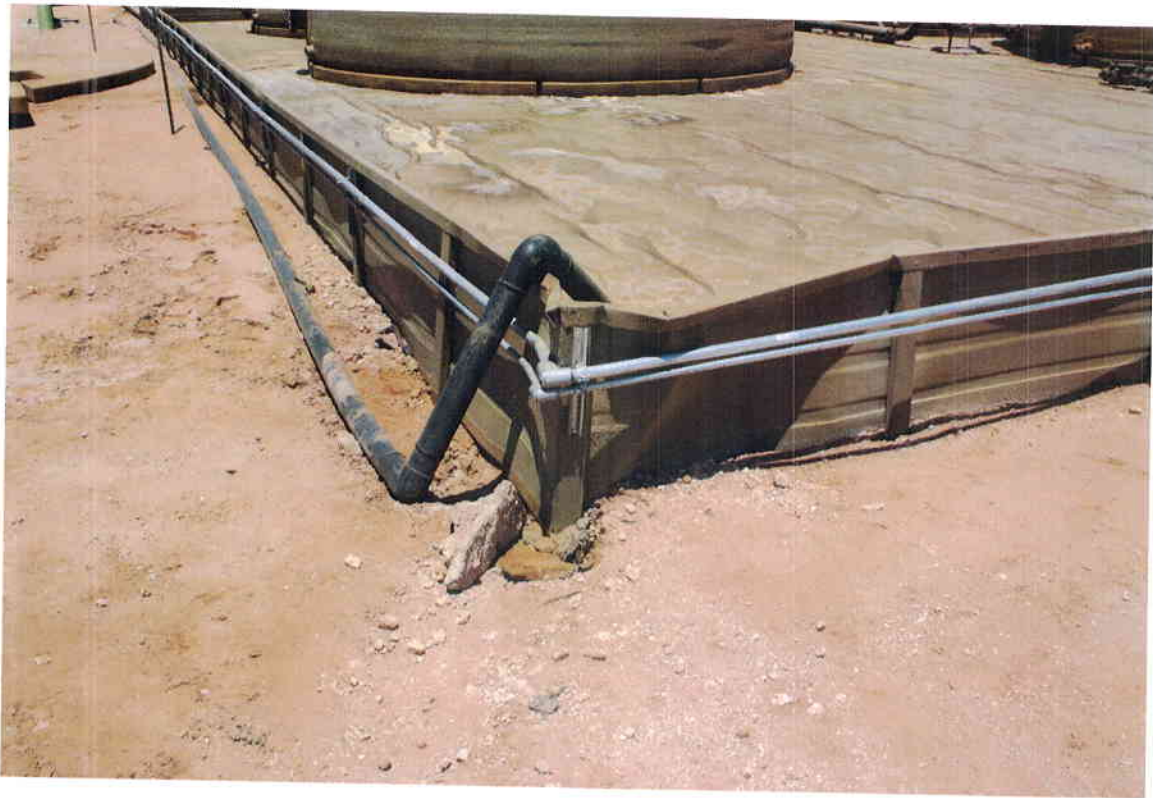
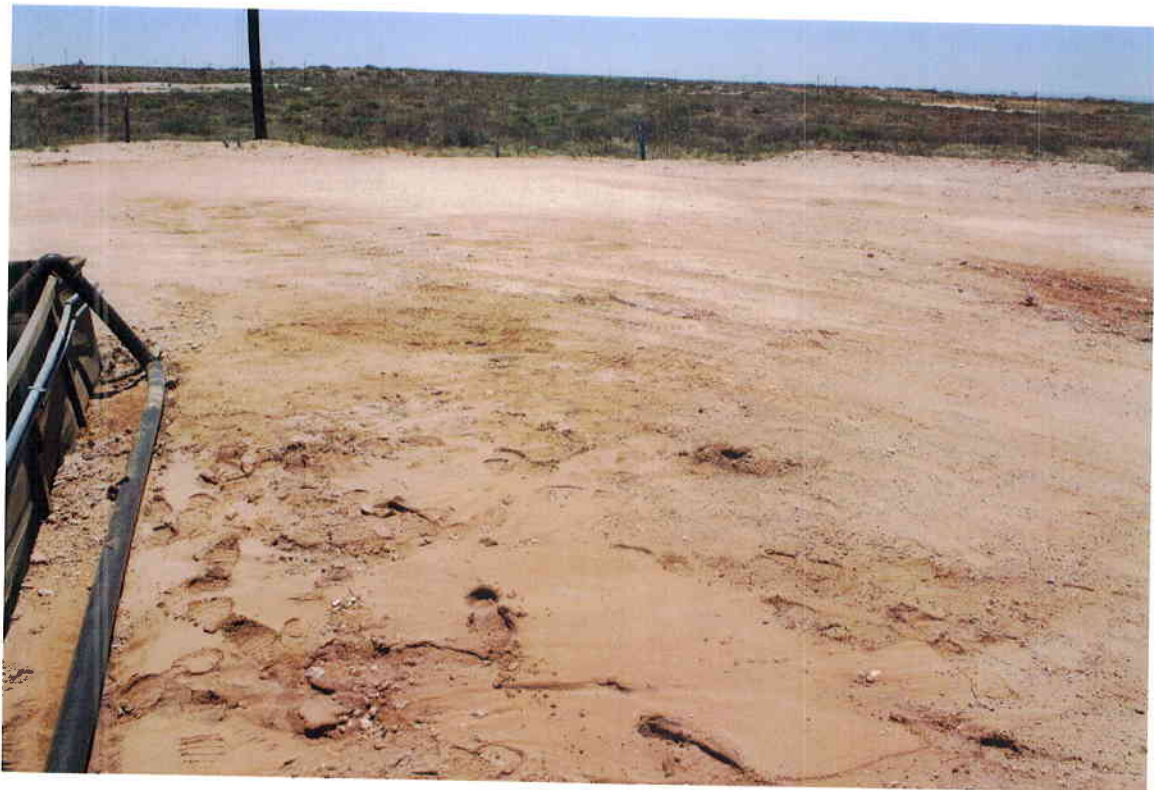
**Initial Photo 6/25/12**

On the 6/23/12 BOPCO L.P. was notified by Horizon Trucking that a transport truck hit the South West edge of the 0 Perm containment and had also damage a 3" poly line coming into the SWD. The poly line spilled produced water onto the SWD pad and traveled off-site onto the pasture area South and South West of the tank battery.

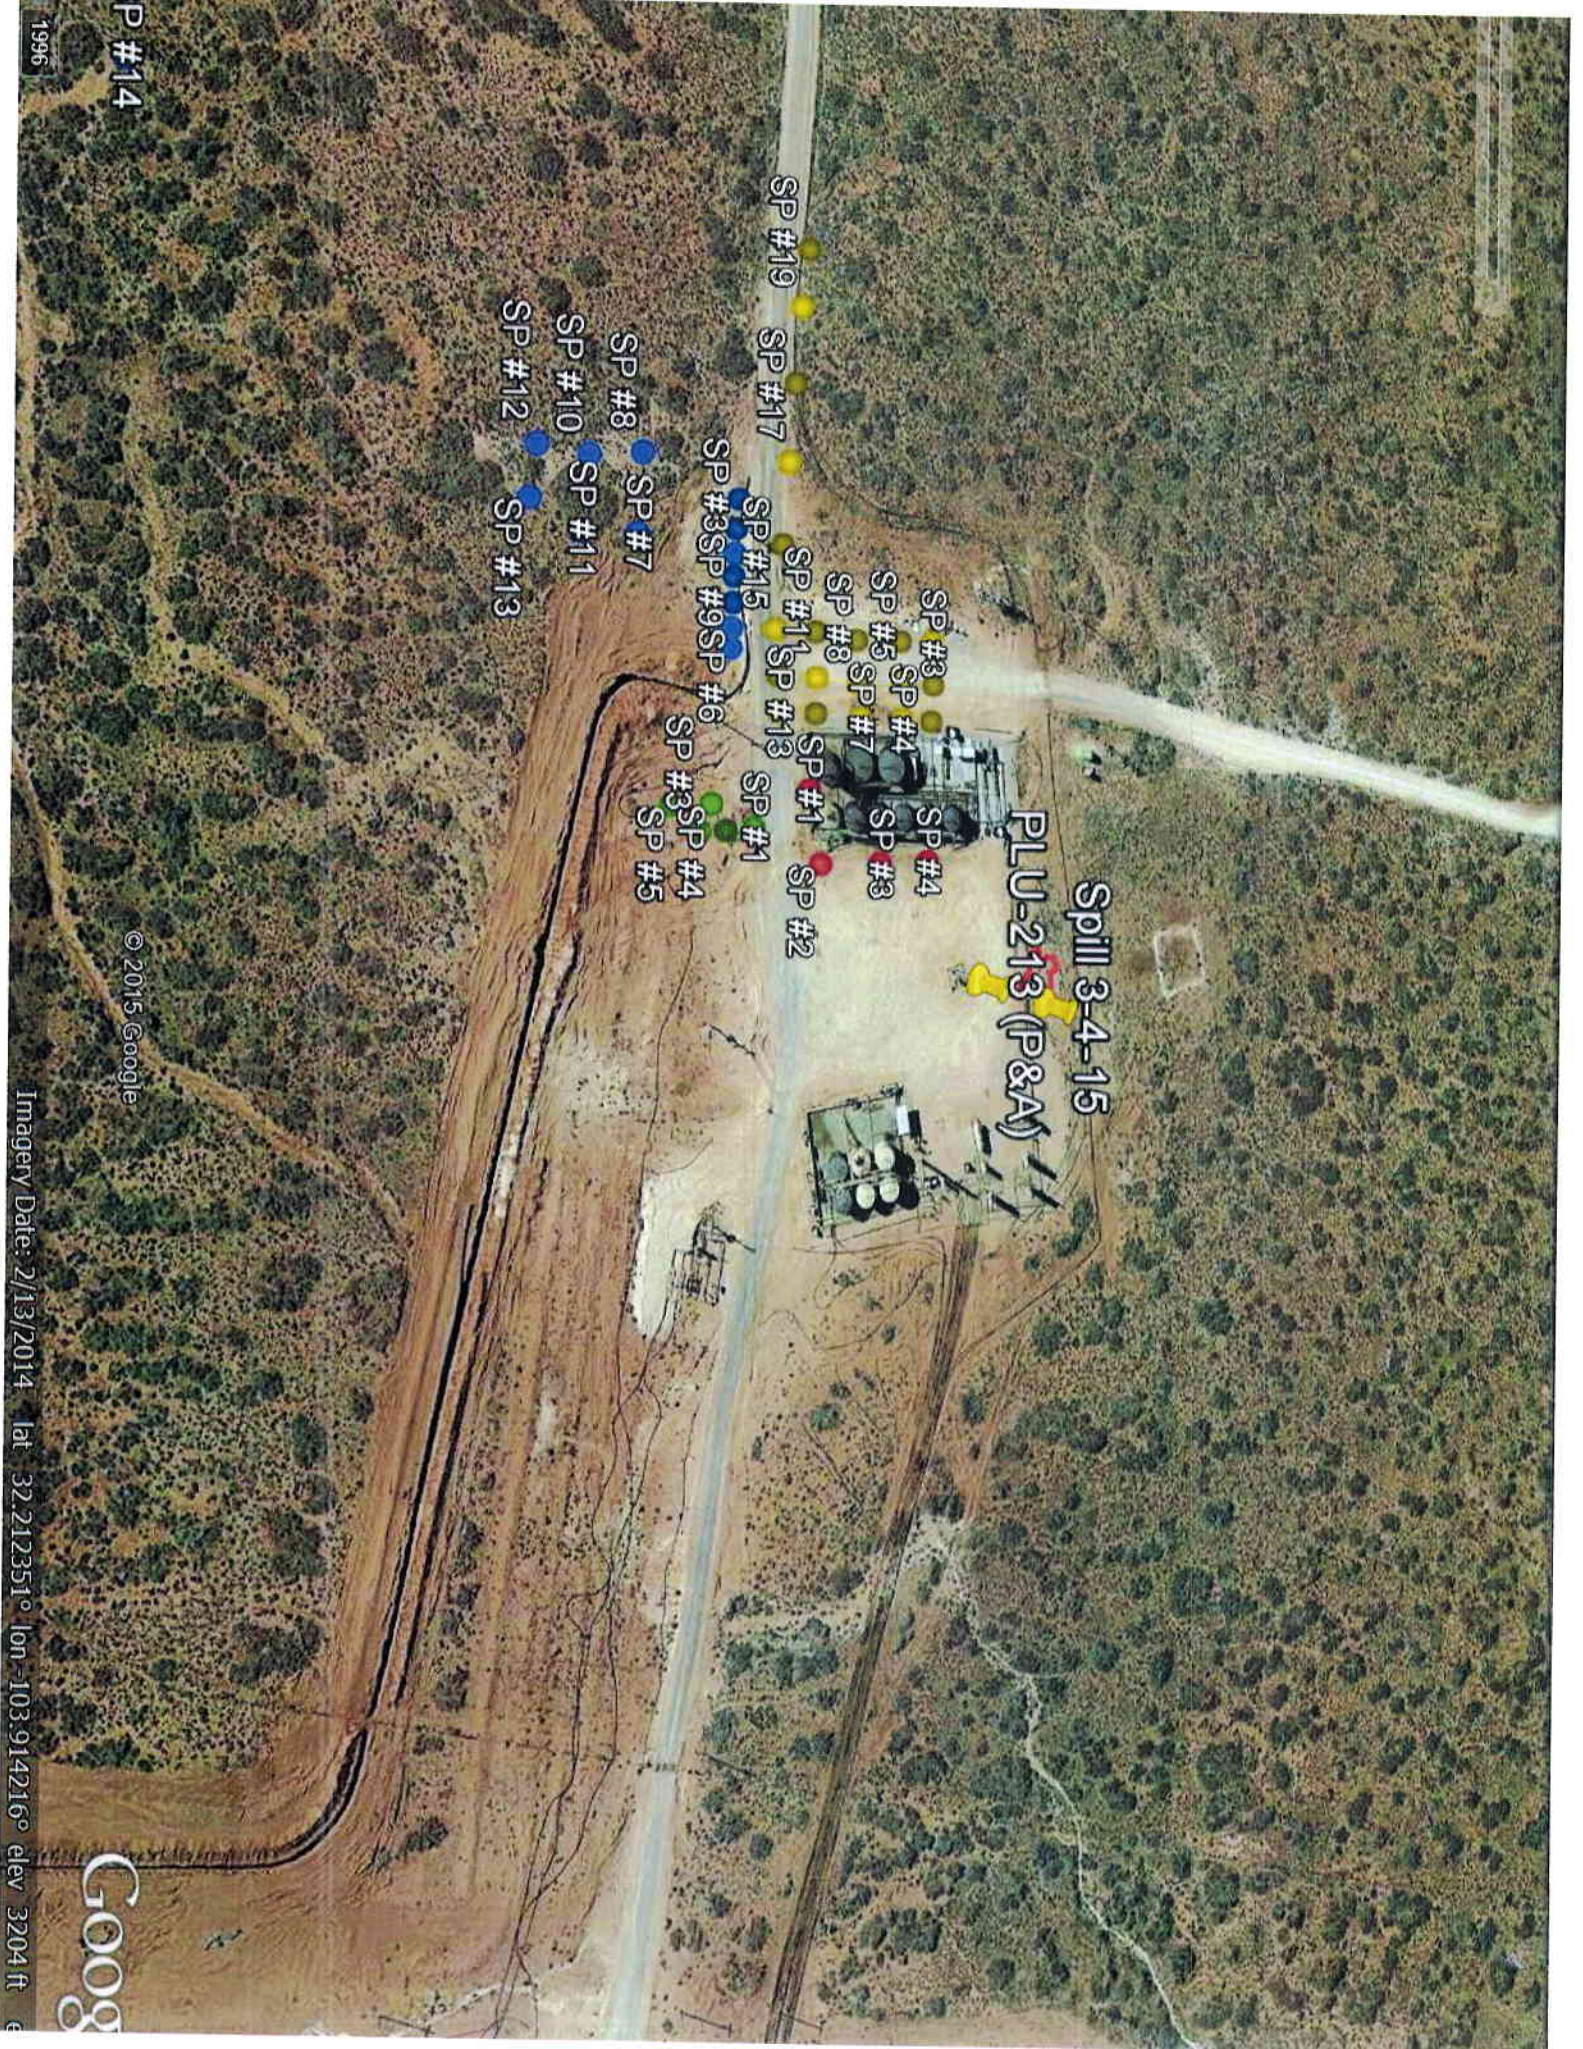
Spill 3-4-15

Beginning on 1/23/15 Basin Environmental began a sampling event of the release point, pad area, lease road, and run over area just to the south of the SWD road and pad area. The pad area was referenced to area "Yellow" and the flow path area was referenced to area "Blue."

The sampling event revealed that all of the areas in the lease road, bar ditch and pasture area were below the remediation action level "RAL" for TPH, BTEX and Chlorides.

The sample locations and analysis were discussed with the NMOCD in a meeting on 3/4/15. It was determined that the areas on the pad would be excavated to approximately 2 ft. in depth. This would include the "Yellow Sample Points #2, #4, #7, #10 and #11.
