REMEDICATION SUMMARY
AND
SITE CLOSURE
FOR
ABO 16' INLET PIPELINE

Prepared By:
Harley Everhart
EH&S

January 30, 2016

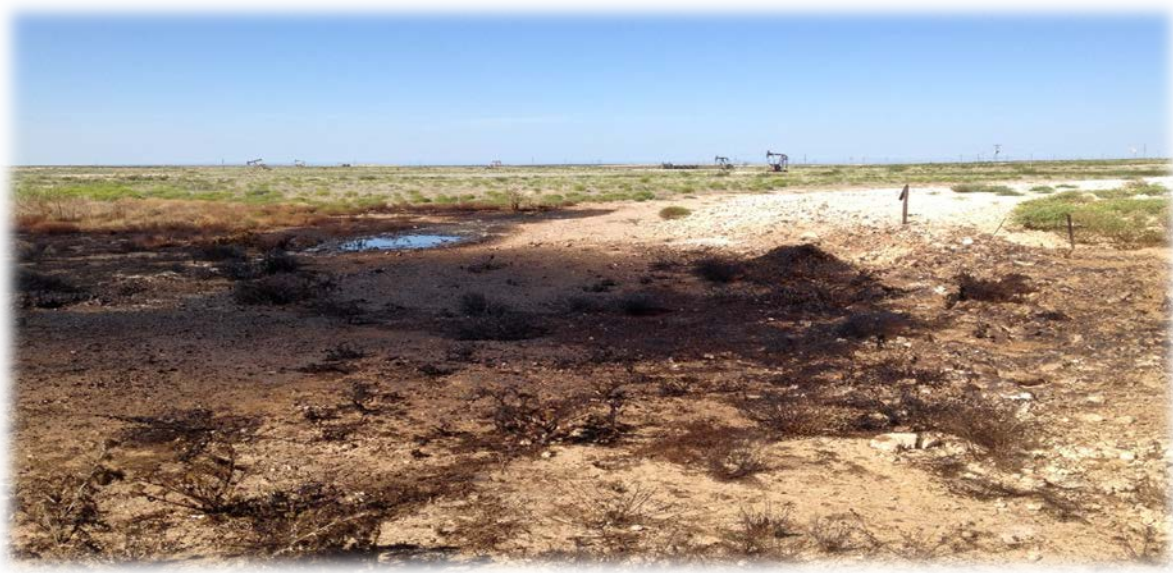
Figure 1

On 8/10/2015, Frontier Field Services received a call from an oilfield employee about a possible leak located at Latitude: 32.780425N, Longitude: -104.220458W. Frontier identified the pipeline in question and immediately blocked in the Abo GP 16” Inlet. Frontier dispatched field personnel to identify the leak and upon arriving at the location, they discovered a puddle of heavy condensate gathered on the surface above a known underground condensate discharge pipeline. Notifications were made internally to the Environmental Group approximately 14:00 hundred hours.

On 8/11/2015, Frontier recovered an estimated 4bbl of released liquid from the Remediation Site surface using a hydro-vacuum truck. All free liquid recovered was disposed of at an OCD approved facility (Figure 1). Excavation was quickly commenced to delineate and remove contaminated soils and to restore the integrity of the pipeline. On 8/11/2015, it was determined the total release was to exceed 5bbl and made appropriate notifications to NMOCD. The Initial C-141 was presented to NMOCD Mike Bratcher on 08/17/2015 (Appendix 1).

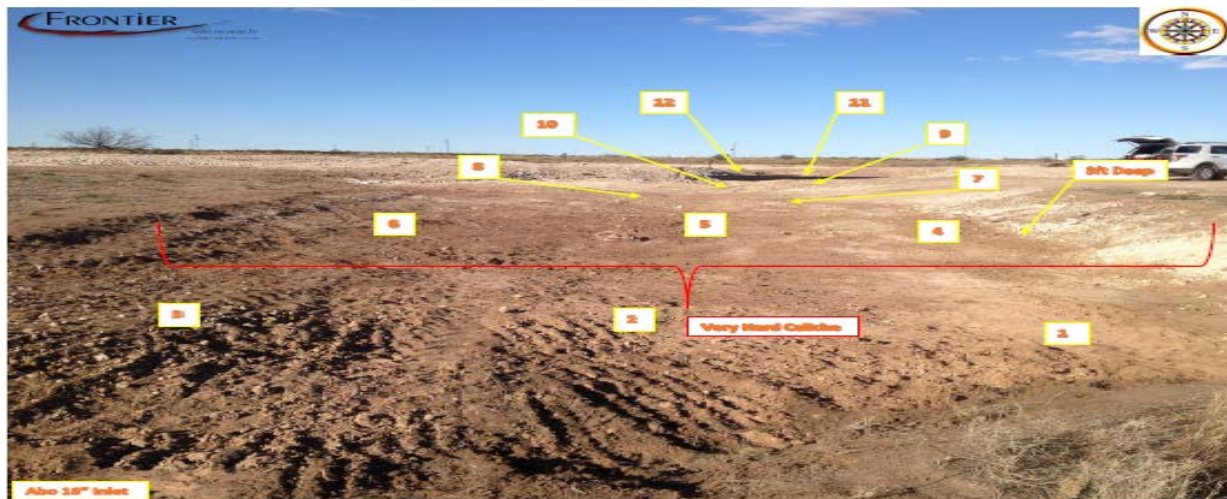
Figure 2

Twelve samples were collected at the Remediation Site (Figure 2). All samples were carefully collected, documented, and preserved by Frontier EHS on 12/15/2015. The samples were promptly transported to Cardinal Labs located in Hobbs N.M. 88240, followed by a chain of custody form. Soil samples were analyzed for the following:

The cause and conditions of the leak were identified and alleviated by replacing a section of the 16" line. Soil samples 1(56.6), 2(45.6), 3(<10), 4(383), 6(124), 8(576), 11(28.2), and 12(337), were below the levels outlined in "NMOCD Guidelines for Remediation of Leaks, Spills, and

Releases". Samples 5(6660), 7(4200), 9(2360) & 10(10800) were above the required TPH levels; however, the geological formation of these four sample areas is a very hard caliche formation and further remediation beyond existing depth is not practicable. Because the caliche formation provides a natural barrier, distance to surface water is > 1000ft, and depth to groundwater is > 100ft, the area does not pose significant risk to fresh water, public health, or to the environment.
