22 November 2013

Re: Initial C-141
Chevron
Skelly Unit #952
UL-D, Section 21, Township 17 South, Range 31 East
Eddy County, New Mexico

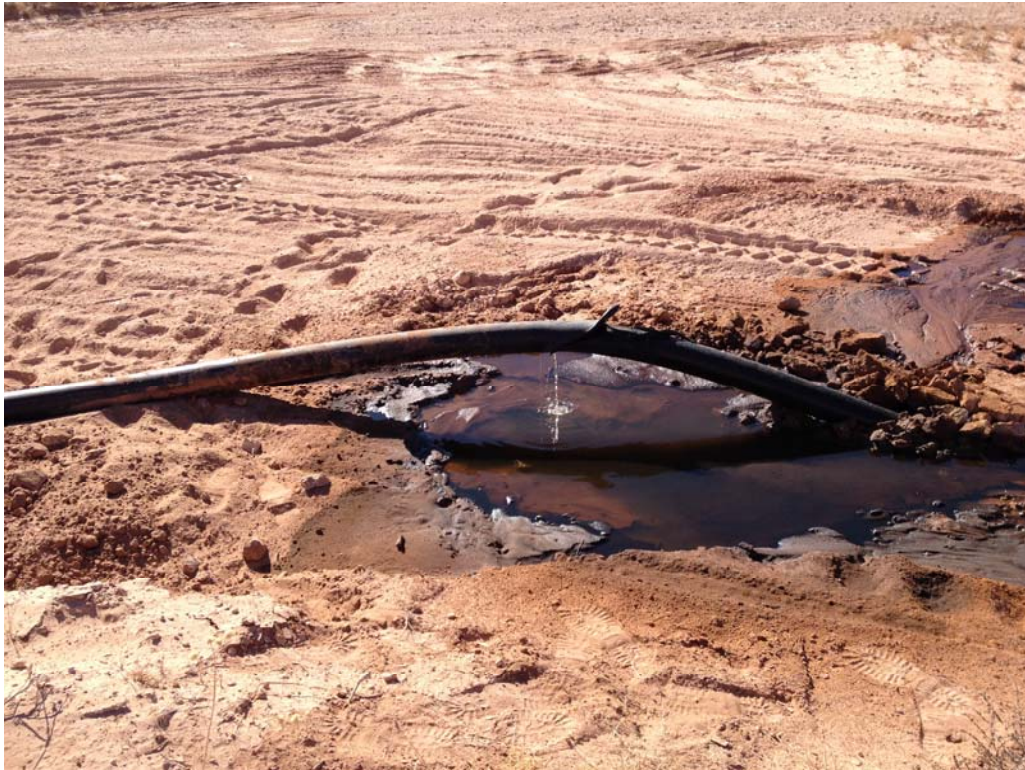
Photograph #1- Point of release.

Describe Cause of Problem and Remedial Action Taken.* Approximately 53.8 bbls of produced water were released when a 3rd party contractor doing road work damaged the main water transfer line. Approximately 15 bbls volume recovered. The poly line has been repaired and an emergency response crew dispatched to remove surface contaminants.

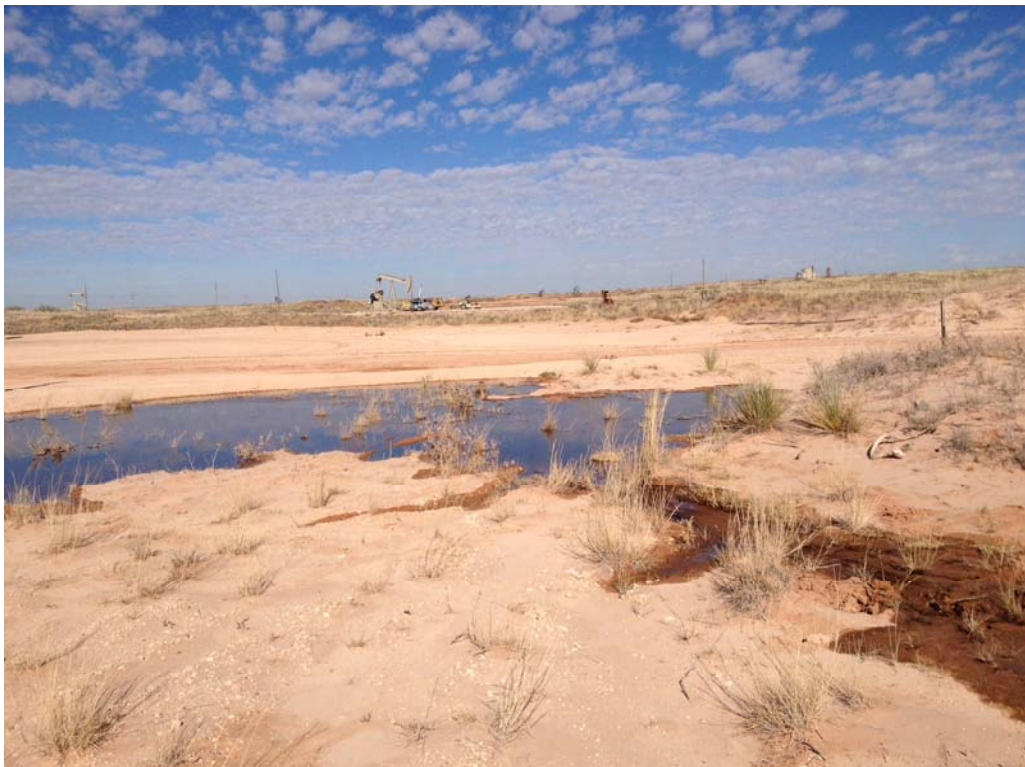
Photograph #2- Looking across release area.

Describe Area Affected and Cleanup Action Taken.* An area approximately 725 ft x 10 ft was impacted by the release with ~15 bbls of fluid recovered from the site. Soil samples will be collected from release area and submitted to Cardinal Laboratories for testing. Upon receipt of laboratory analytical data from soil samples collected during delineation operations, a Remediation Proposal will be prepared for approval.
