FIELD SPILL REPORT

DATE: September 14, 2015

LOCATION OF SPILL SITE: PLU CVX JV BS 008H

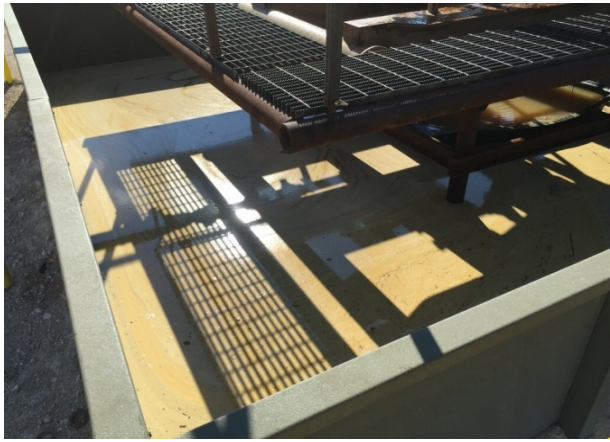
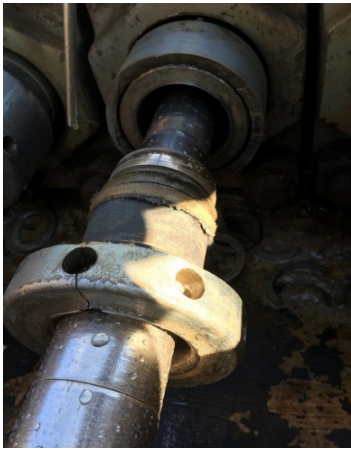
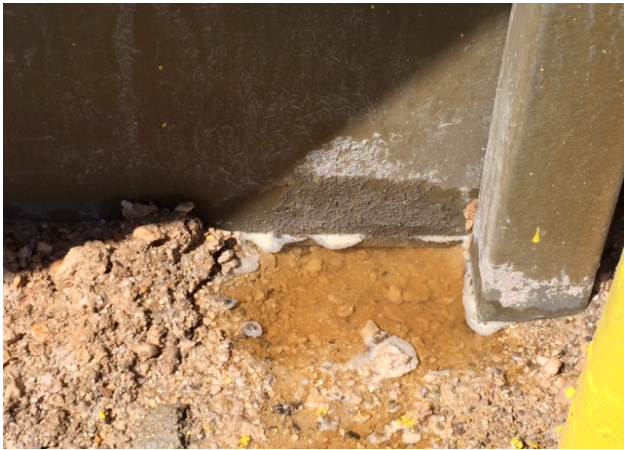
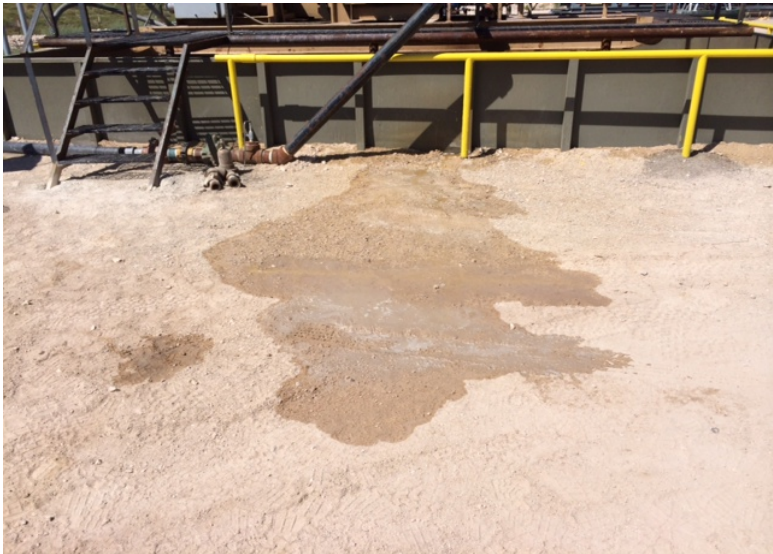
PICTURE ATTACHMENT:

EHS was notified of a release that occurred when the packing gland failed on the triplex pump.

Vacuum truck recovered 48 bbls of PW from the lined containment. The containment failed releasing 1 bbl PW to the ground surface. Remediation to be planned
