**Release Notification and Corrective Action**

Name of Company ENERGYQUEST	Contact Larry Davis
Address 4526 RESEARCH FOREST DRIVE, SUITE 200 THE WOODLANDS, TX 77381	Telephone No. 281-651-5201
Facility Name GRAYBURG JACKSON	Facility Type OIL
Surface Owner BLM	Mineral Owner
API No.

Type of Release OIL	Volume of Release >2 bbls	Volume Recovered 0
Source of Release DAMAGE TO FLOWLINES – THREE (3) LOCATIONS	Date and Hour of Occurrence 21-23 AUG 2014, EXACT TIME UNKNOWN	Date and Hour of Discovery 23 AUG 2014, 1500 HOURS
Was Immediate Notice Given? <input checked="" type="checkbox"/> Yes <input type="checkbox"/> No <input type="checkbox"/> Not Required	If YES, To Whom? BLM via voice mail	
By Whom? GREG MCWILLIAMS, ENERGYQUEST	Date and Hour 23 AUGUST 2014, 1500 HOURS	
Was a Watercourse Reached? <input type="checkbox"/> Yes <input checked="" type="checkbox"/> No	If YES, Volume Impacting the Watercourse.

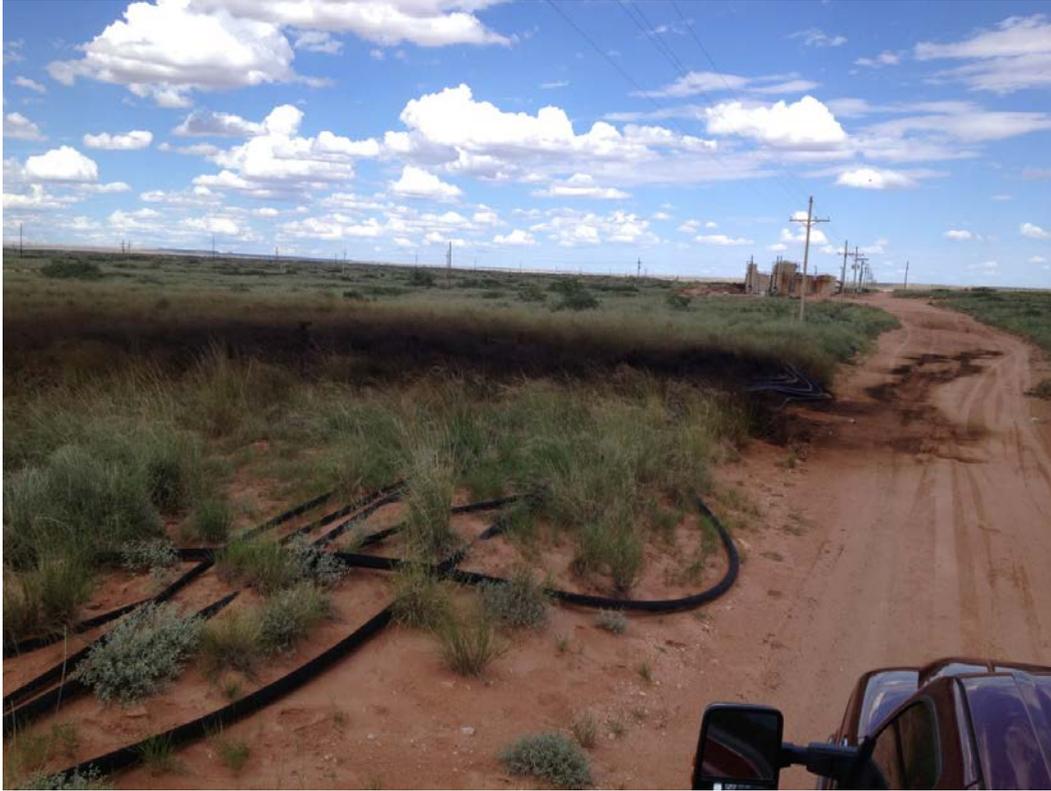
Release Point #1

- Leak 1: West of the water station.  
Leak #1 was caused when a Dean's Electric vehicle was stuck in the sand. The exhaust of the vehicle got caught on the flow line and burned a hole in the flow line. This was the biggest of the three leaks because it sprayed in the air and soaked the nearby vegetation. Dean's electric notified our pumper of a leak after their equipment was removed. Apparently this occurred around 5 p.m. on August 21, 2014, but the extent of the damage was not communicated to EnergyQuest.

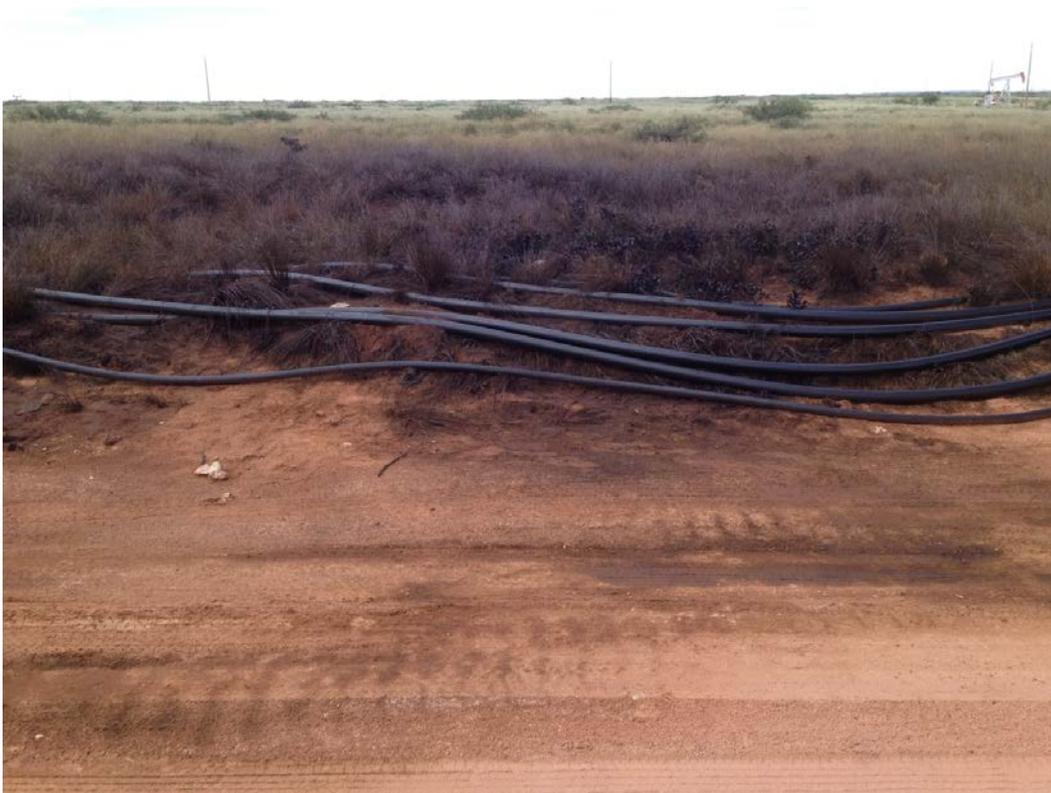
Leak #1 caused by vehicle exhaust

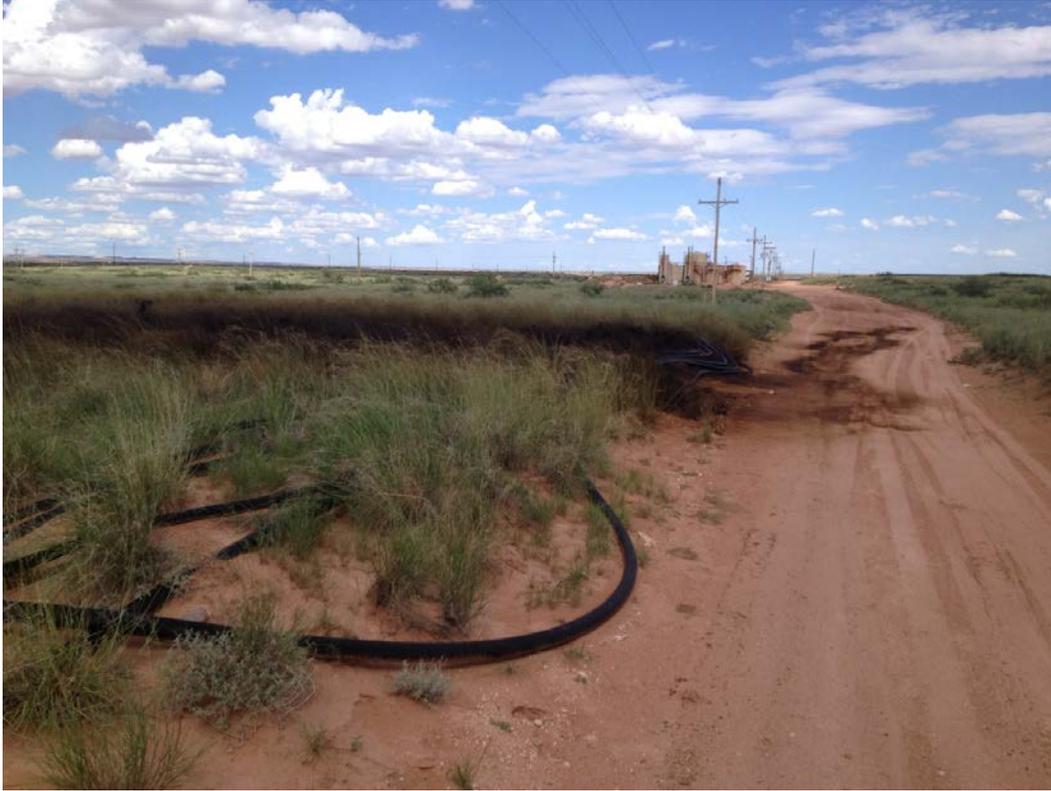
Leak #1 looking east towards the battery

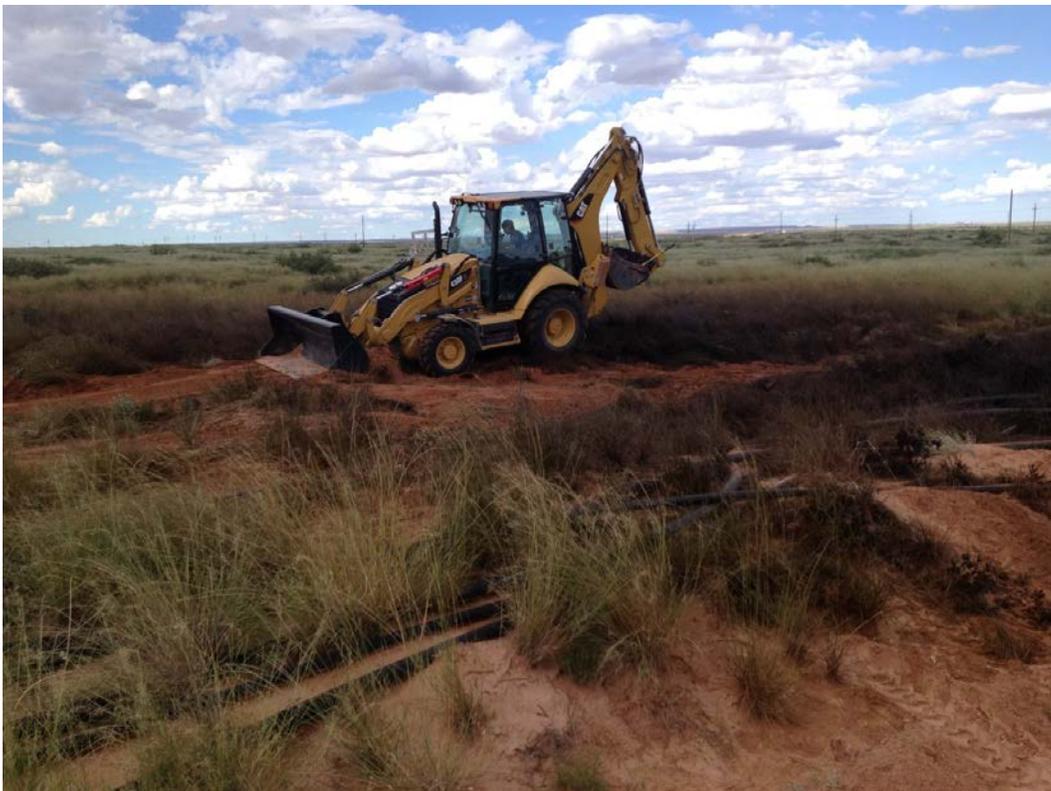
Leak # 1 – Clean up underway.

Greg McWilliams, EnergyQuest, reported the leaks to the BLM on Saturday, August 23, 2014, at approximately 1500 hours by leaving a message on their answering machine. A backhoe has been hired to clean up the oil and to back drag the oily foliage. Other than the oily foliage, the leaks caused only minor surface damage. Flow lines will be surveyed on foot to locate damage, and damaged sections will be repaired or replaced as necessary.

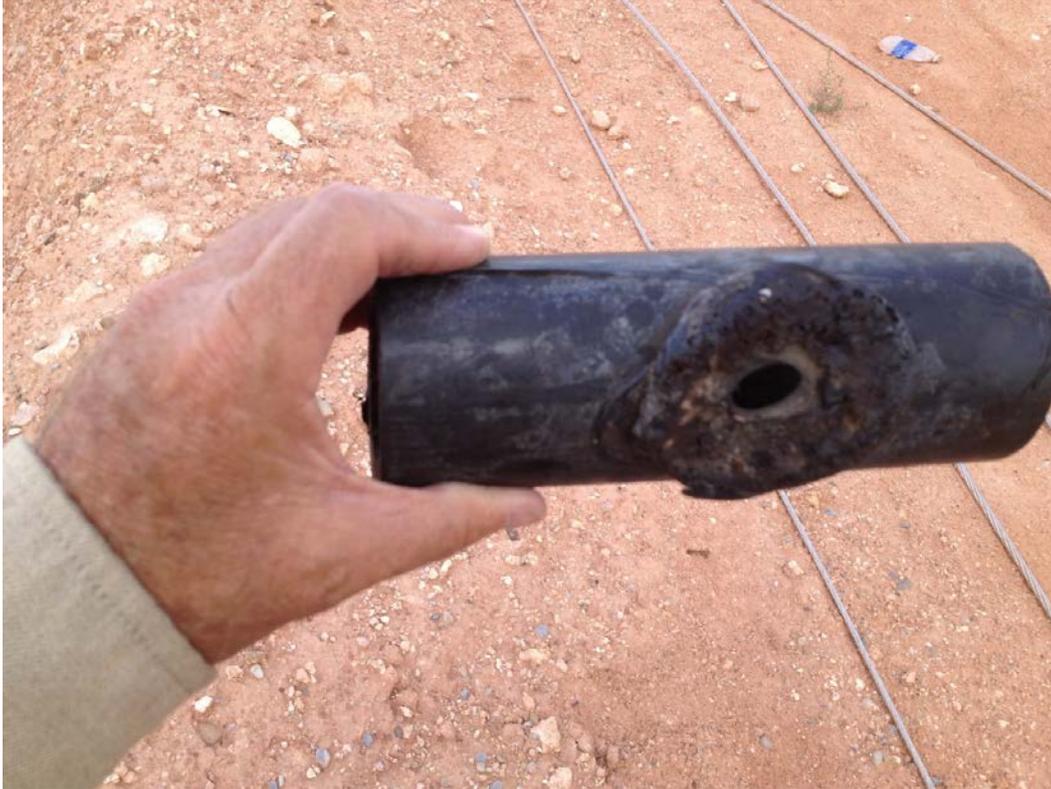
Leak #1 - Flowline section damaged by vehicle exhaust

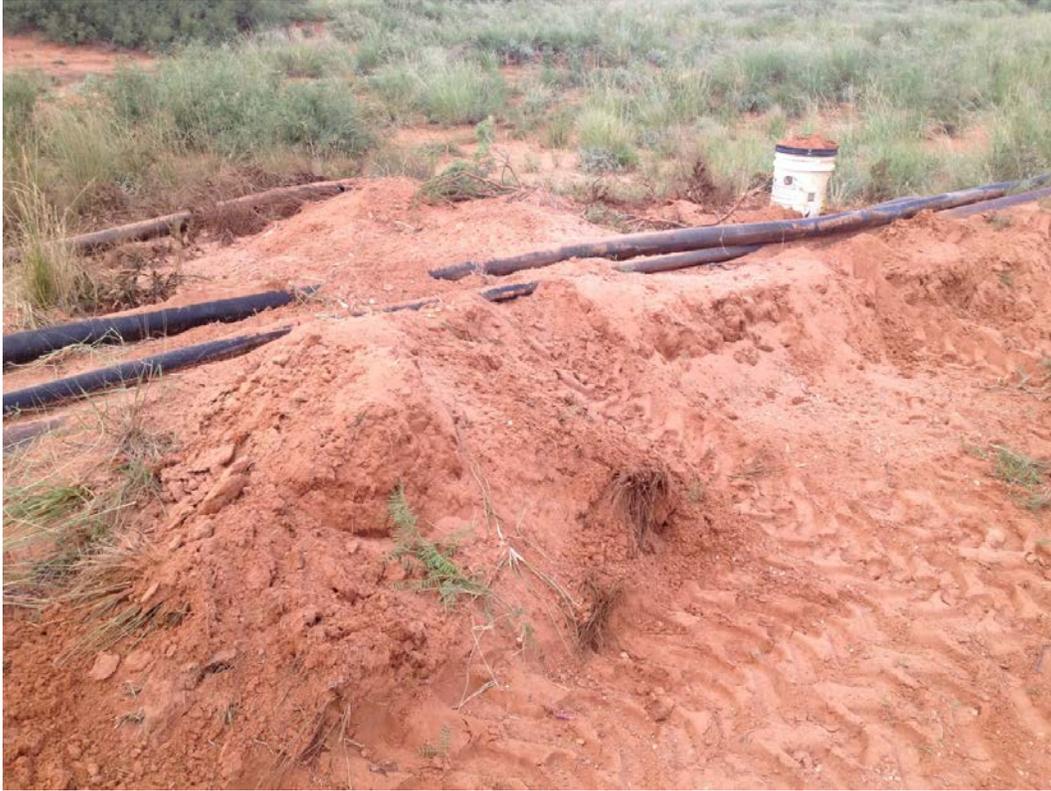
- Leak 2: West of the water station, East of Leak #1  
Leak #2 was caused by the steel tracks of the bulldozer used by Dean's Electric running over the flow line. Damage site is located about 500 ft. east of the first release point and before reaching the battery. Inspecting the flow lines where Dean's Electric was working revealed that the tracks from the bulldozer go up to and across the flow lines several times. This caused several large gashes that must be repaired. The damage appears to have been done on August 21, 2014, but was not reported to our pumper until 0100 hours August 22, 2014.

Release Point #2 – Damage caused by dozer treads – only location of product release from damage line.

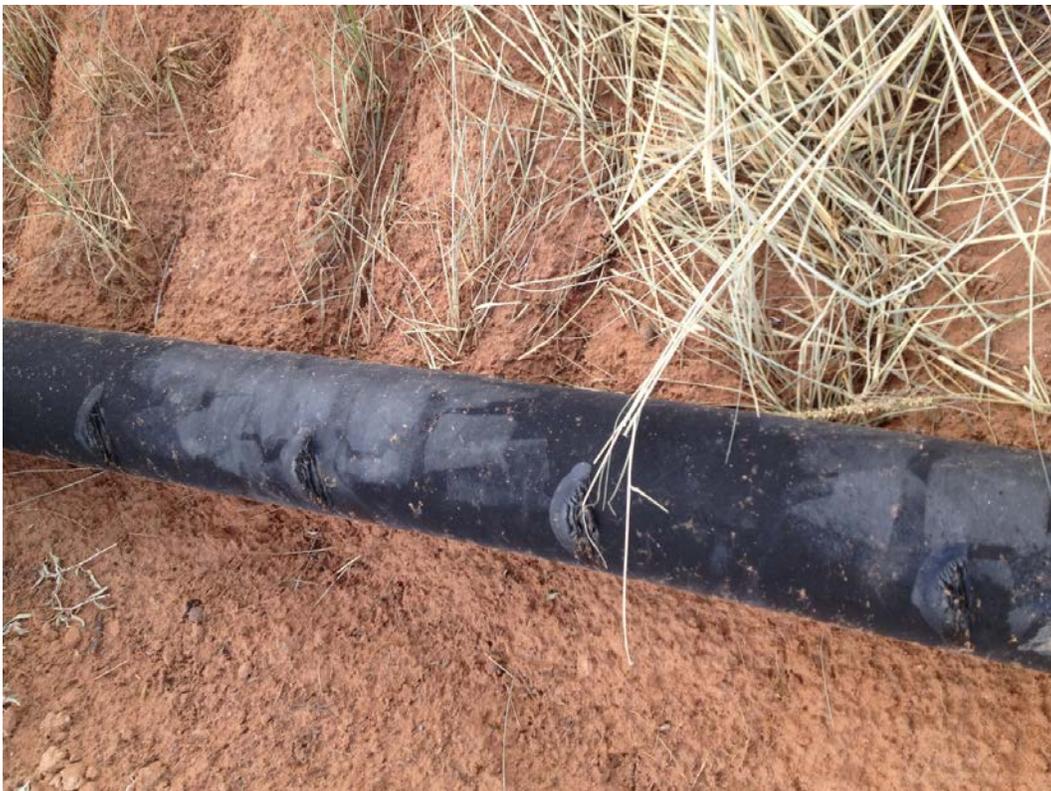
Leak 2 – Damage caused by bulldozer – **NOTE: no product release at this damage site**

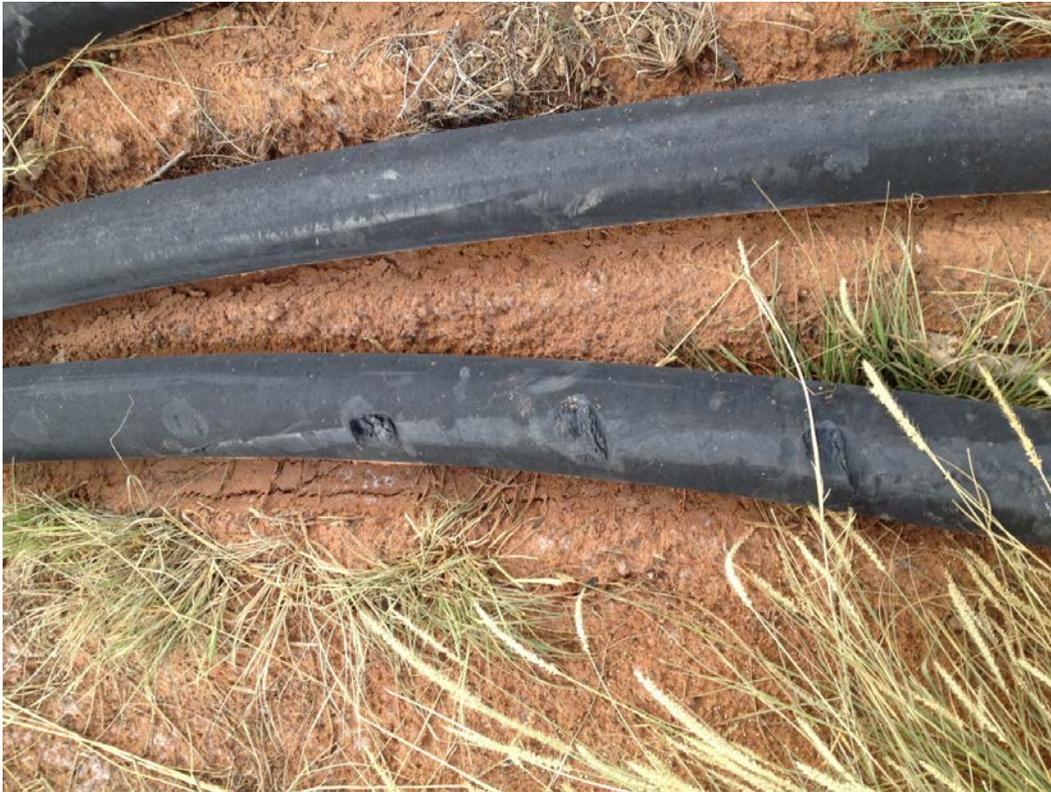
Leak 2 – Damage caused by bulldozer – **NOTE: no product release at this damage site**

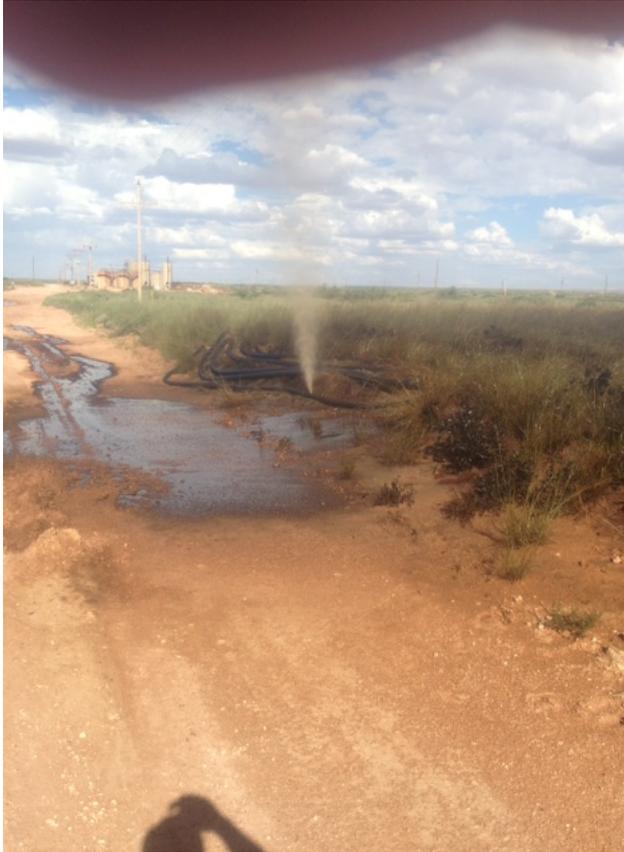
- Leak #3: East of the water station  
Leak #3 also was caused by the steel tracks of the bulldozer used by Dean's Electric running over the flow line. Damage site is located about 1000 ft. east of the release point #2 and east of the battery; damage to the line resulted in a release of a fine mist into the air. This release was called in to the EnergyQuest's emergency number on Saturday, August 23, 2014.

Release Site #3 – Only active line at time of incident. Pump shut down after photo taken
