# **Devon Energy Production Co LP**

**Cotton Draw Unit #172H**

## **Delineation Report and Work Plan**

**May 27, 2016**

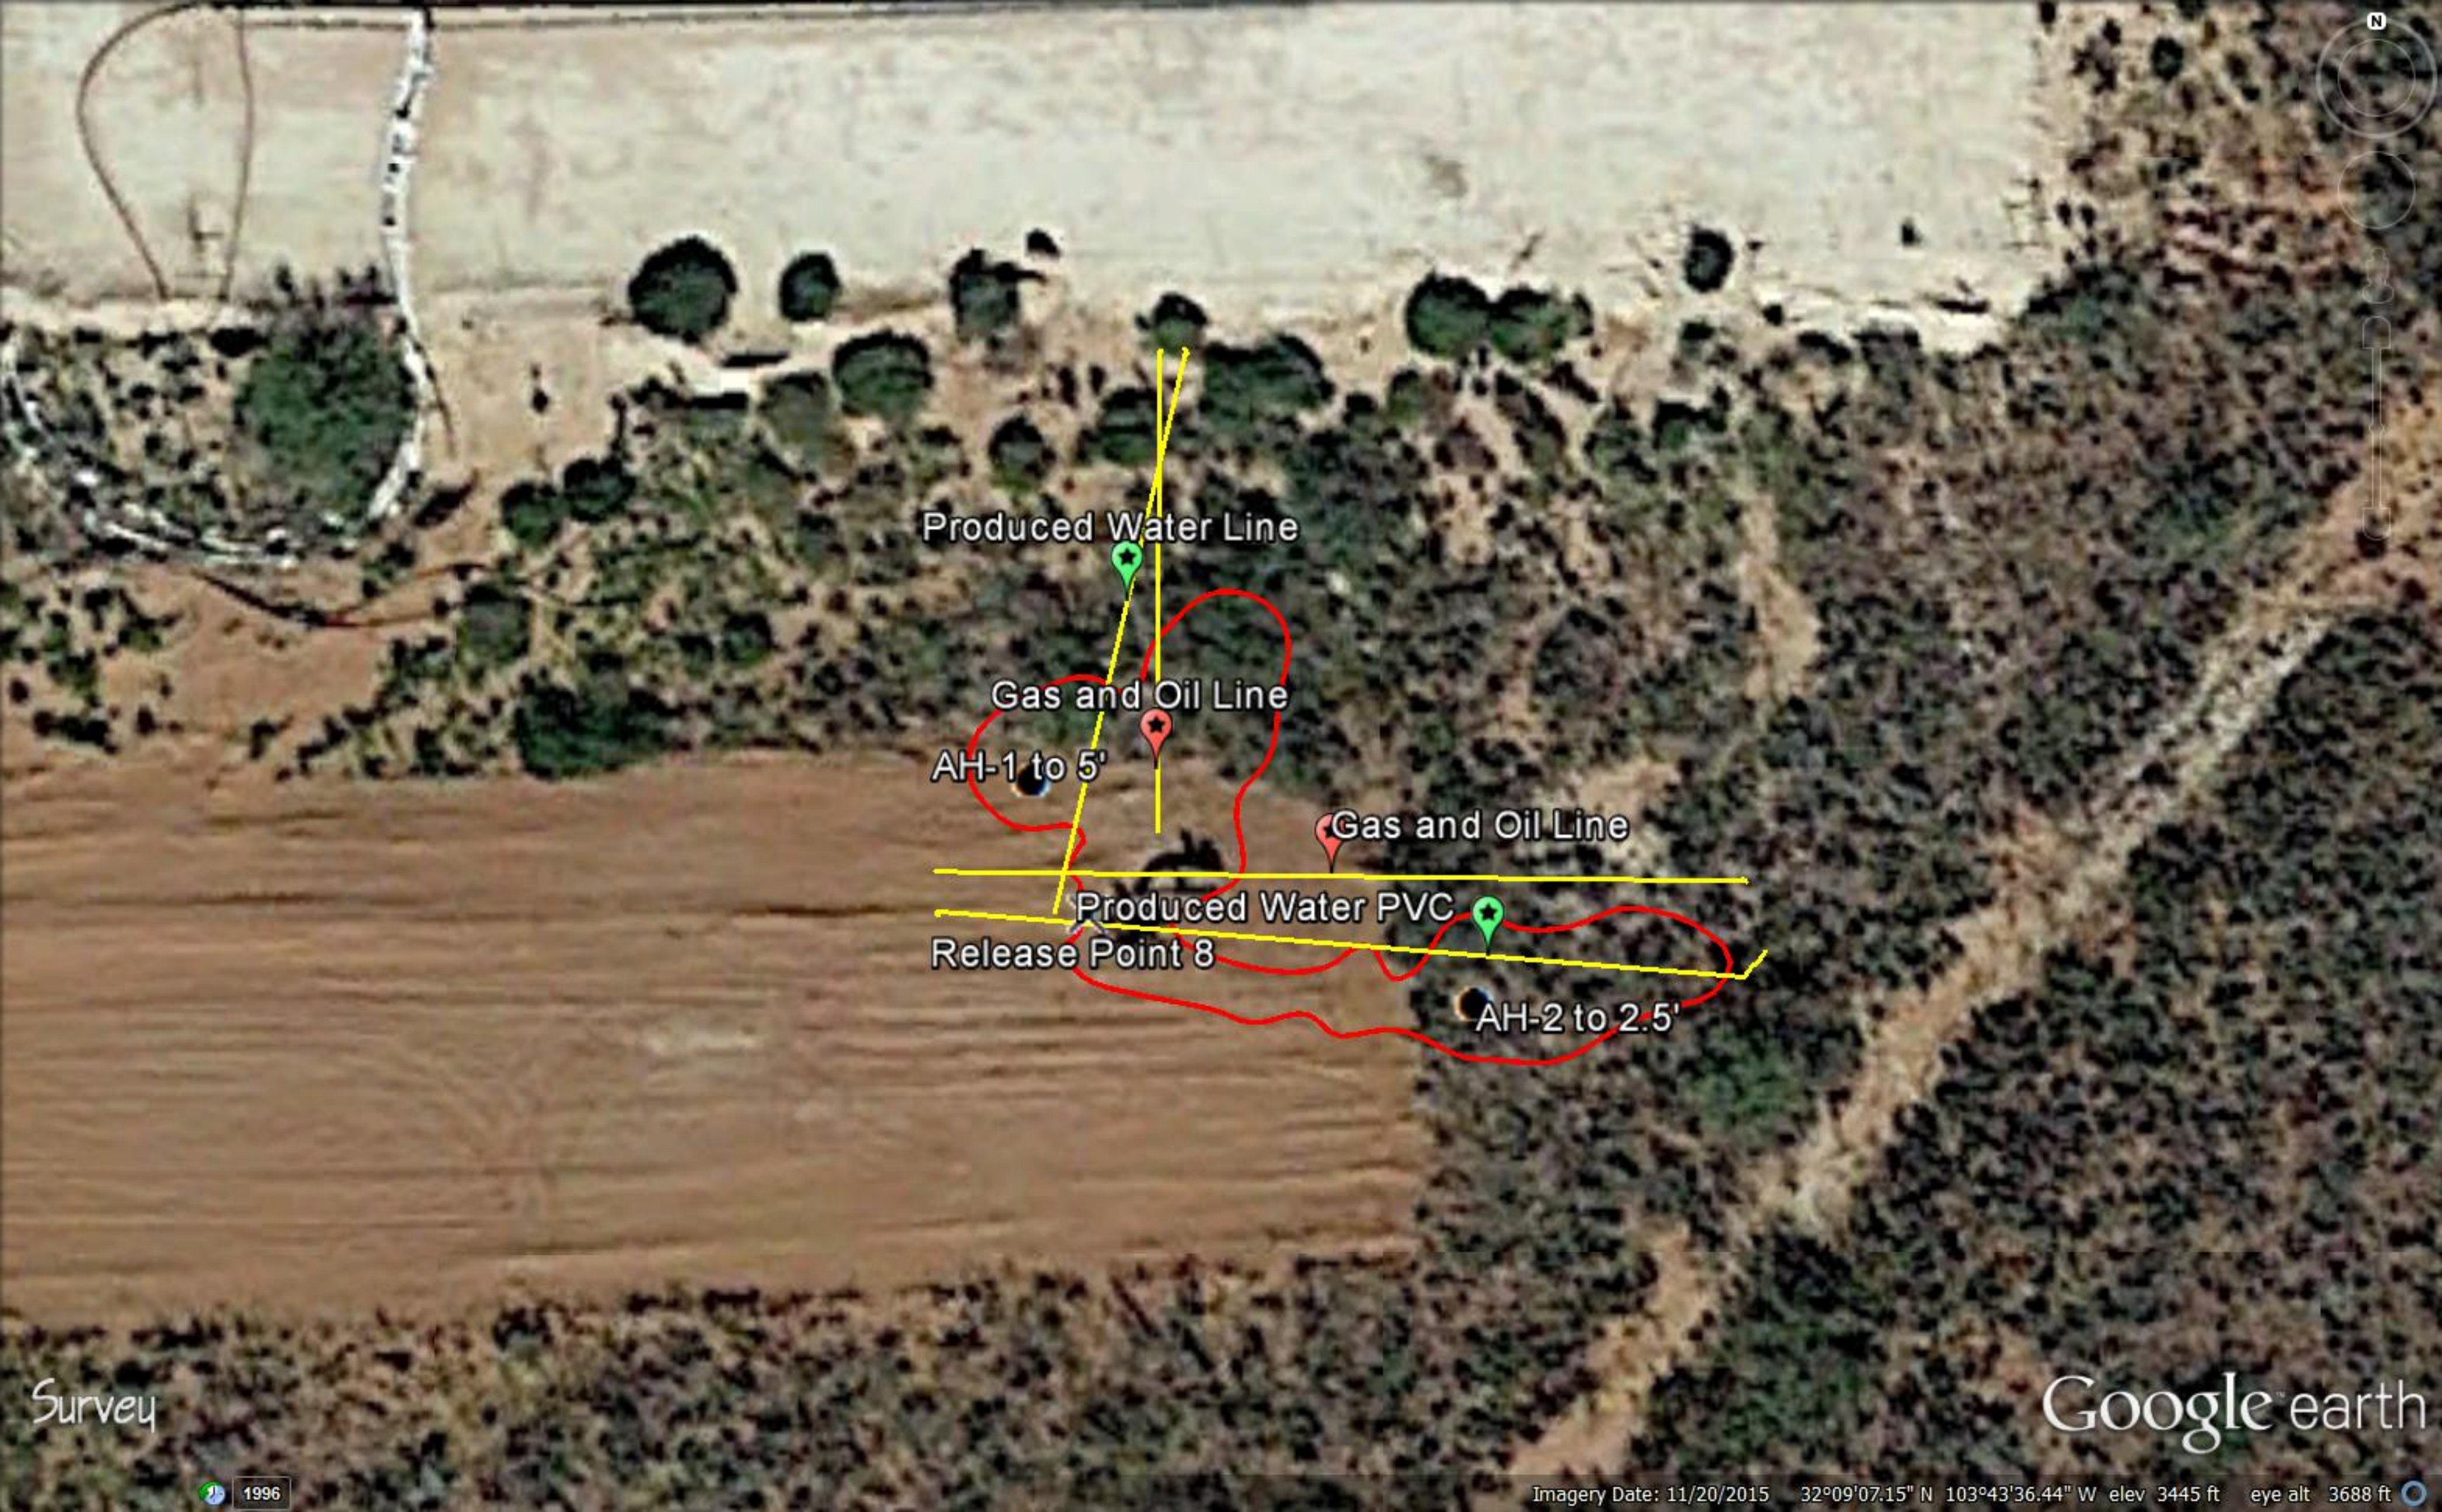
**Figure 2**  
**Site Plan**

On May 13, 2016 SESI was onsite to photograph, assess and map the spill area. The area of the leak was located southeast of the battery, traversing from East to West in the Right of Way. Please note: There were 4" water lines connected to 10" pipe that traverse both East and West as well as North and South of the impacted area (Figure 2). Two Auger holes were advanced at an attempt to determine vertical extent. The first Auger hole labeled as AH-1 was advanced, retrieving representative soil samples at 1' intervals to a depth of 5', whereby auger refusal was encountered. The second Auger hole, labeled as AH-2 was advanced, retrieving representative soil samples at 1' intervals until refusal was again met at 2.5' BGS. In both areas of sampling a solid rock bed of Caliche was encountered. Representative soil samples were properly packaged, preserved and transported to Cardinal Laboratories, Hobbs New Mexico and analyzed for Chloride (Cl<sup>-</sup>) (Method SM 4500Cl-B). The results of the analysis are presented in the table below (Appendix C):

Sample Date 05/13/16	Depth	Chloride (mg/kg)
Sample ID		
AH-1	Surface	8260
AH-1	5'	2680
AH-2	Surface	8130
AH-2	2'	6080

Since the average depth to groundwater for this area is 390' BGS., SESI respectfully requests approval to remove the impacted soil to a depth of 2' BGS, where the hard layer of caliche is encountered. It is further requested that in order to maintain safety and clear any risk of any further impact, that the areas lying within 10' of either side of the high pressure water lines remain undisturbed. Representative soil samples of the sidewalls and bottom of excavated area will be sent to Cardinal Labs of Hobbs, NM for confirmation. The excavated area would be lined with a 20 mil. Liner, backfilling with material similar to that removed and returning the area to grade.

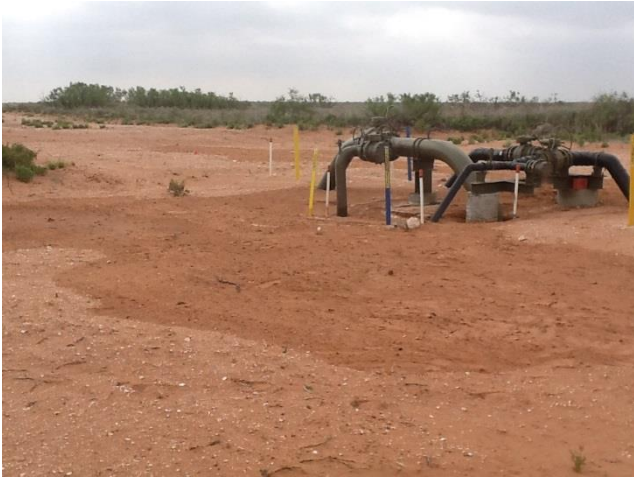
Spill Area looking Northwest

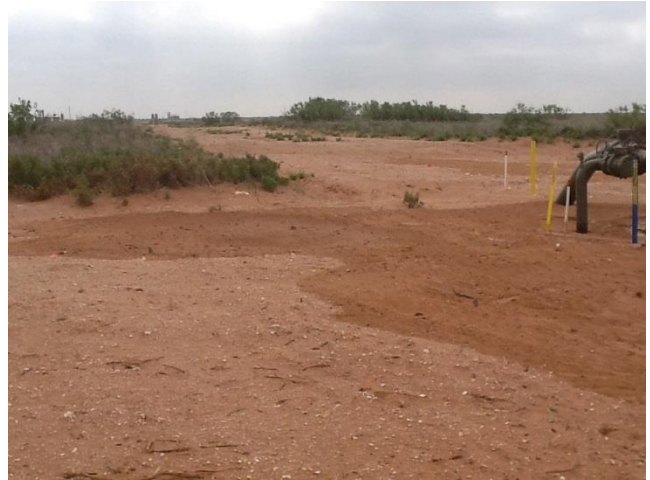
Spill run looking West

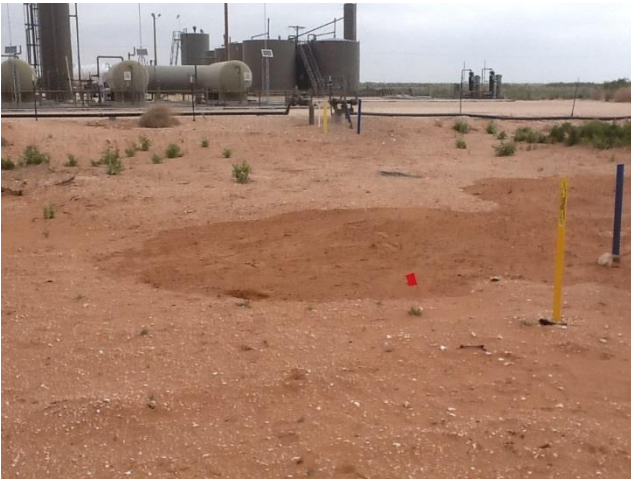
Impacted area looking North

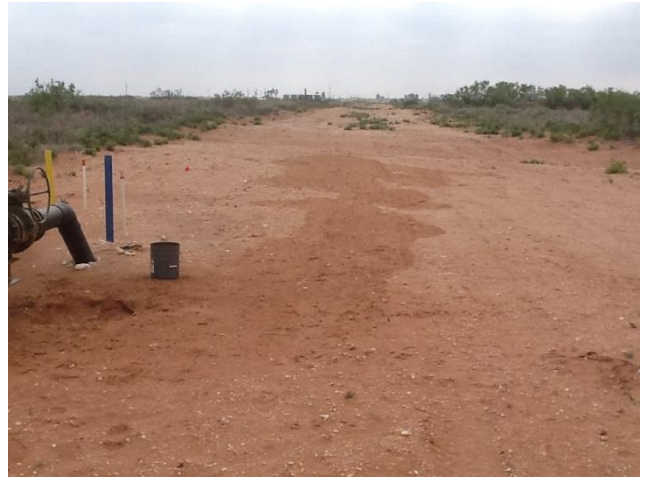
Impacted area traversing East Right of Way

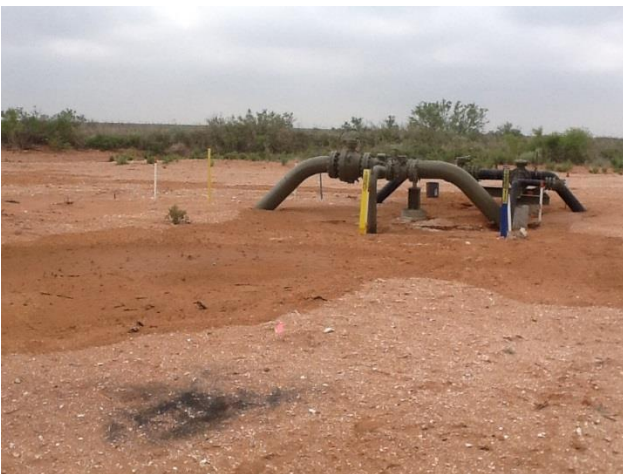
**Describe Cause of Problem and Remedial Action Taken.\***  
Gasket blew out on main water line between the valve and the pipe. The valves on each side of the line were immediately shut so the line could be bypassed to stop the water flow. The line is currently out of service waiting on repairs.

Source of Impact

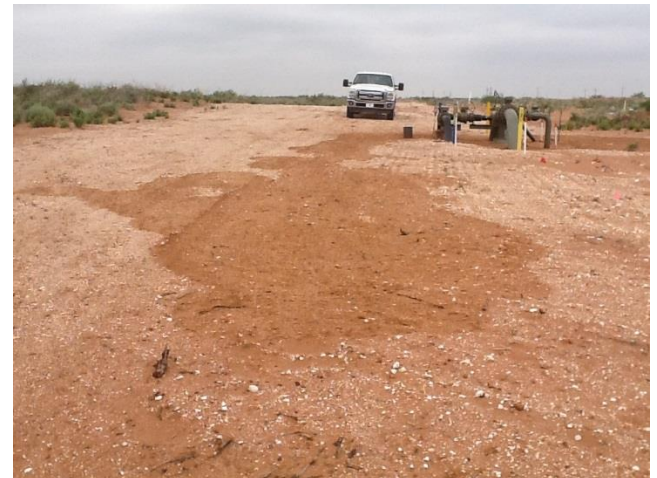
Impacted area traversing East Right of Way

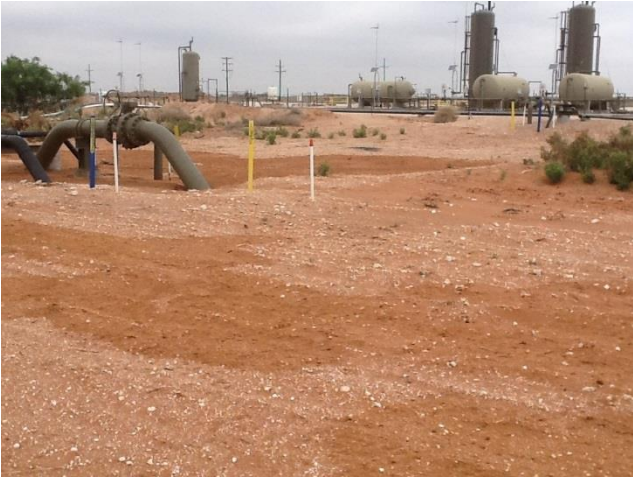
Impacted area looking Northeast

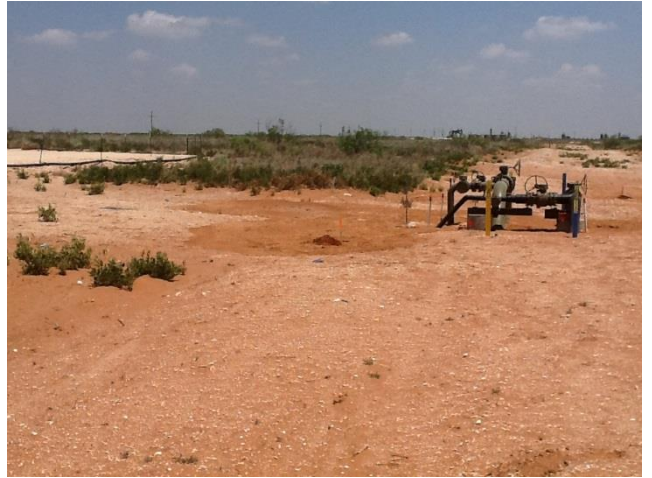
Pooling area of AH-2

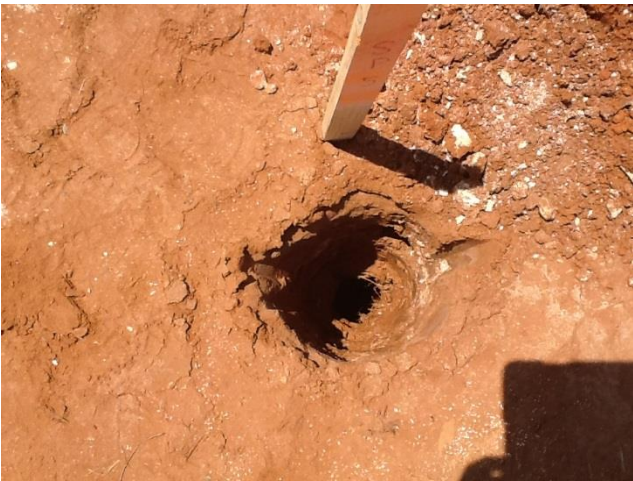
View of Auger Hole 2-Refusal

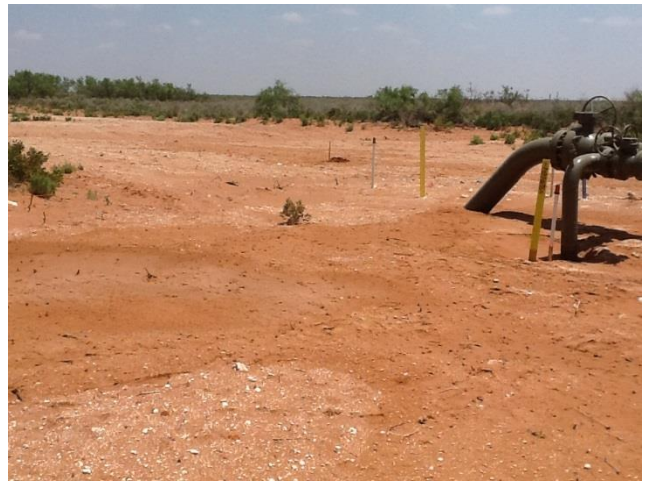
Pooling Area of AH-1

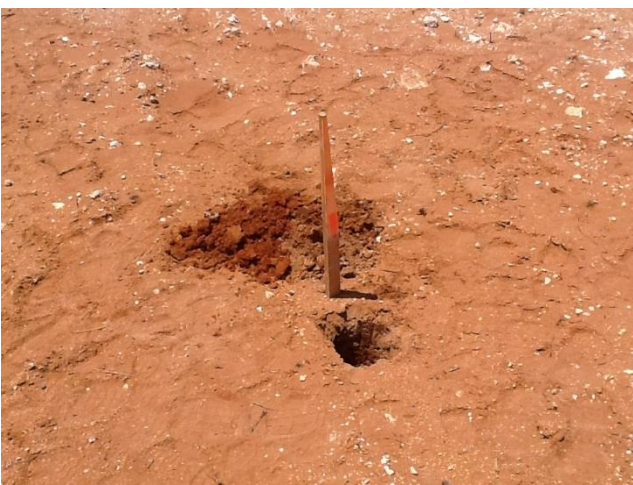
View of Auger Hole 1

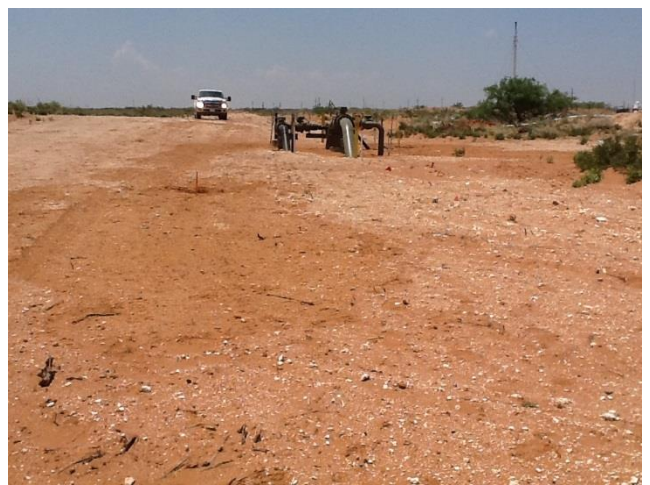
View of Sample Points
