Release Notification and Corrective Action

Name of Company: Linn Energy	Contact: EL Gonzales	
Address: 2130 W Bender, Hobbs, NM 88240	Telephone No. 575-738-1739	
Facility Name: Skelly #247	Facility Type: Oil	
Surface Owner: Federal	Mineral Owner: Federal	API No. 30-015-28788

Linn Skelly #247 (2R-1188)

Unit Letter N, Section 21, T17S, R31E

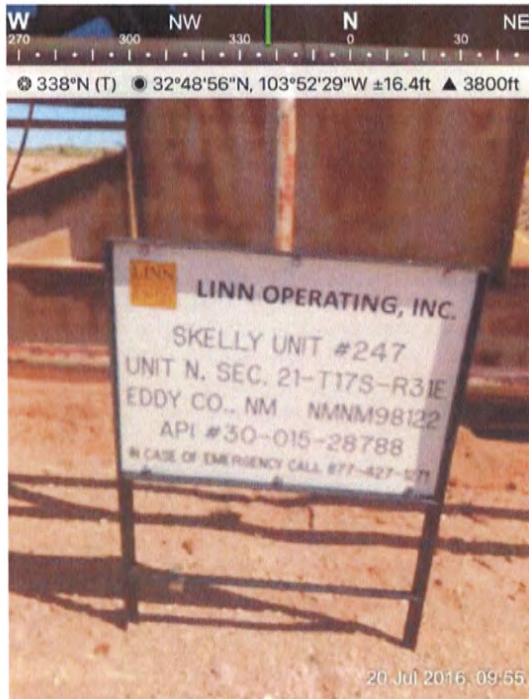
Current site photo documentation, facing
northwest-north 7/20/2016

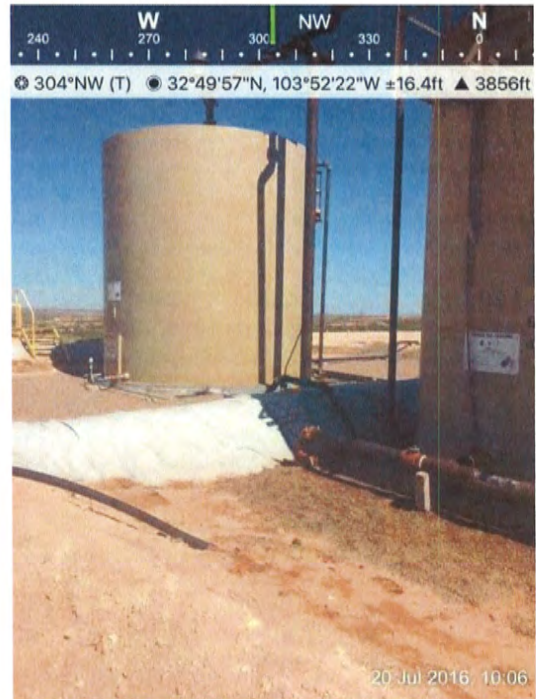
Current site photo documentation, facing
northwest 7/20/2016

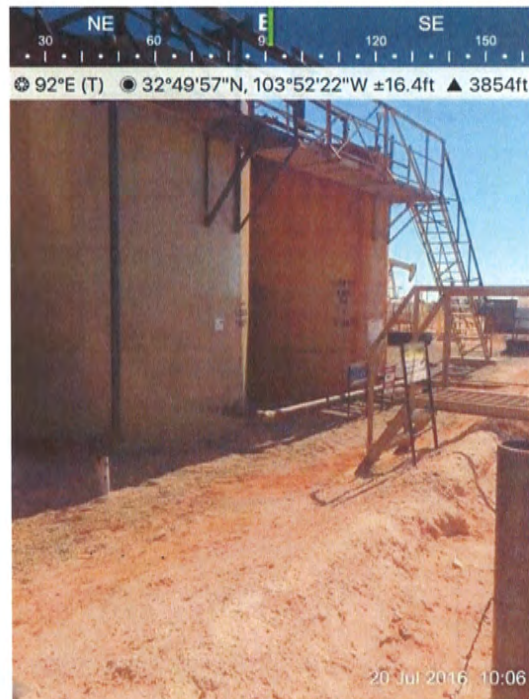
Current site photo documentation, facing
east 7/20/2016

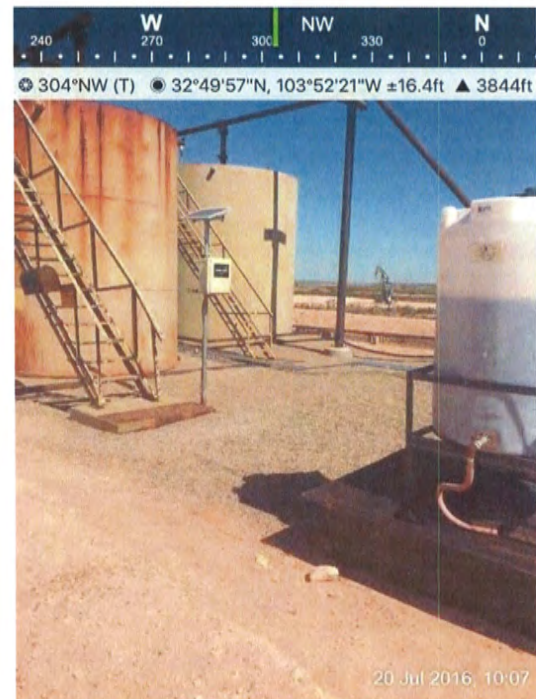
Current site photo documentation, facing
northwest 7/20/2016

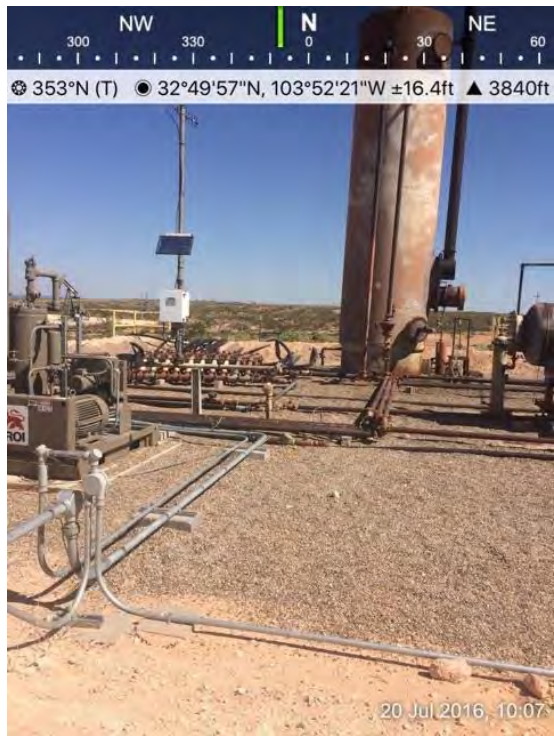
Current site photo documentation, facing
north 7/20/2016

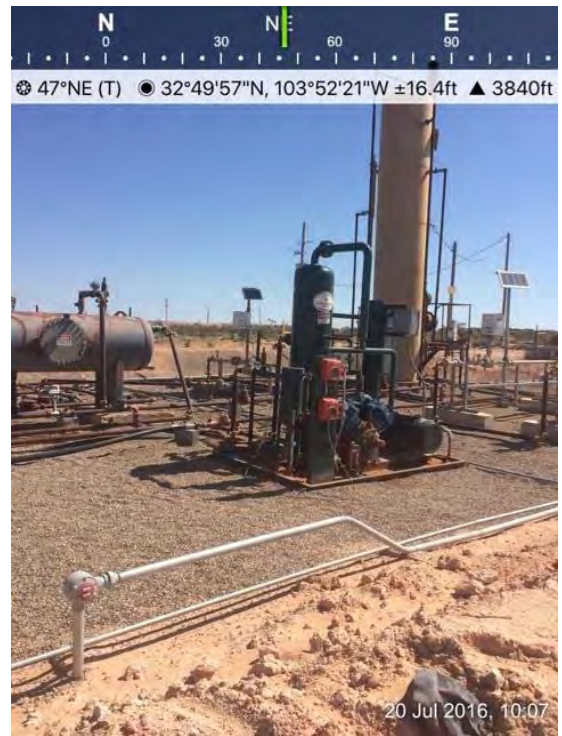
Current site photo documentation, facing
northeast 7/20/2016
