Re: Spill No. 2 Summary Report  
Candelario 24 #1 SWD Battery  
UL/E Section 24 T23S R28E  
API No. 30-015-26536

**ATTACHMENT 1  
PHOTOGRAPHIC LOG**

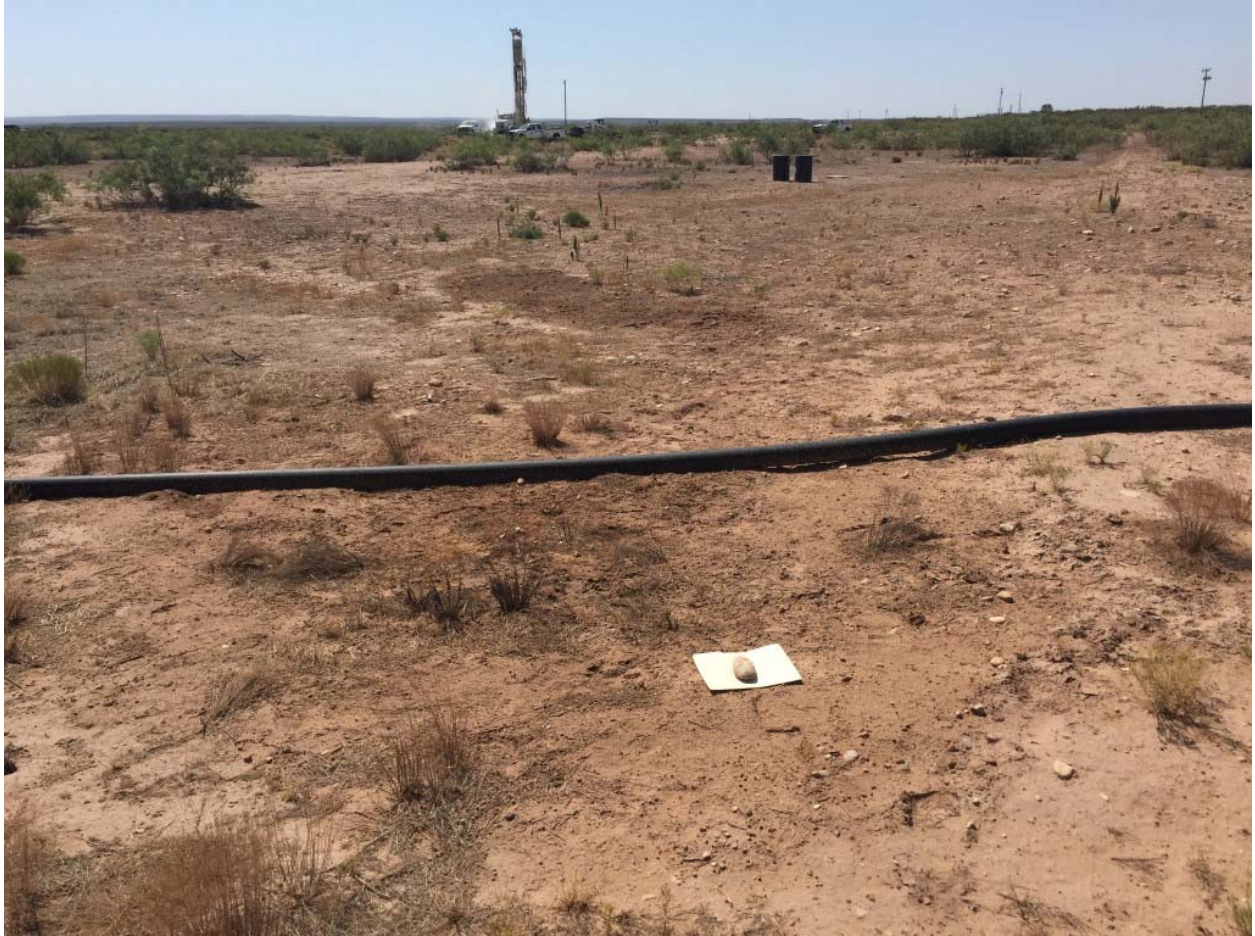
An assessment of the 2<sup>nd</sup> release area was conducted by SQE while onsite for the July 2016 groundwater assessment discussed above. Based on observations of the 2<sup>nd</sup> release area by SQE staff, the vegetation in the release area appeared be similar to vegetation in the surrounding area. A photograph of the release area on 18 July 2016 is attached.

Photograph 1: View of area of spilled produced fluid located north of the Candelario 24 #1 Salt Water Disposal Tank Battery. Direction: East.

Based on the liner installed in the release area, previously completed response actions, and observations of vegetation in the area of the release, no additional assessment or response actions appear to be necessary in regards to the 2<sup>nd</sup> release of produced fluid that occurred near the Candelario 24 #1 SWD Battery site.
