SITE INFORMATION												
REPORT TYPE: Closure Report 2RP-200												
General Site Information:												
Site:	Parkway Delaware Unit #304 (205 Injection Well)											
Company:	SM Energy Company											
Section, Township and Range	35	Township 19S	Range 29E									
Unit Letter:	G											
Lease Number:	NM-67102											
County:	Eddy County											
GPS:	N32°.62022 W104°04230											
Surface Owner:	BLM											
Mineral Owner:	BLM											
Directions:	From the intersection of Hwy 62/180 and 360, head north on 360 for 5.6 miles and turn left onto carry comb (CR235) go 4.7 mi., turn left for 0.6 mi. to T turn left for 0.7 mi. to T turn right for 0.4 mi. turn right for 0.4 mi, turn left 0.1 mi to site.											
Release Data:												
Date Released:	7/13/2008											
Type Release:	Produced water											
Source of Contamination:	Injection Well											
Fluid Released:	275 BBLS											
Fluids Recovered:	80 BBLS											
Official Communication:												
Name:	Zachary Luikens		Ike Tavaréz									
Company:	SM Energy		Tetra Tech									
Address:	6301 Holiday Hill Rd. Bldg 1		4000 N. Big Spring St., Ste 401									
P.O. Box												
City:	M

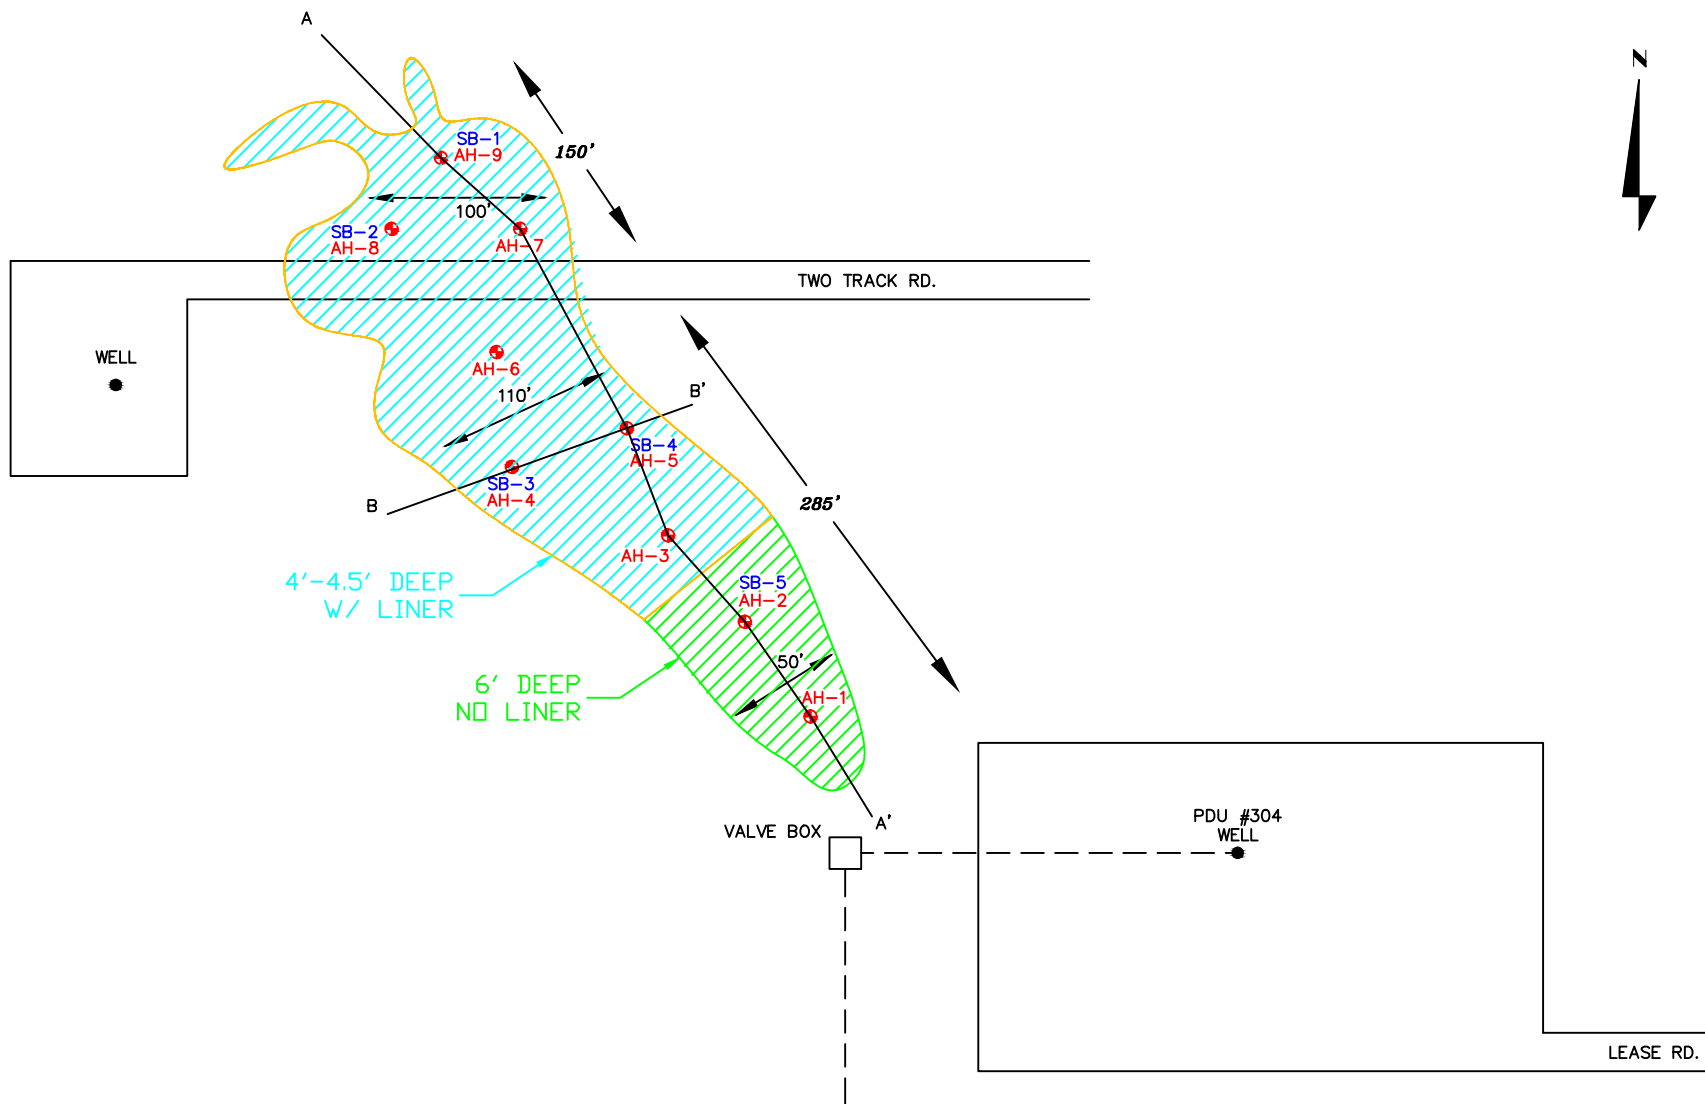
FIGURE NO. 4

Referring to Table 1, analytical results indicate the maximum extent of chloride impact greater than 1,000 mg/kg extended to 2.0' to 4.0' at, AH-3, AH-6 and AH-7, 6.0'-9.0' at AH-1, AH-2 (SB-5), AH-5 (SB-4), and AH-8 (SB-2), and to 13.0' to 18.0' at AH-4 (SB-3) and AH-9 (SB-1). All samples had chloride concentrations that decreased with depth. The soil boring logs are included in Appendix C. Copies of laboratory analysis and chain-of-custody documentation are included in Appendix D. The results of the sampling are summarized in Table 1. The borehole locations are shown on Figure 3.

The areas of SB-1, SB-2, SB-3, and SB-4 were excavated to 4.0'-4.5' and lined with a 40 mil liner at 4.0' below surface. The area of SB-5 was excavated to 6.0' below surface. Once the areas were excavated to the appropriate depths, and the liner placed, the area was backfilled with clean soil and brought to surface grade. The excavation depths and liner placement are shown on Table 1 and Figure 4.
