# HUNGRY HORSE, LLC

23Nov16

To: Mike Bratcher, New Mexico Oil Conservation Division  
Shelly Tucker, Bureau of Land Management  
Reference: Remediation Work Plan  
Operator: Devon Energy Production Company  
Location: Cotton Draw Unit #182H Battery  
Legals: UL. D, Sec. 36, T24S, R31E Eddy County, NM  
GPS: 32. 1793 -103.7378

Devon Energy Production Company-Cotton Draw Unit #182H

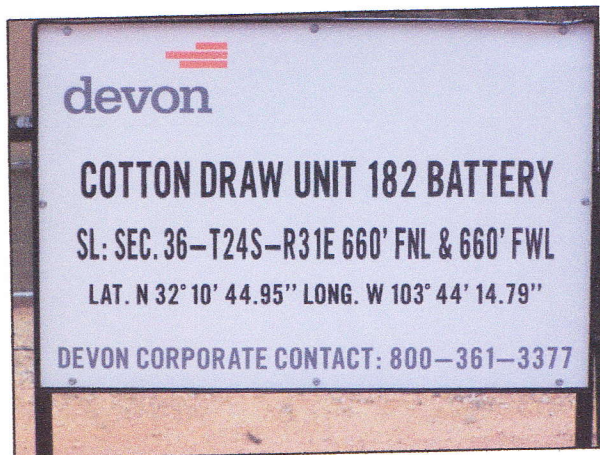
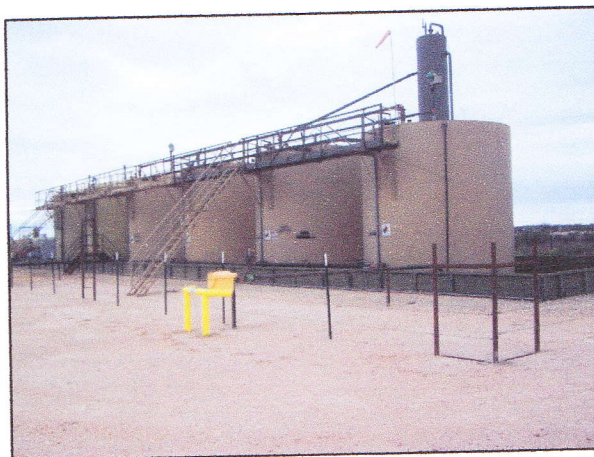
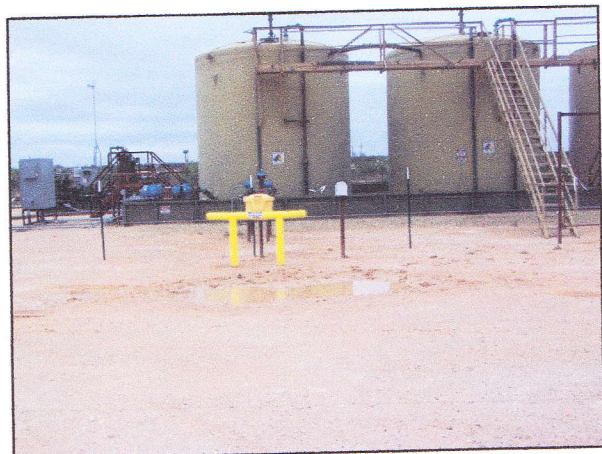
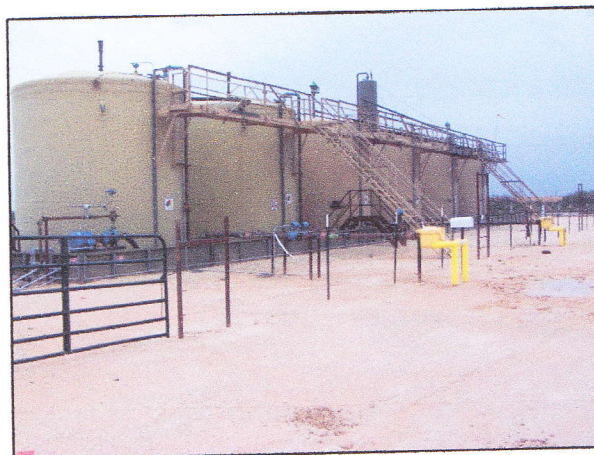
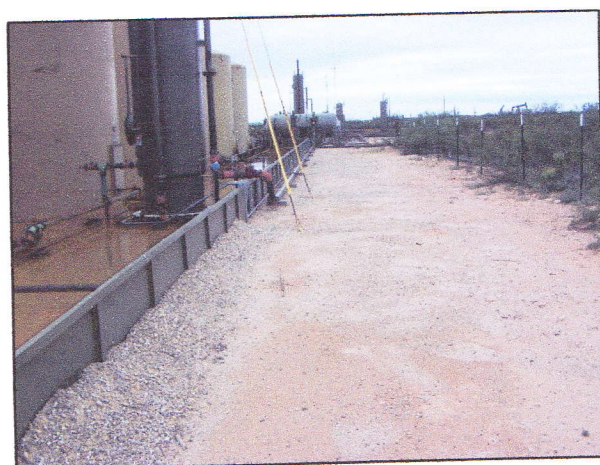
At the time of the release into the lined containment, a small area outside the containment was impacted from a slight over spray. This impact, approximately 15' x 15', was on the south side of the battery and in front of the west end tank. All other released fluids were recovered. The impacted area is on the caliche pad in front of the battery and no area off the pad is impacted.

Due to chlorides being the contaminant of concern for this remediation, I propose to use the dig and haul method of remediation for this site. I propose to excavate the impacted area, approximately 15' x 15', to a depth of 2' BGS and backfill with fresh caliche bringing the area back to the original grade. All impacted soils will be transported to a division approved for disposal.
