J L Keel B #37

REMEDIATION WORK PLAN

API No. 30-015-25934

RE: Linn Energy J.L Keel B #37 – Amended Remediation Work Plan
UL/E, Section 5, T17S, R31E
API No. 30-015-25934

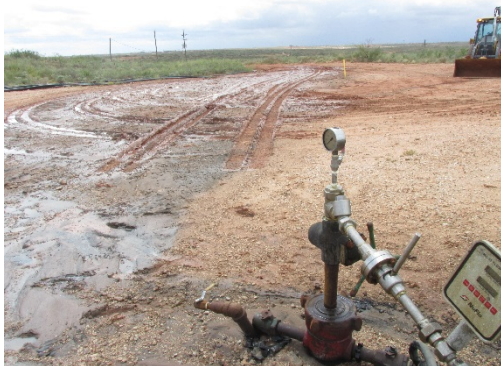
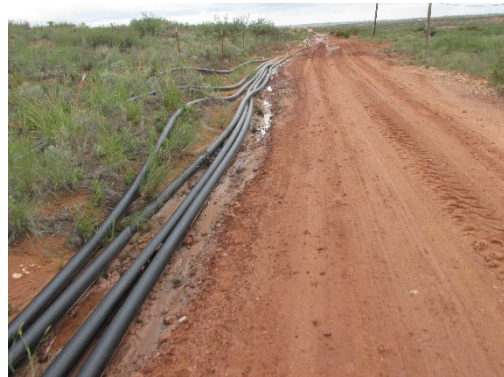
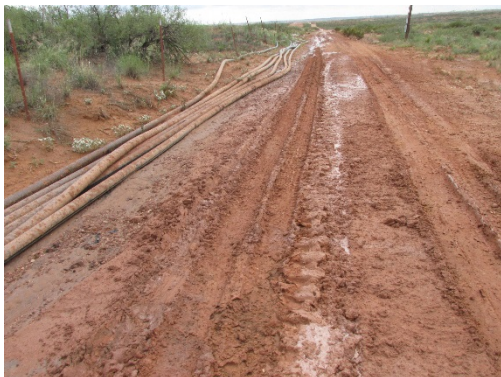
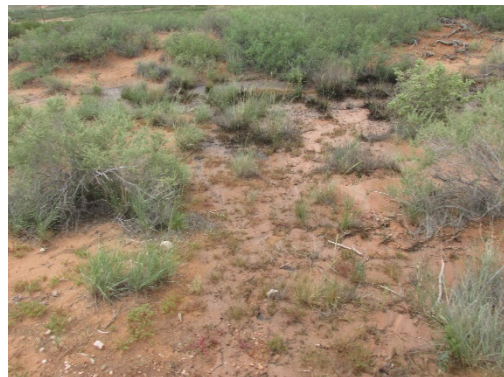
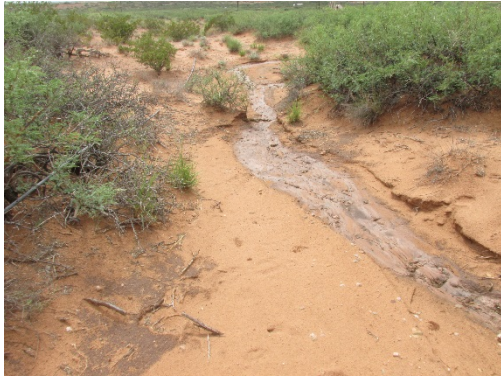
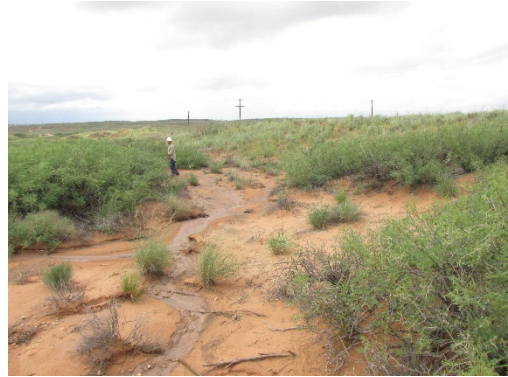
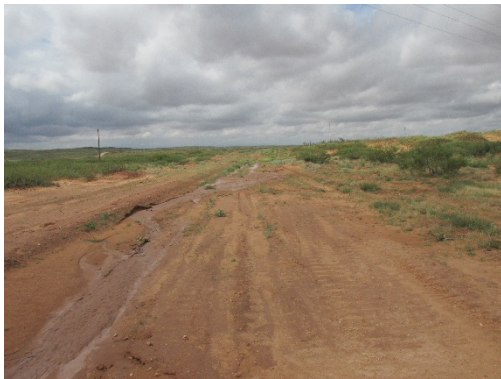
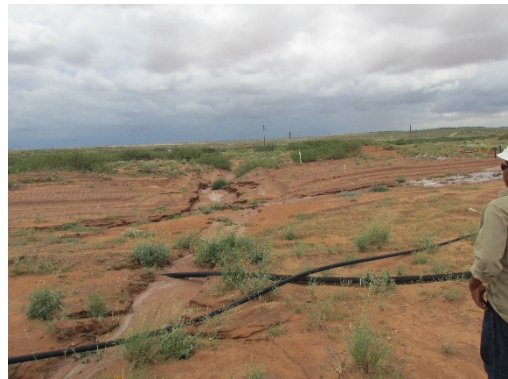
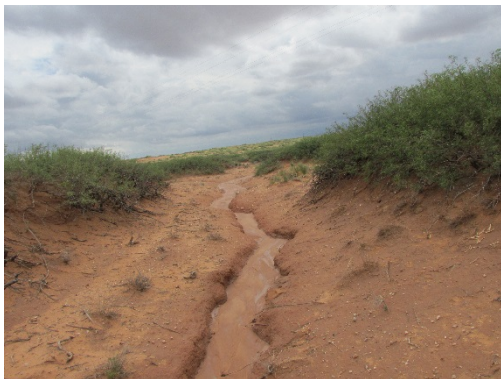
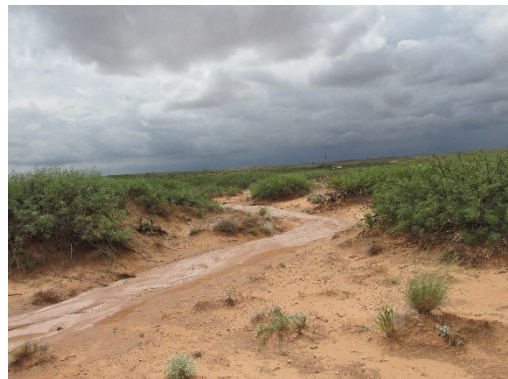
9/14/13

The site is located northeast of Loco Hills NM, in Eddy County. The site resulted from a produced water leak in the injection line at the well head. The line rupture released fluids onto approximately 279,931.6 sq. feet of lease roads and arroyos to the southwest of the leak source. A vacuum truck recovered 45 bbls of standing fluids and the line was repaired. A form C-141 was submitted to the NMOCD on September 12, 2013.

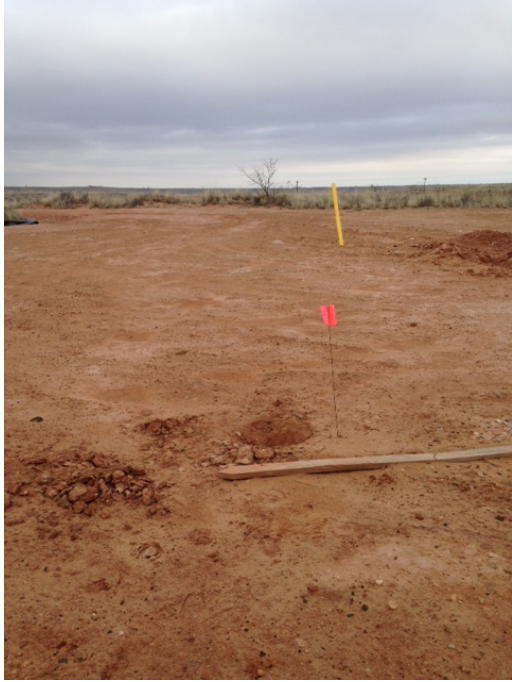
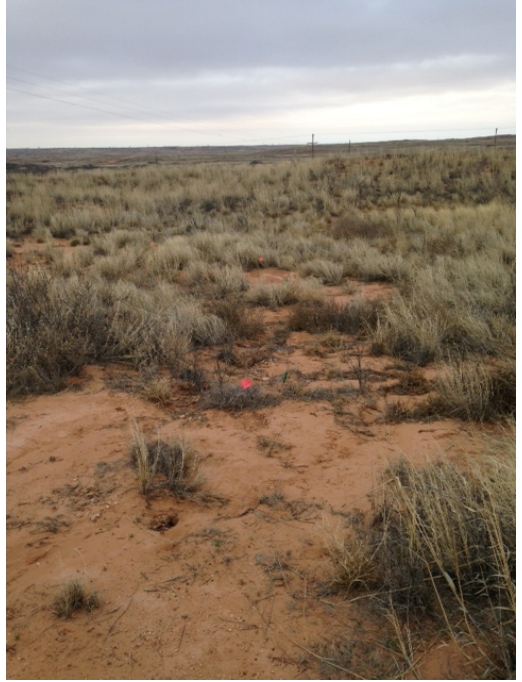
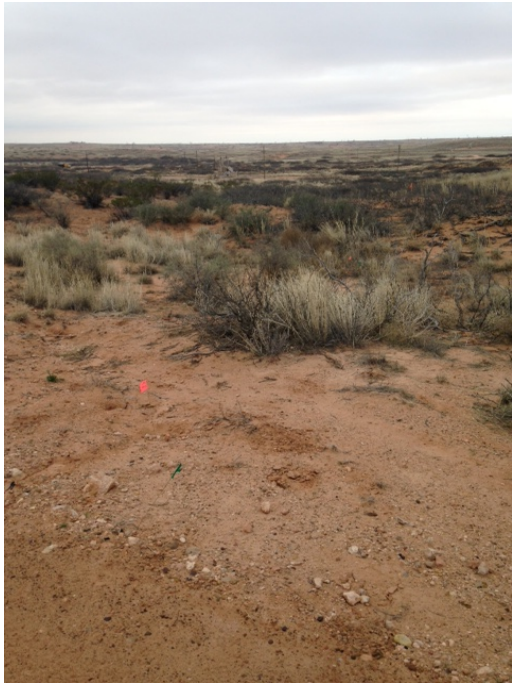
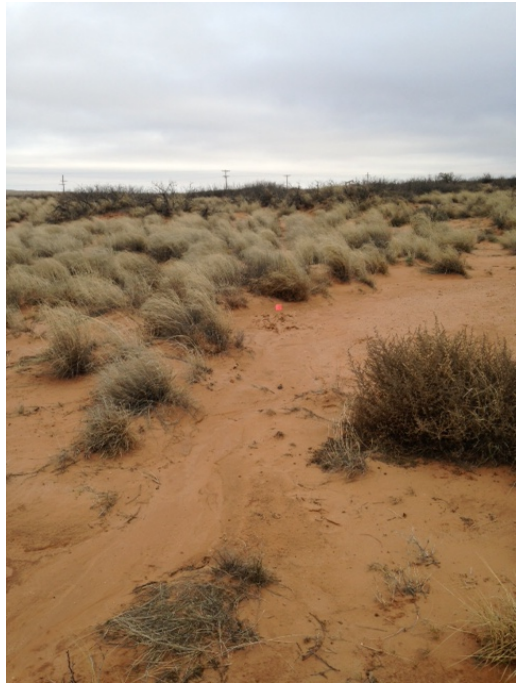
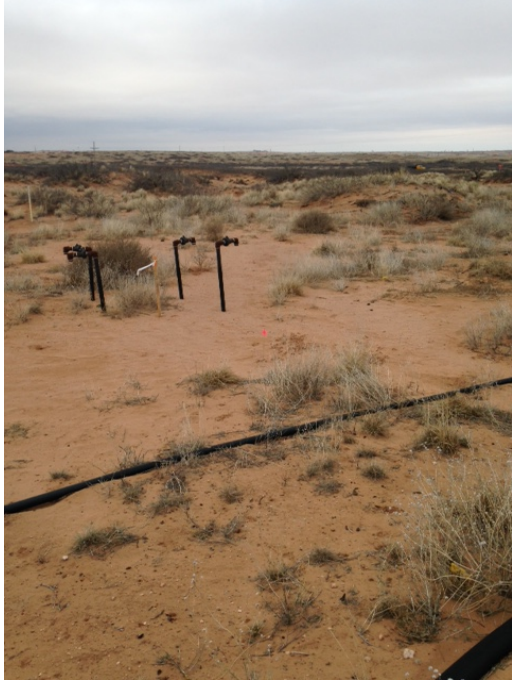
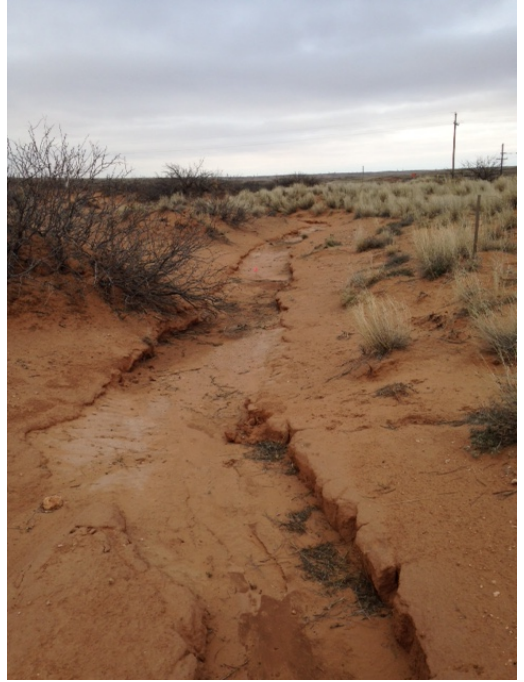
3/20/15

On 03/12/2015 DFSI personal re-sampled the spill location. Sample points were replaced. Only 20 points were needed. All but one surface sample tested clean for chlorides and BTEX. Sample point 1 (on the pad) was delineated down to 2' bgs. All clean samples were taken to Cardinal Labs in Hobbs for confirmation.

Scrape the affected area of the caliche pad to 6" bgs and backfill with clean caliche. The areas of small arroyo will be addressed by installing erosion controls. The style of erosion control will be rock piles bound together with fencing. The erosion controls will help to ensure that the small arroyo slows down the speed of water and helps sediment settle in the small arroyo. In the areas that are not in a wash out we will seed with BLM approved seed mix.
