Turner B #082

CLOSURE REPORT

API No. 30-015-26385

February 2, 2017

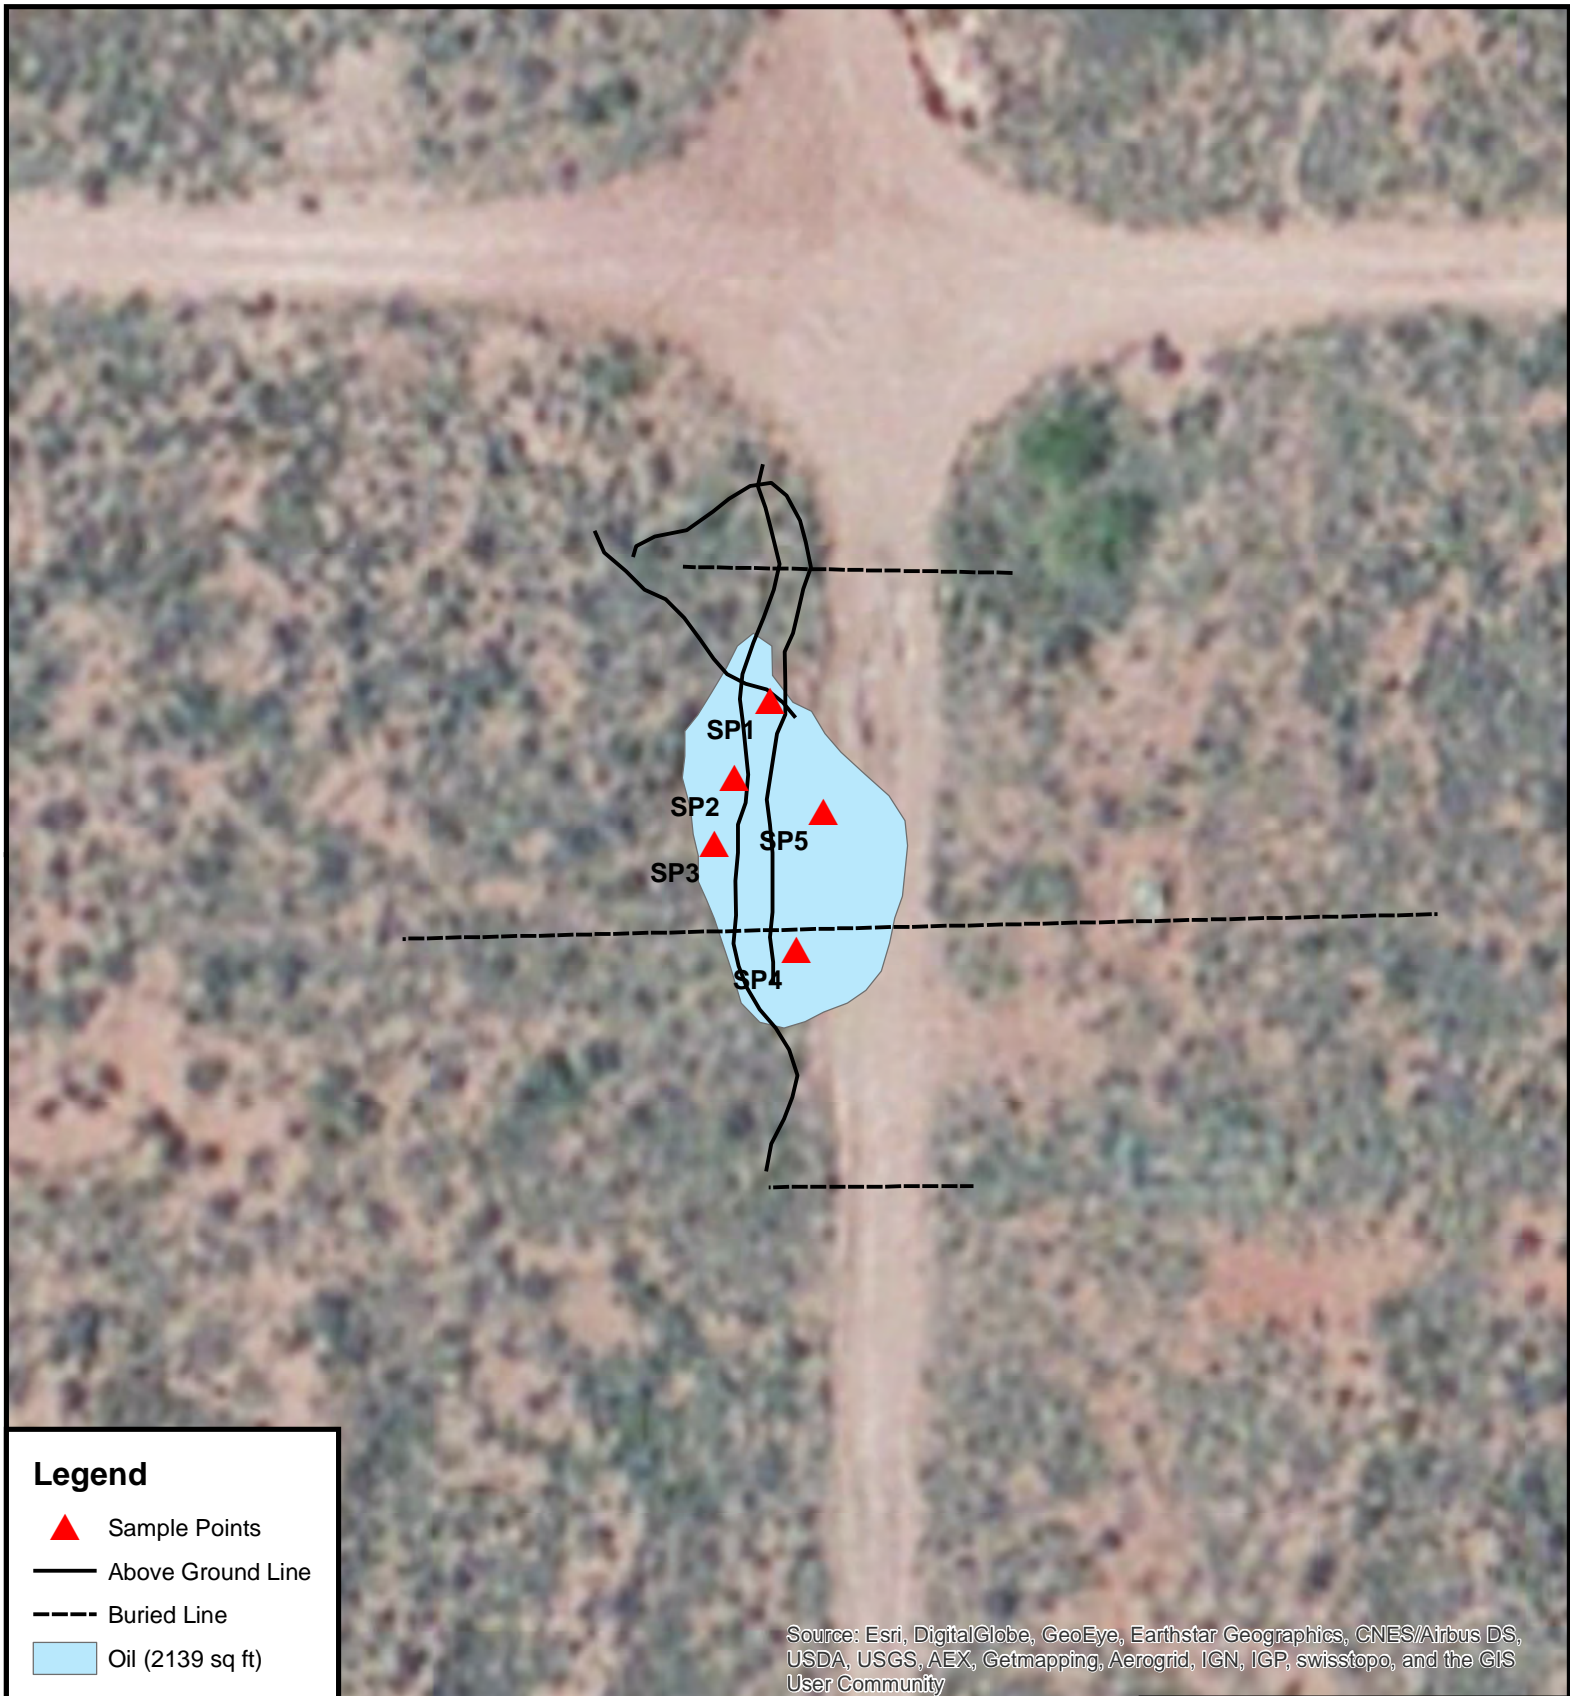
Figure 1

On June 23, 2016, DFSI personnel were on site to obtain samples within both of the leak areas. Within the release area, five samples were obtained and field sampled for chloride levels, as well as BTEX (Figure 1). The BTEX samples were performed using a Mini Rae Photoionization Detector (PID). All clean field samples under NMOCD and BLM regulatory guidelines were submitted for laboratory analysis at Cardinal Laboratories of Hobbs, NM to obtain confirmation, resulting in concentrations that decreased with depth.

Soil Delineation

On June 30, 2016, a Work Plan was submitted to NMOCD and BLM and approved by both agencies on July 13, 2016. Based on the approved Work Plan, the area around SP5, located within the lease road, was excavated to a depth of 4' bgs. The excavation was backfilled with clean, imported soil and capped with caliche to ground surface and contoured to the surrounding area. The remainder of the release, located within the pasture area, was tilled and seeded with a blend of BLM – NMOCD approved vegetation (Appendix V).

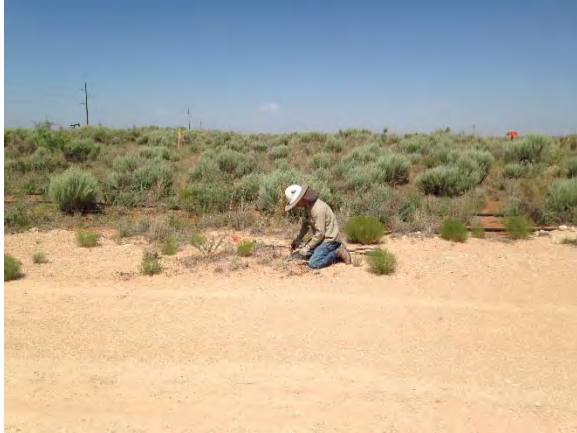
Collecting sample

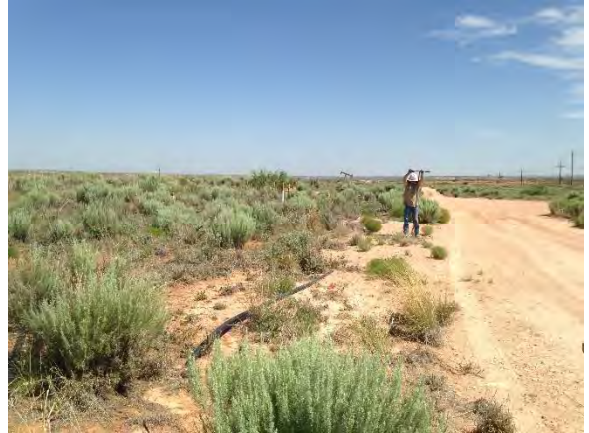
Collecting sample

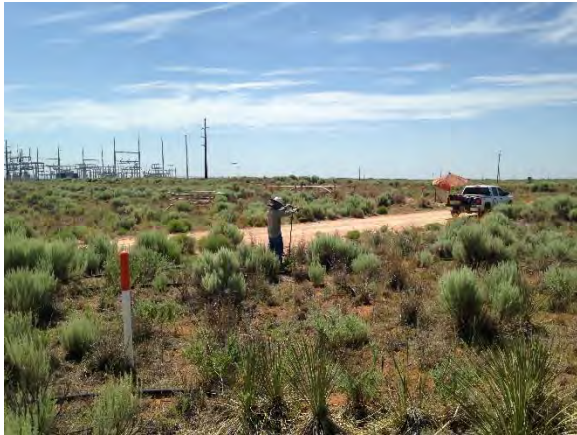
Collecting sample

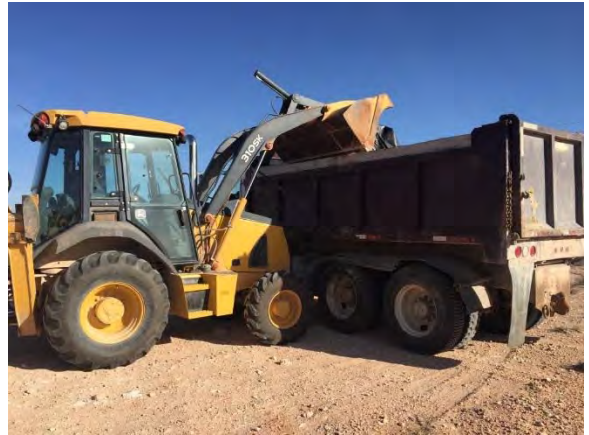
Exporting soil

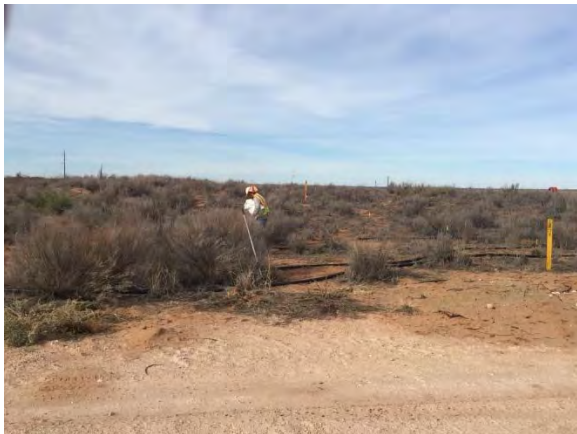
Seeding site

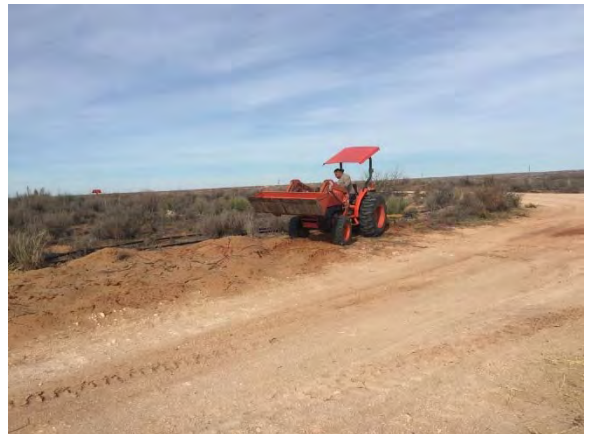
Tilling site
