June 20, 2017

Re: Permission to Backfill Section A and Road Crossing
Former Maljamar Station
NMOCD Reference No. 2RP-2504
Plains SRS No. HDO-95-61 Former Maljamar Station
Latitude 32.71932° / Longitude -103.82819°
Eddy County, New Mexico

Permission to Backfill Sec. A and Road Crossing

Former Maljamar Station ■ Eddy County, New Mexico

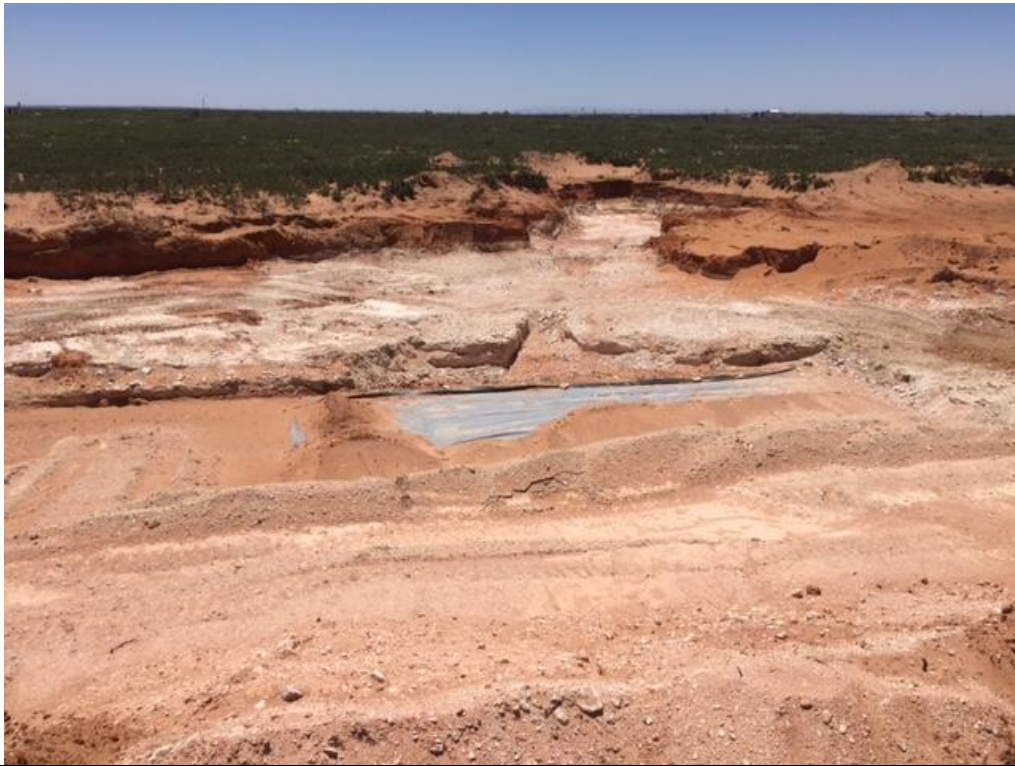
PHOTO 1: View of portion of the excavated Road Crossing and Section A, facing south.

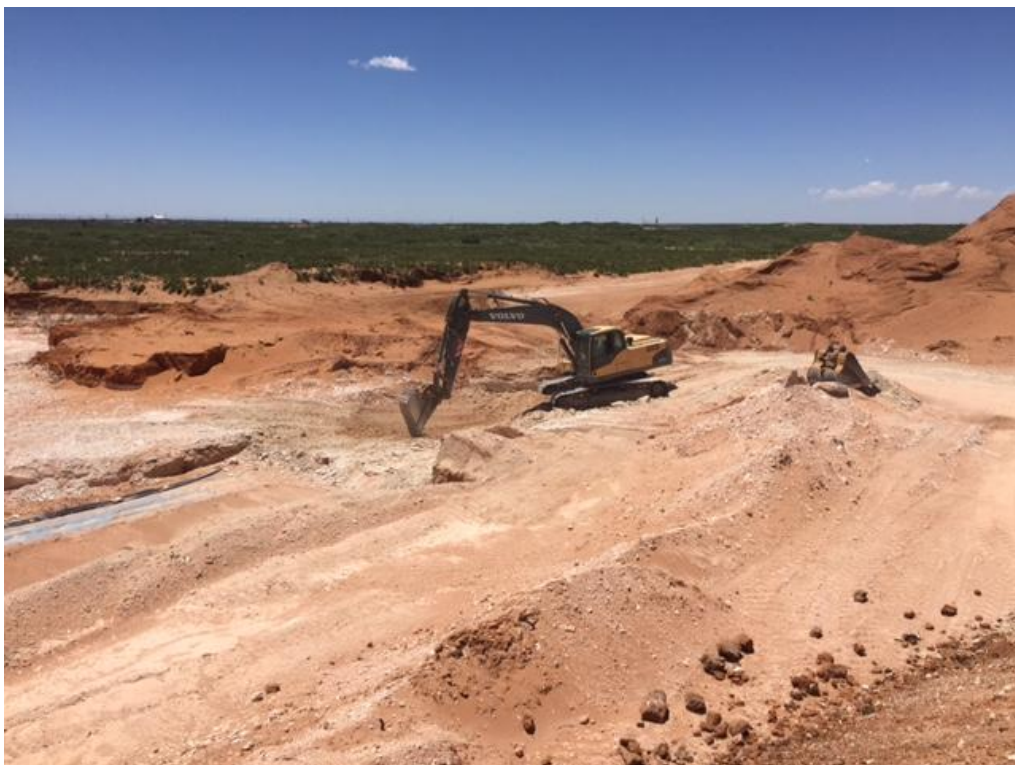
During the installation and continued use of the access ramp in the northwest portion of the road crossing excavation, stained soil was identified near the southeast corner of Section B. Upon identifying the affected area, one (1) soil sample (Ramp Stain @ 9') was collected at the existing grade of the caliche access ramp along with one (1) delineation soil sample (Ramp Stain TT @ 18') from soil beneath the affected area. The collected soil samples were submitted to the laboratory for analysis of TPH and chloride. Laboratory analytical results indicated soil sample Ramp Stain @ 9' exhibited a TPH concentration of 8,500 mg/kg; soil sample Ramp Stain TT @ 18' exhibited a TPH concentration of 71.9 mg/kg; chloride concentrations were less than the applicable sample detection limit (SDL) in each of the submitted soil samples. Soil sample Ramp Stain TT @ 18' was also analyzed for concentrations of BTEX, which were determined to be less than the applicable laboratory SDL.

PHOTO 2: View of excavation of affected in the area characterized by the "Ramp Stain", facing southwest.

On May 31, 2017, Plains requested NMOCD and BLM permission to excavate impacted soil represented by soil sample Ramp Stain @ 9' and backfill the resulting excavation with stockpiled soil represented by soil sample 5/11 Sec. A Stockpile #1; the requests were subsequently approved.

On June 6, 2017, upon receiving NMOCD and BLM permission, the affected area represented by soil sample Ramp Stain @ 9' was excavated to a depth of approximately 18 ft. bgs. Upon excavating impacted soil, five (5) confirmation soil samples (Ramp Stain Floor @ 18', Ramp Stain NSW @ 17', Ramp Stain ESW @ 17', Ramp Stain SSW @ 17' and Ramp Stain WSW @ 17') were collected from the floor and sidewalls of the excavated area and submitted to the laboratory for analysis of BTEX, TPH and/or chloride concentrations, which were determined to be below the NMOCD RRAL. Upon collecting the necessary confirmation soil samples, the excavated area was backfilled with stockpiled soil represented by soil sample 5/11 Sec. A Stockpile #1.

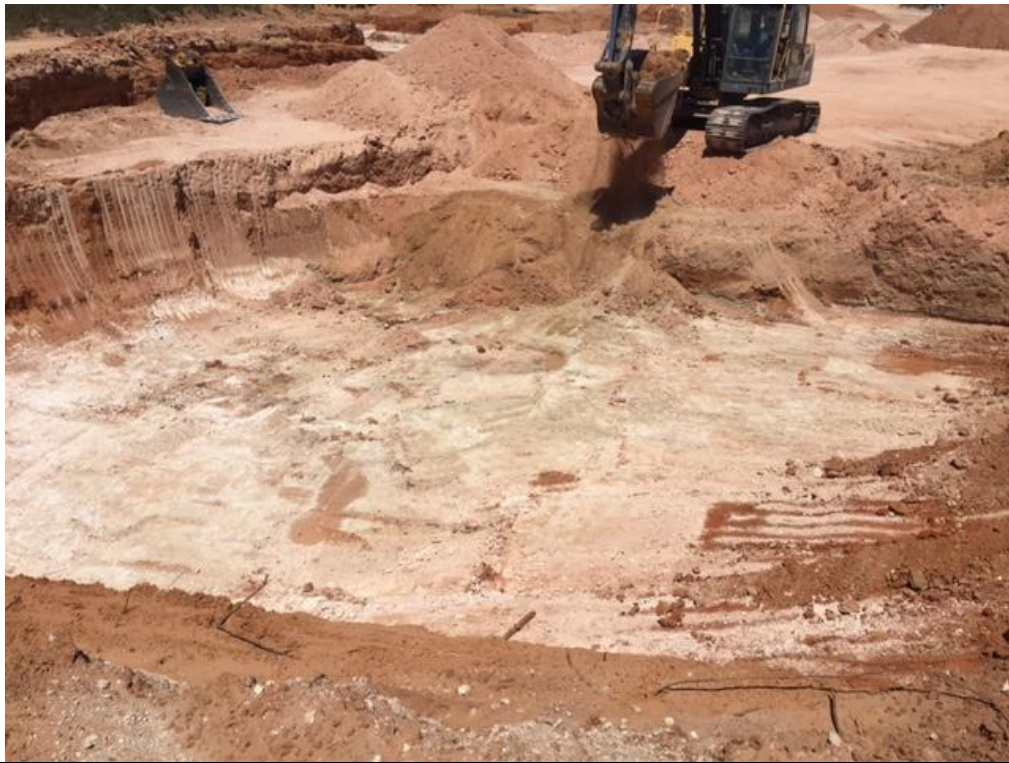
During the excavation of affected soil within the caliche access road, stained soil was identified in the north sidewall of the excavated caliche access road near the southeast corner of Section D. Affected soil was excavated, and three (3) confirmation soil samples (SE Sec. D NSW, SE Sec. D Floor @ 9' and SE Sec. D ESW) were collected and submitted to the laboratory for analysis of BTEX, TPH and/or chloride concentrations. Laboratory analytical results indicated BTEX, TPH and chloride concentrations were below the NMOCD RRAL in each of the submitted soil samples, with the exception of soil sample SE Sec. D Floor @ 9', which exhibited a TPH concentration of 7,190 mg/kg. Impacted soil represented by soil sample SE Sec. D Floor @ 9' was excavated.

PHOTO 3: View of excavation of affected soil in the area characterized by SE Sec. D., facing west.

In addition, one (1) confirmation soil sample (SE Sec. D Floor @ 10') was collected from floor of the excavation in the area previously characterized by soil sample SE Sec. D Floor @ 9' and submitted to the laboratory for analysis of BTEX and TPH concentrations, which were determined to be below the NMOCD RRAL.

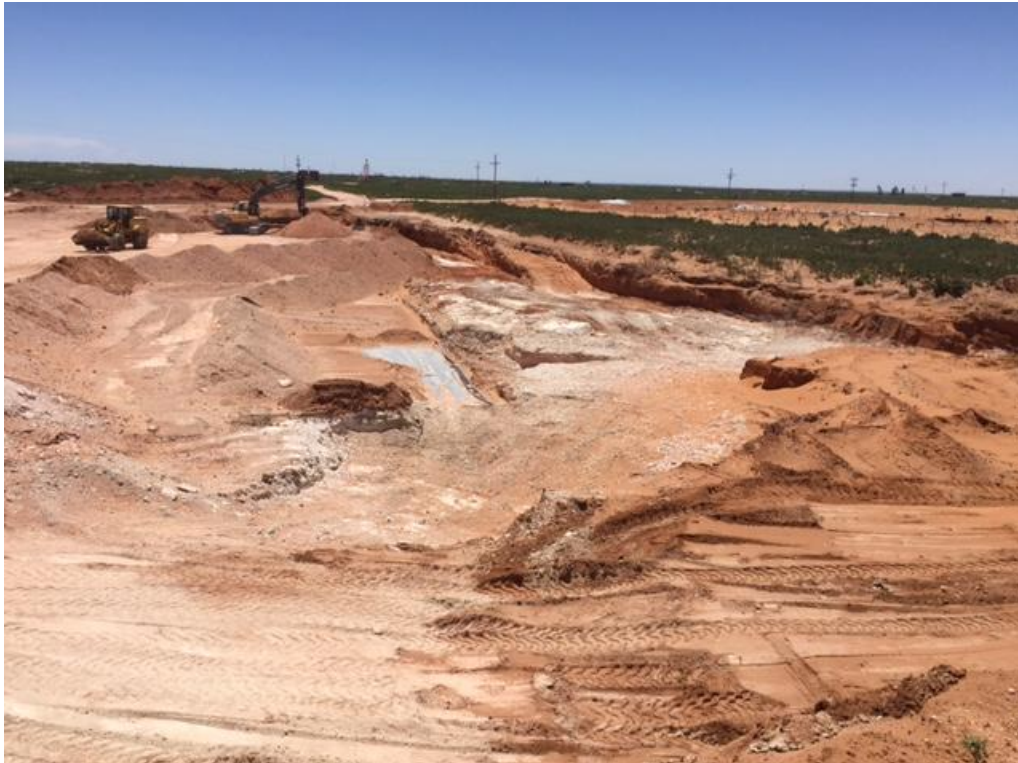
PHOTO 4: View of portion of the excavated Road Crossing and Section A, facing east.

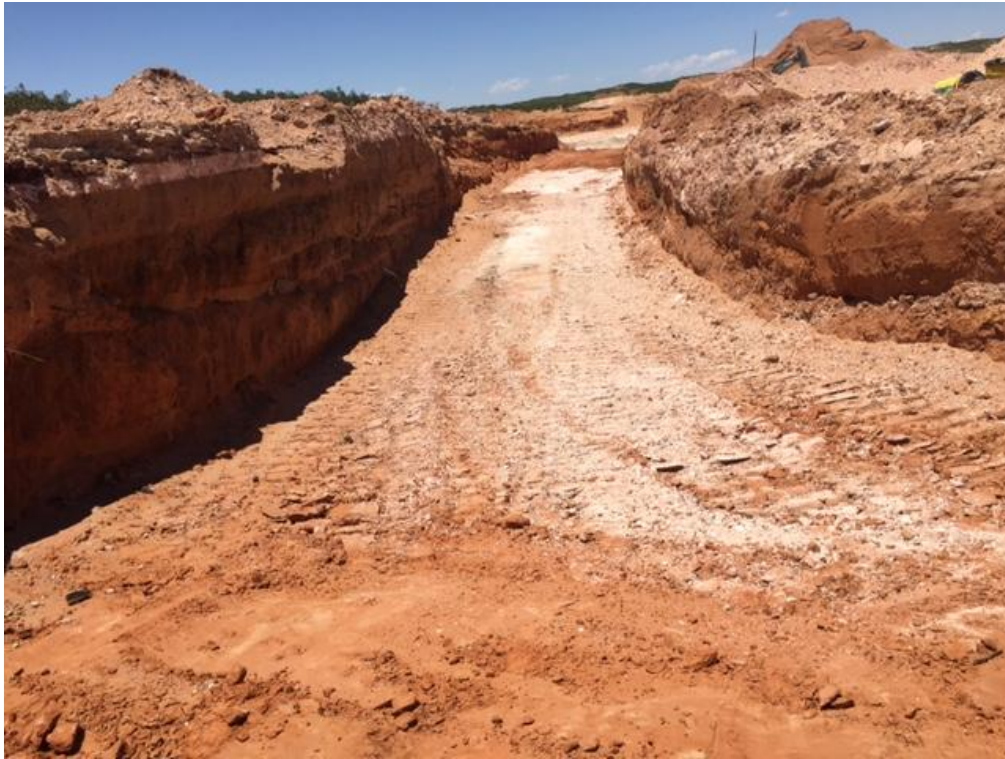
PHOTO 5: View of eastern portion of the excavated area, facing west.

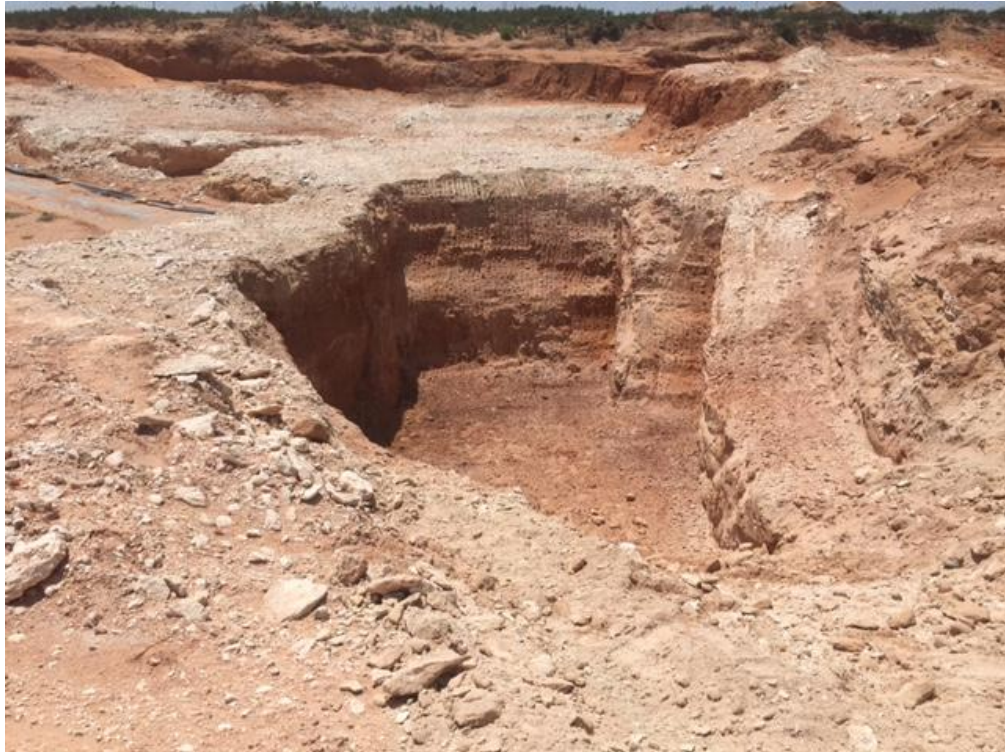
PHOTO 6: View of the excavated area characterized as "Ramp Stain", facing southwest.

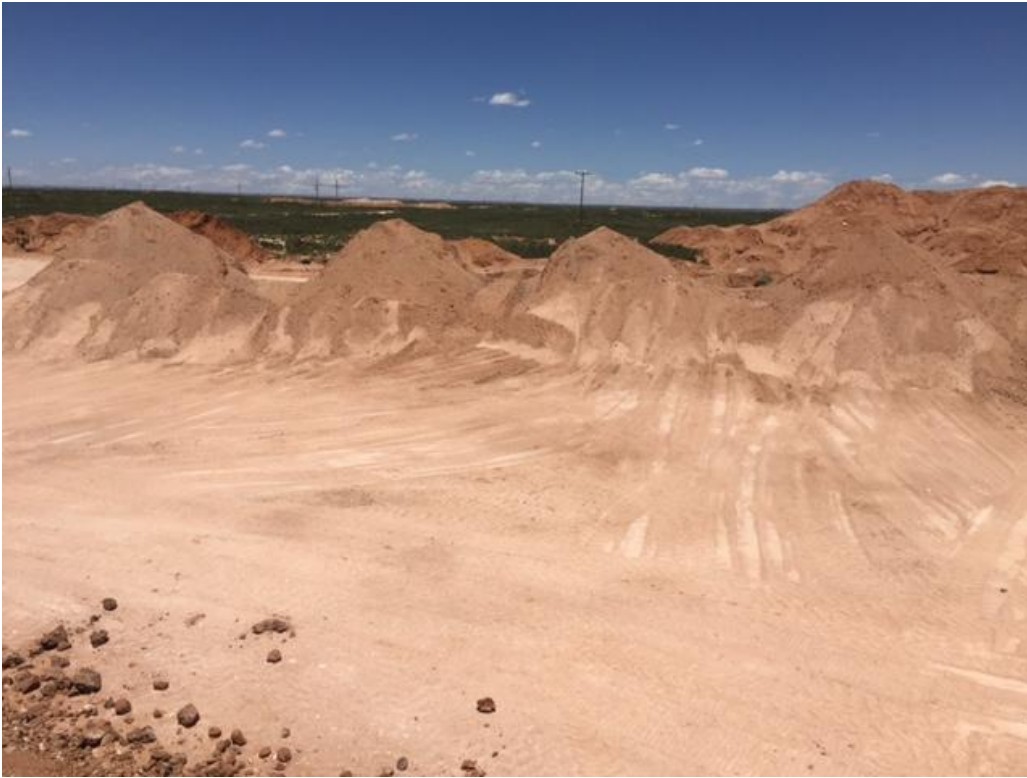
PHOTO 7: View of selection of soil stockpiles, facing north.

- Backfill the excavated areas in the southern portion of the remediation site with stockpiled soil represented by soil samples 5/19 Sec. A Stockpile #2 through 5/19 Sec. A Stockpile #8, 5/25 Sec. A Stockpile #9, 5/25 Sec. A Stockpile #10 and 6/8 Sec. A Stockpile #11 through 6/8 Sec. A Stockpile #13.
- The affected area will be backfilled to approximately 3 ft. bgs utilizing soil stockpiles exhibiting BTEX, TPH and chloride concentrations that are below the NMOCD RRAL and/or locally sourced caliche, if necessary.
- Upon bringing the affected area up to approximately 3 ft. bgs, the original caliche access road will be rebuilt utilizing locally-sourced caliche.
