R. T. HICKS CONSULTANTS, LTD.

November 9, 2017

RE: Chi Operating – Benson Delaware Unit #6 Battery (32.67997, -103.93143)
Remediation Plan 2RP- 4251

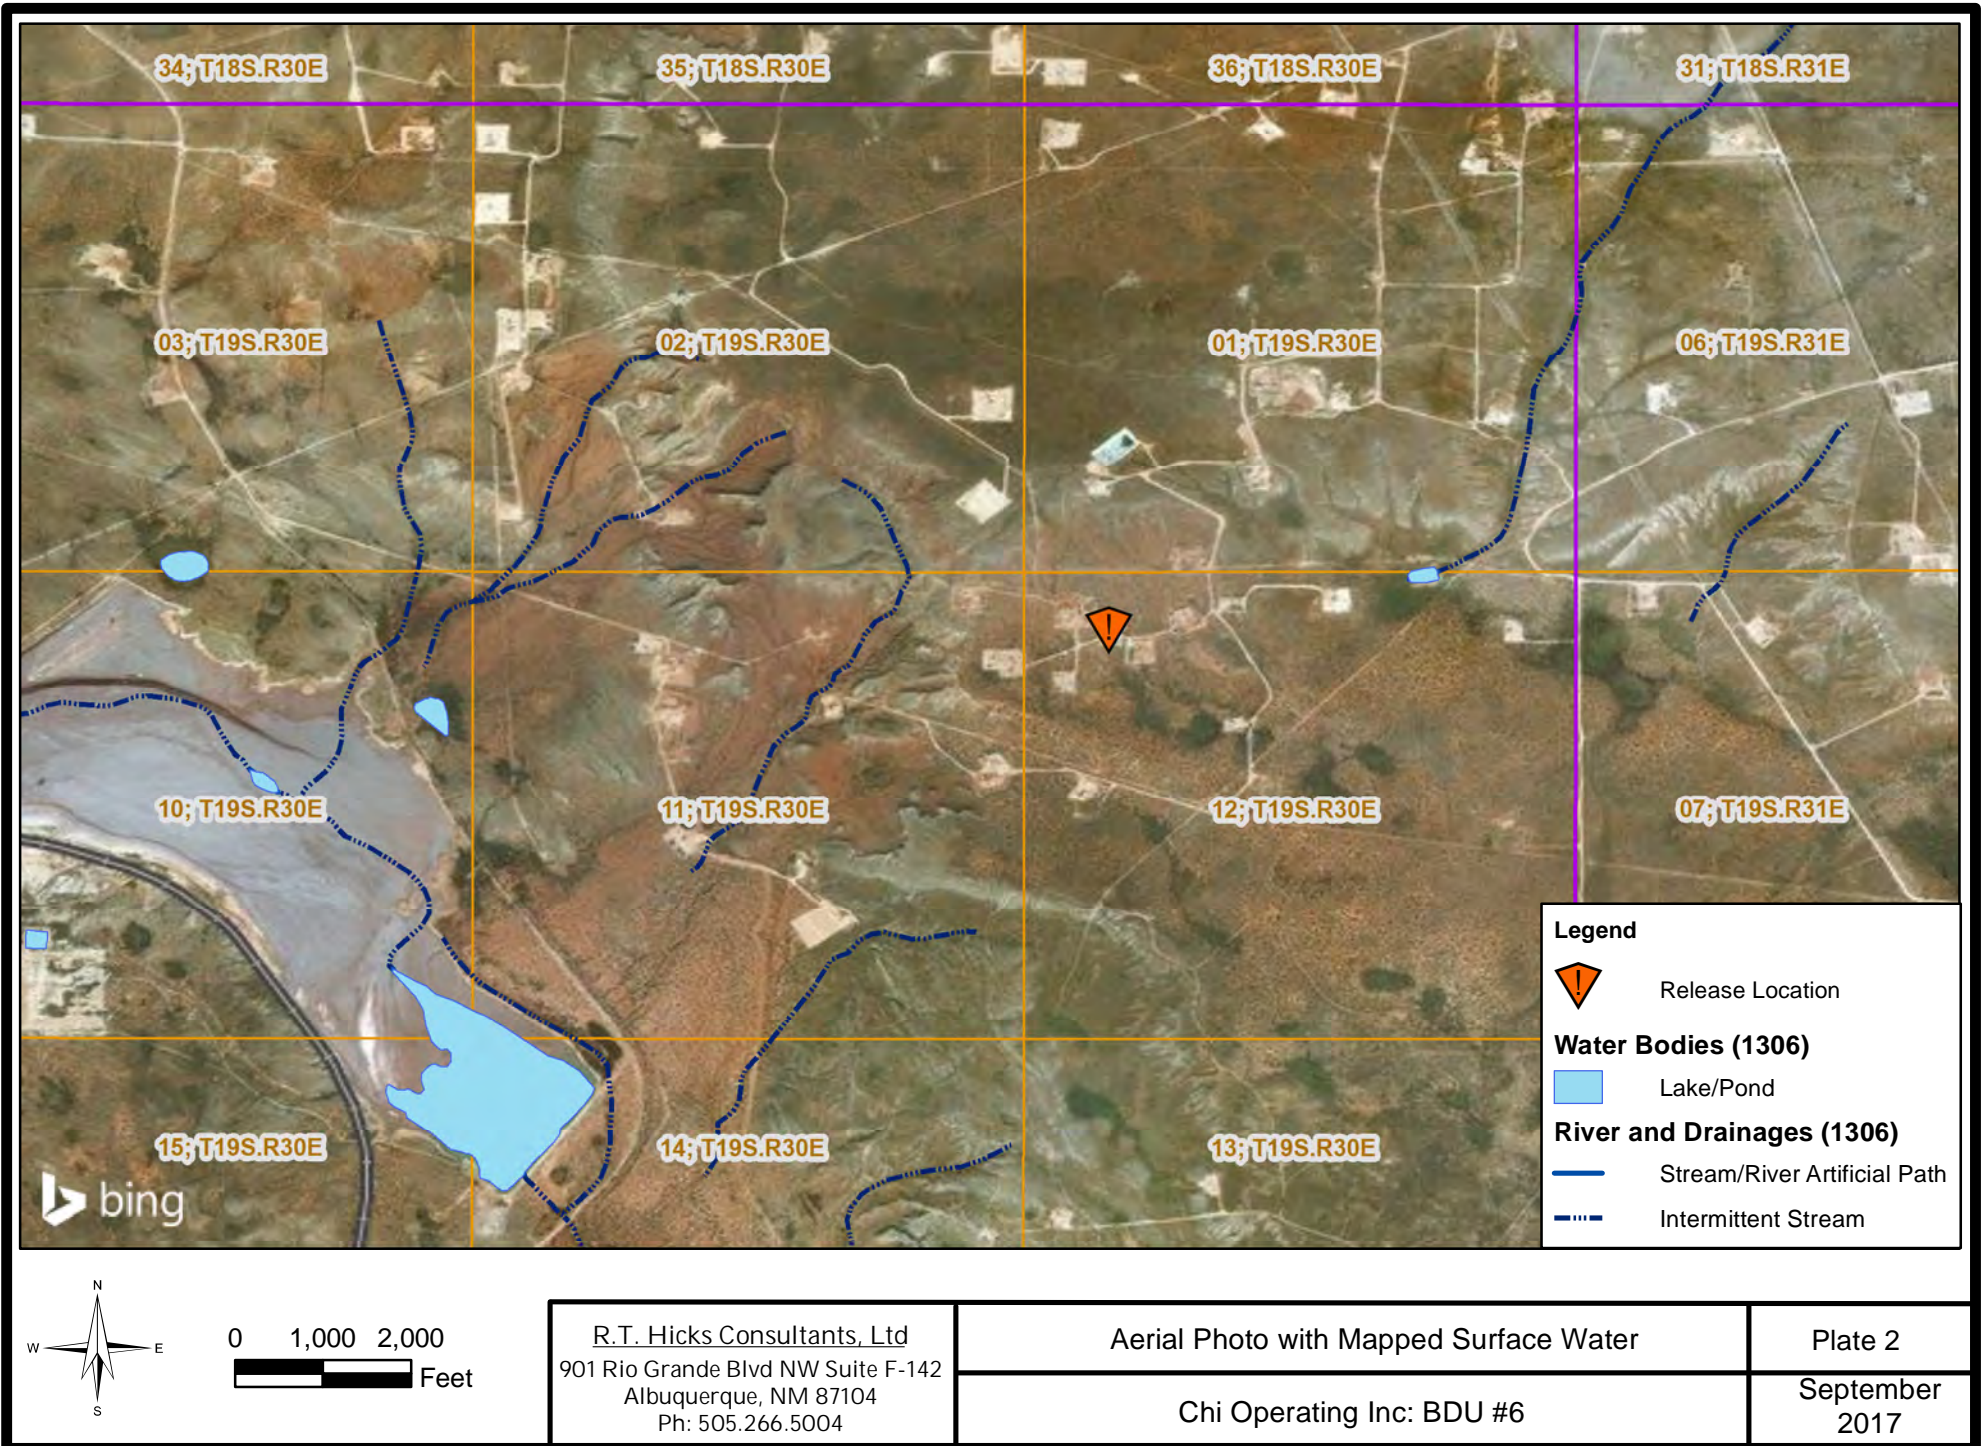
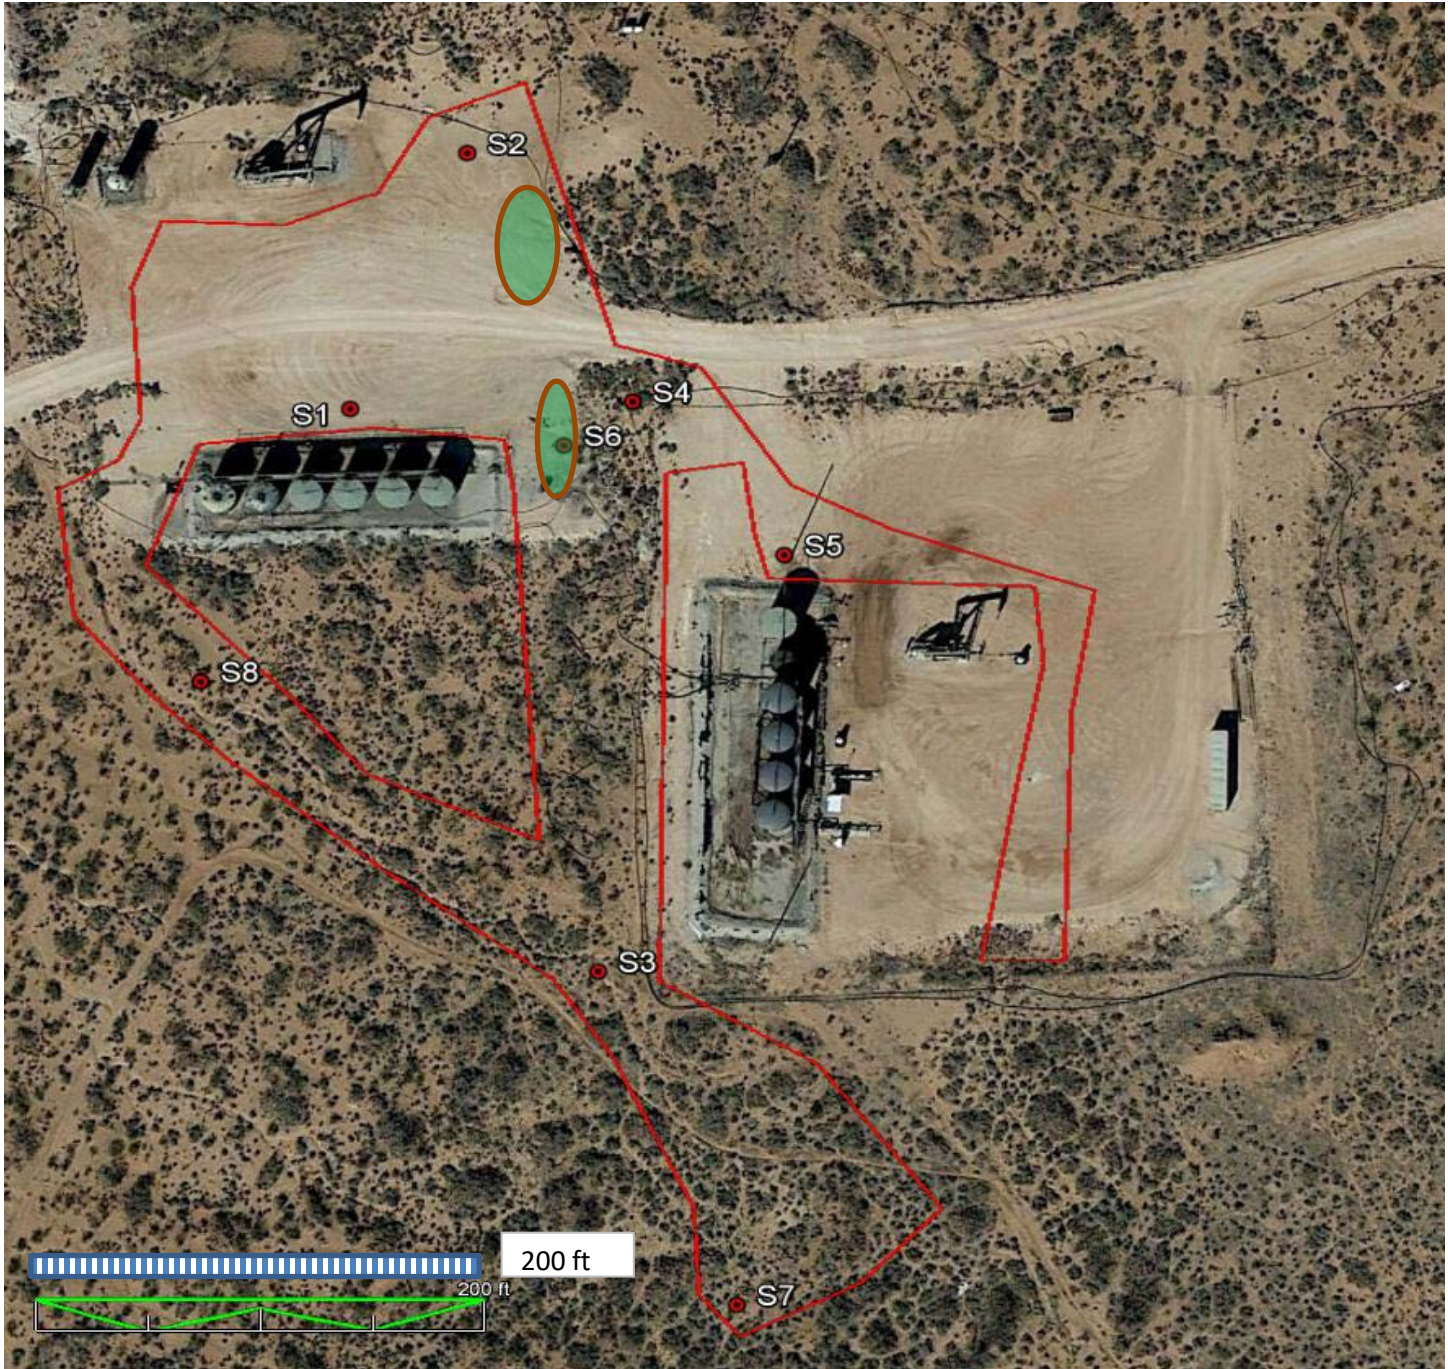
As indicated in the C-141, the release of crude from the tank battery appears to be an act of sabotage. On May 28, 2017, the valves on the tanks were opened and a significant volume of crude escaped. The footprint of the release is sketched on Plate 3. Plate 3 also shows sampling locations and laboratory results of analysis. Table 1 provides additional sampling data.

Approximately 300 cubic yards of excavated material lie in two piles. One is located at S-6 (Plate 3) and the northern pile is located on location on the north side of the lease road. The

Release footprint is red outline
Sample locations and labels

Soil stockpiles from initial response

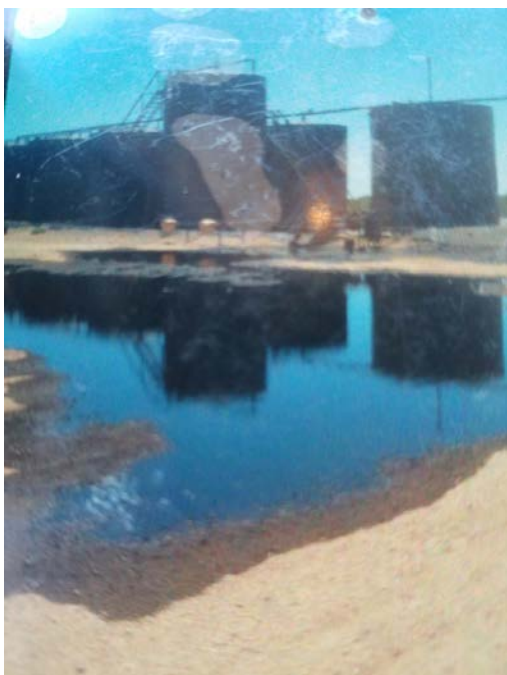
The initial response involved vacuuming puddled crude and excavation of nearly 100% of the visually impacted soil/sand. Two stockpiles of excavated earth remain on the location and 212 cubic yards of visually-impacted earth was removed to disposal. Figure 1 is an image of the pool of crude on the production pad adjacent to the source of the release. Figure 2 shows 12-18 inches of excavation occurred near sample S7, at the southern terminus of the spill. A similar removal effort occurred throughout the off-location footprint. Excavation of impacted caliche did not occur on the constructed pads.

Figure 1- Poor image showing pooling of oil on location during initial response

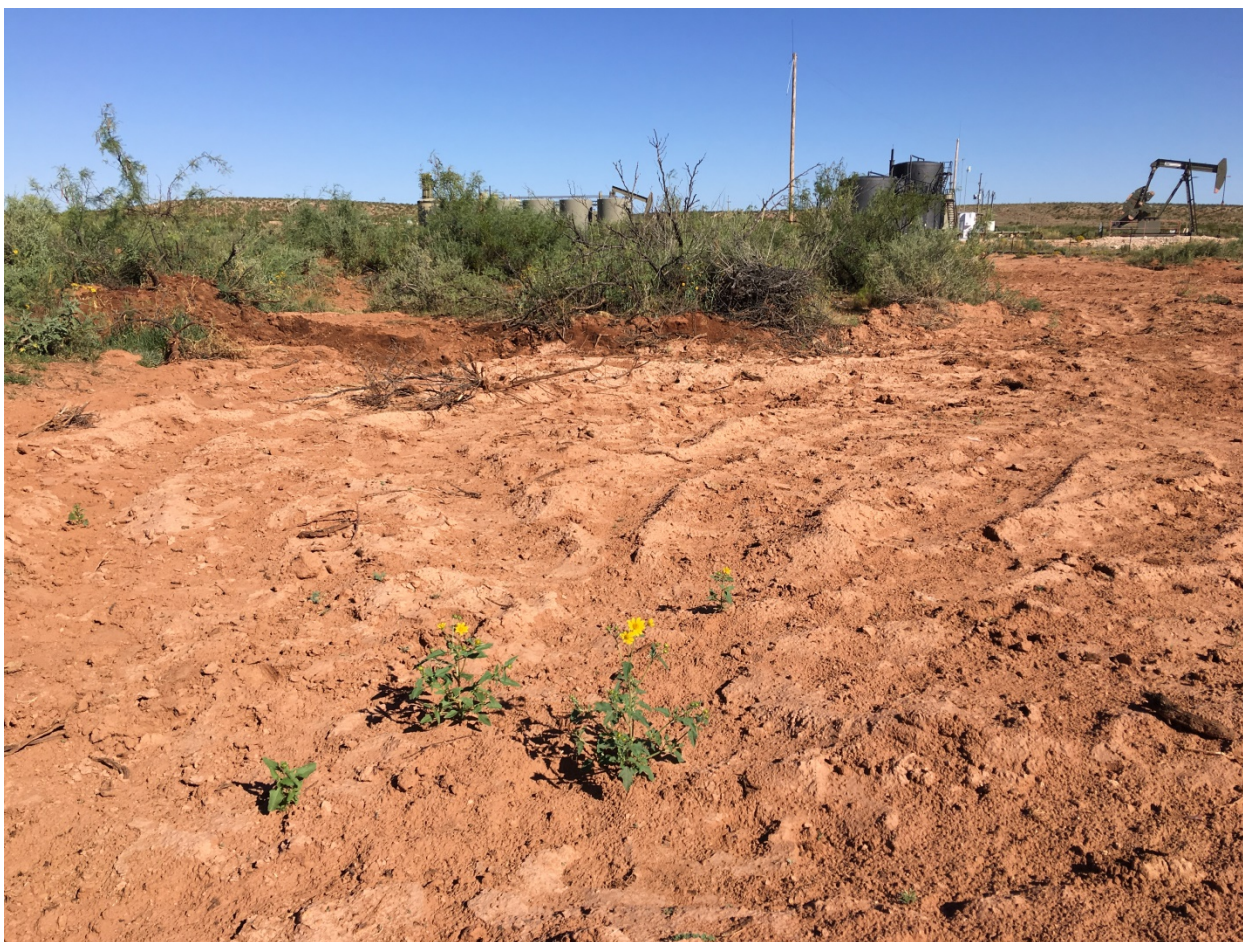
Figure 2 – Area of excavation near sampling location S7 with the BDU 21 in background. Note that volunteer vegetation is starting to grow in this area. About 18-inches of soil/sand was removed from this portion of the spill footprint.

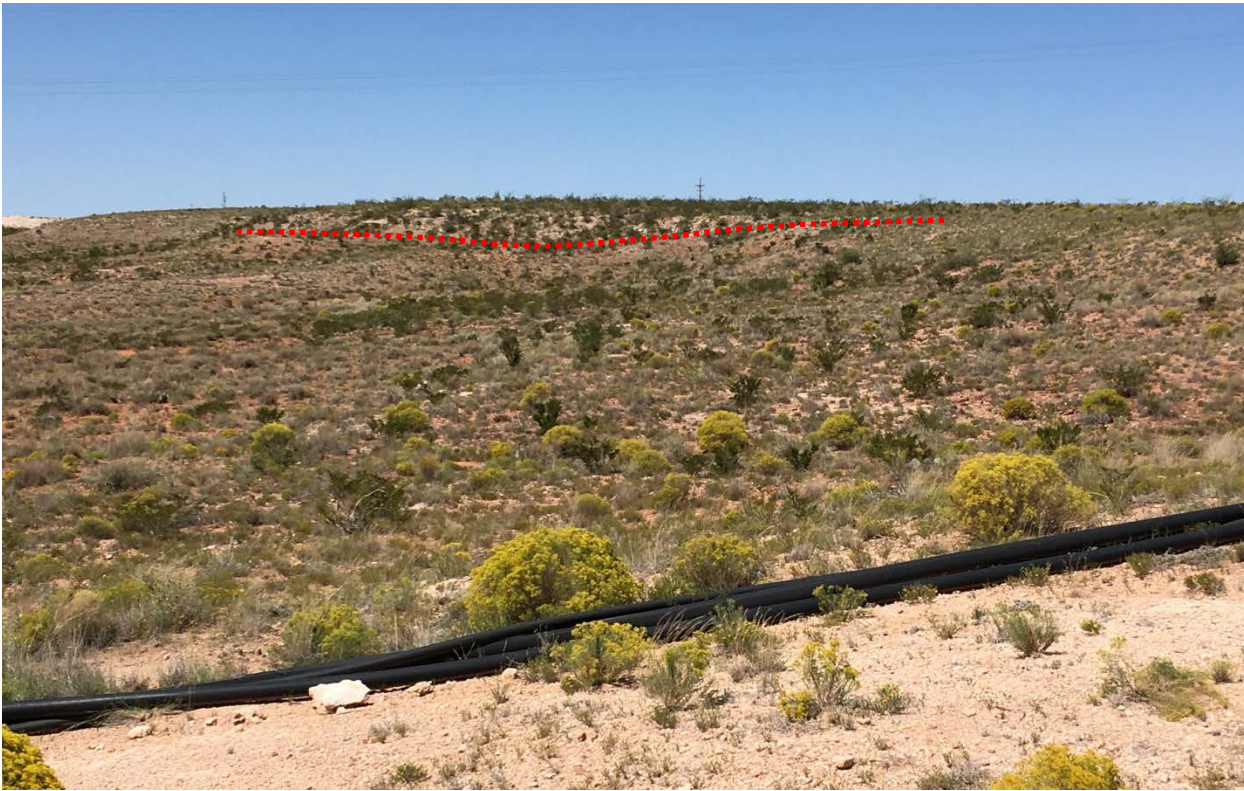
3. Plate 4 also shows that the Permian Quartermaster/Rustler Formation is exposed about 500 yards west of tank battery. Figure 3 shows this Permian unit exposed beneath the caliche and dunes on the slope about 800 feet east-northeast of the location.

Figure 3 – View west from the north-south lease road about 1300 feet east-northeast of the BDU 6 Battery. The light gray exposure above the dotted red line is caliche and the reddish exposure is mapped nearby as Quartermaster/Rustler Formation. Thus, the conclusion that the BDU 6 site is underlain by this Permian bedrock is fully supported by observation.

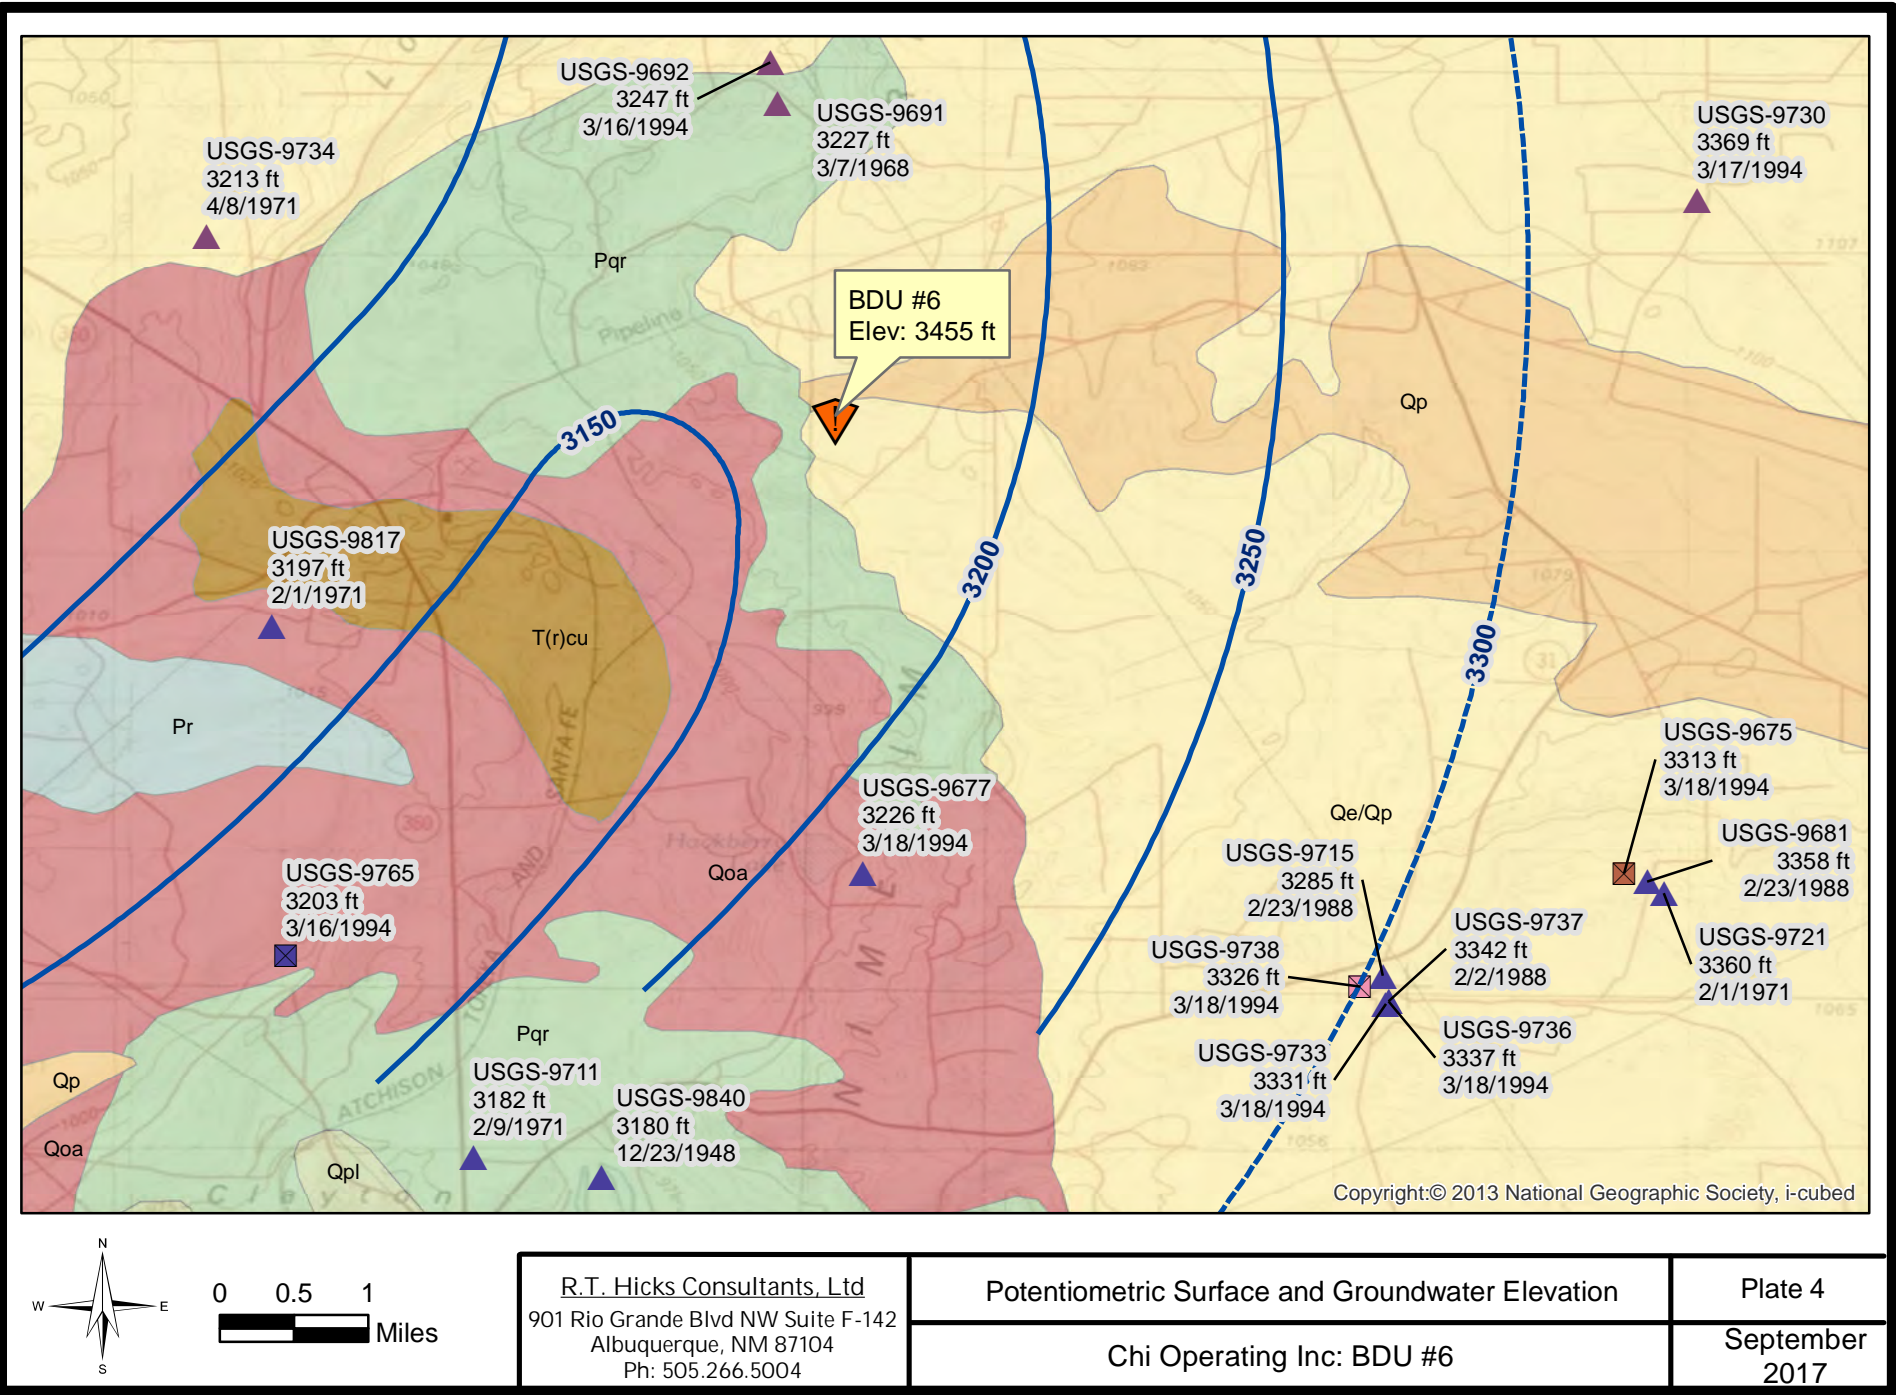
1. The depth to groundwater at the site is about $(3455-3160=)$ 295 feet (Plate 4).

2. Groundwater flows west-southwest based upon USGS well data from the Quartermaster/Rustler Formation that are shown on the map. Groundwater flow is toward the potash mine tailings pond shown on Plate 4.

5. Older alluvium is the maroon outcrop pattern shown on Plate 4. As the Quartermaster/Rustler Formation underlies the caliche and dunes, the Older Alluvium is not present in the area of the tank battery.
