2RP-4490
DELINEATION PLAN
Antelope Tank Battery
Produced Water Spill
Eddy County, New Mexico

LAI Project No. 17-0175-37

November 28, 2017

Prepared for:
Legacy Reserves Operating, LP
303 West Wall Street, Suite 1300
Midland, Texas 79701

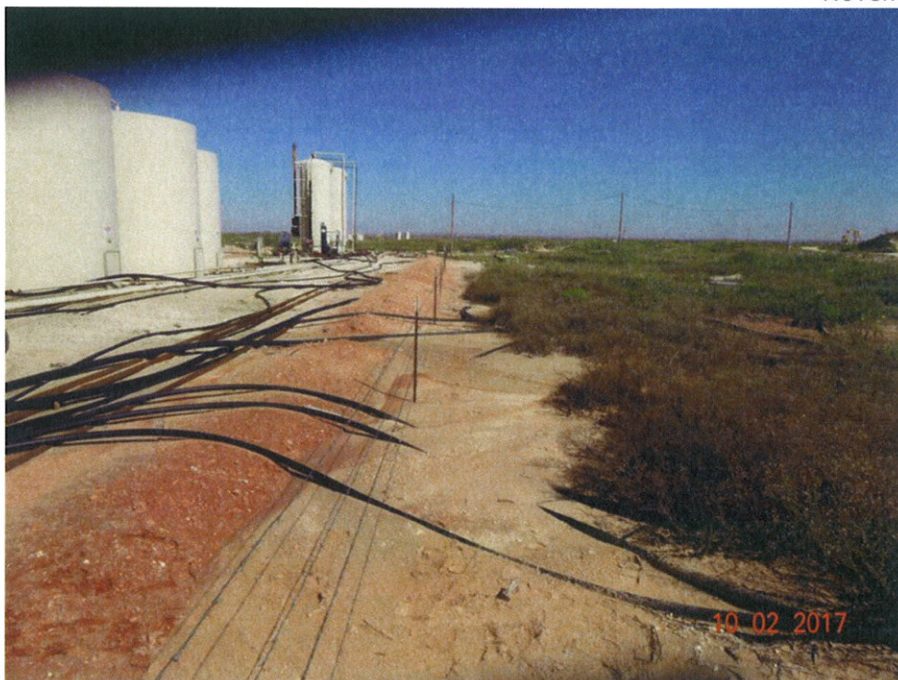
Site Prior to Remediation Viewing North

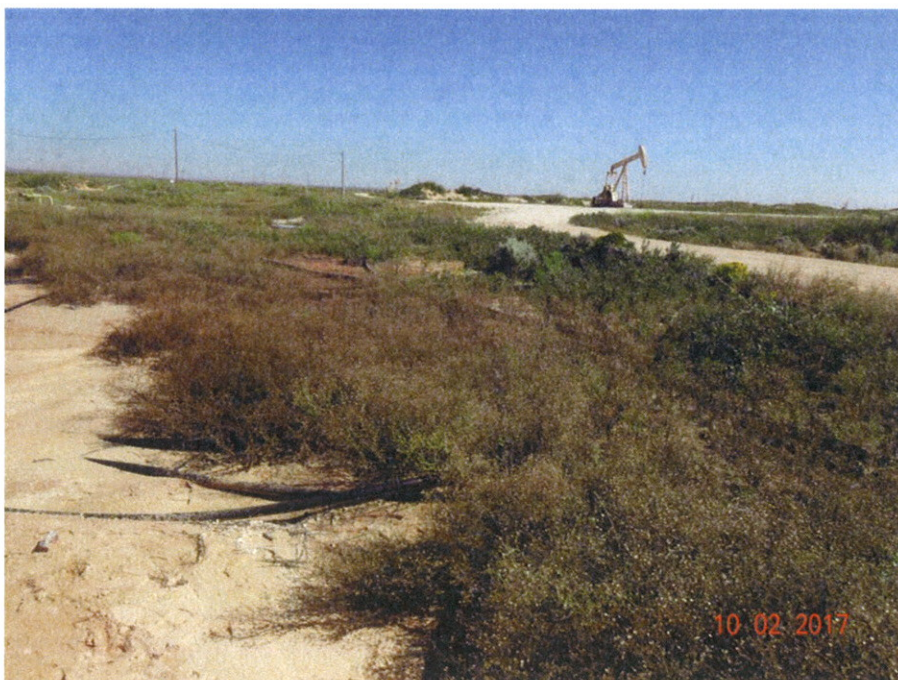
Site Prior to Remediation Viewing Northeast

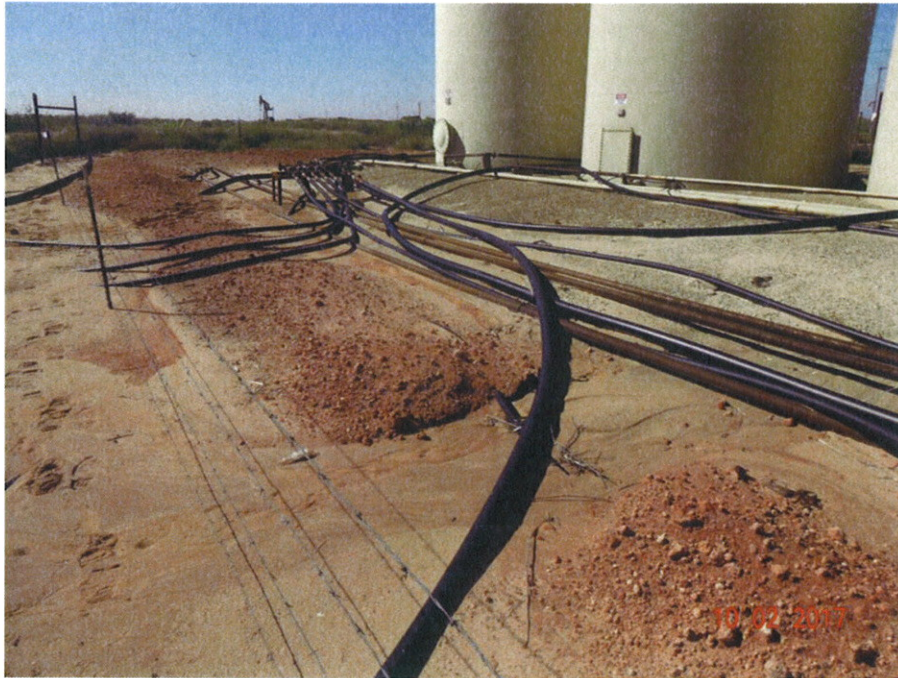
Site Prior to Remediation Viewing South

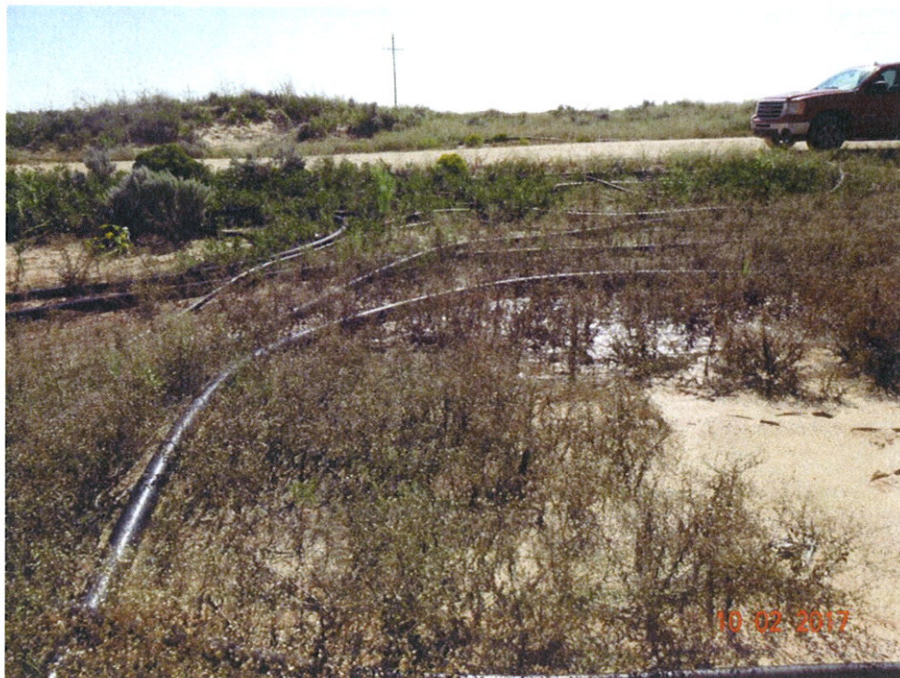
Site Prior to Remediation Viewing East

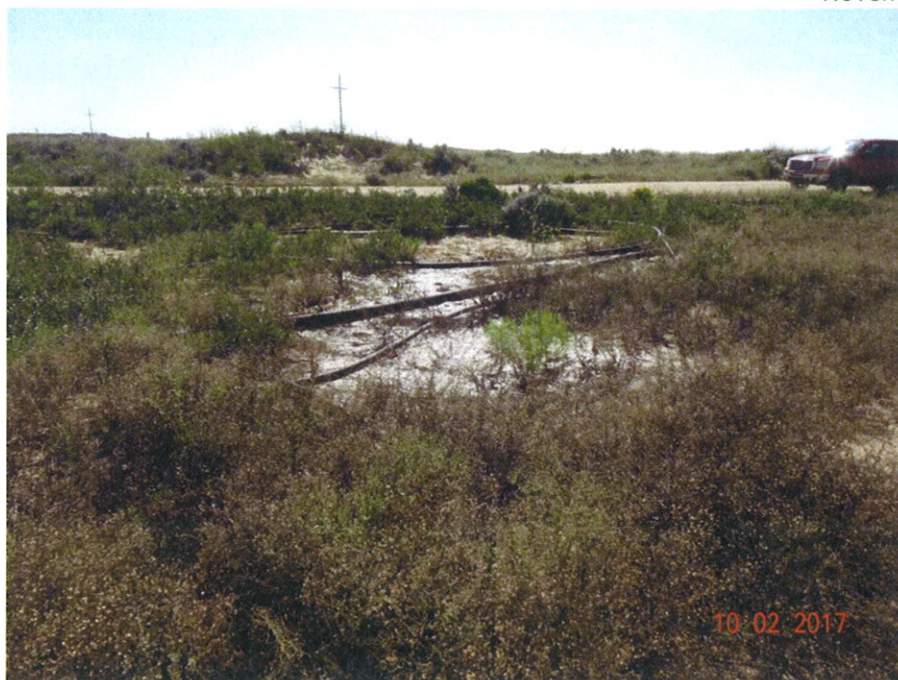
Site Prior to Remediation Viewing Southeast
