FIELD SPILL REPORT

DATE: June 22, 2015

LOCATION OF SPILL SITE: JRU -29 SWD (API 30-015-27735)

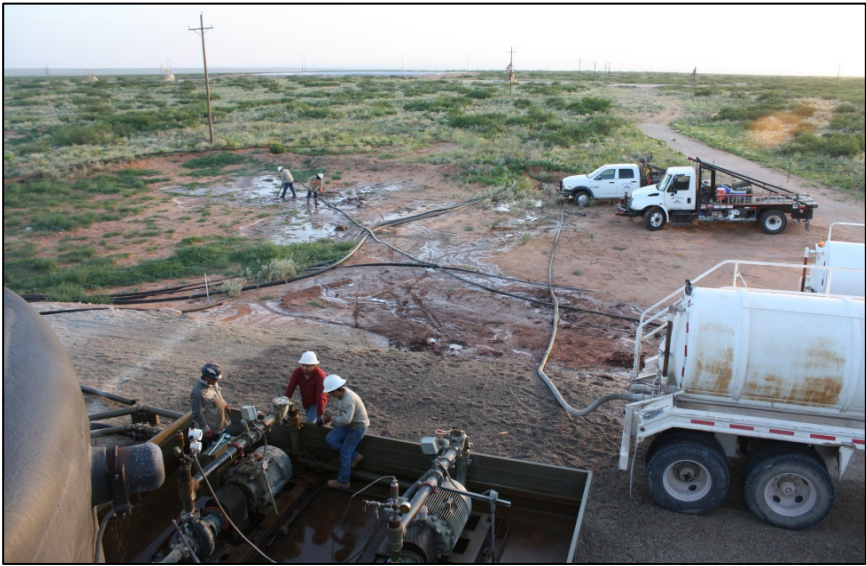
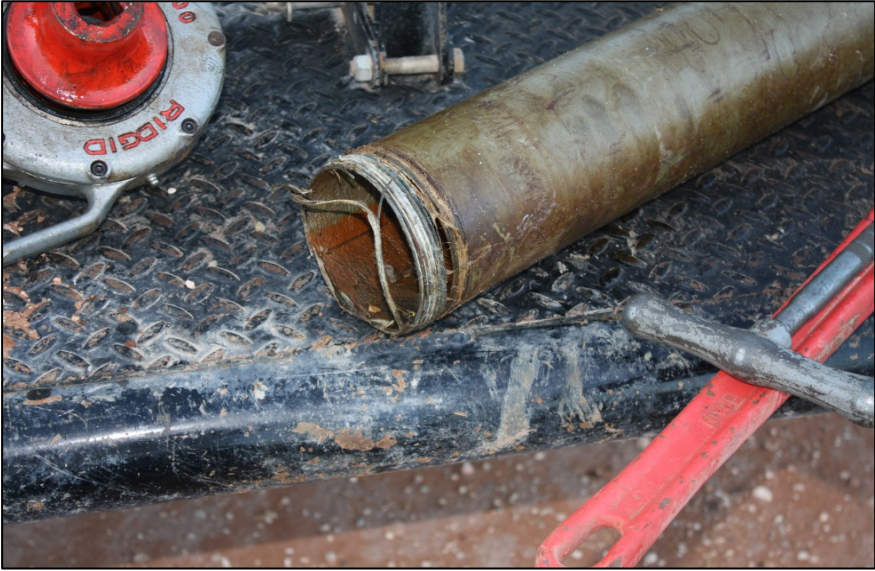
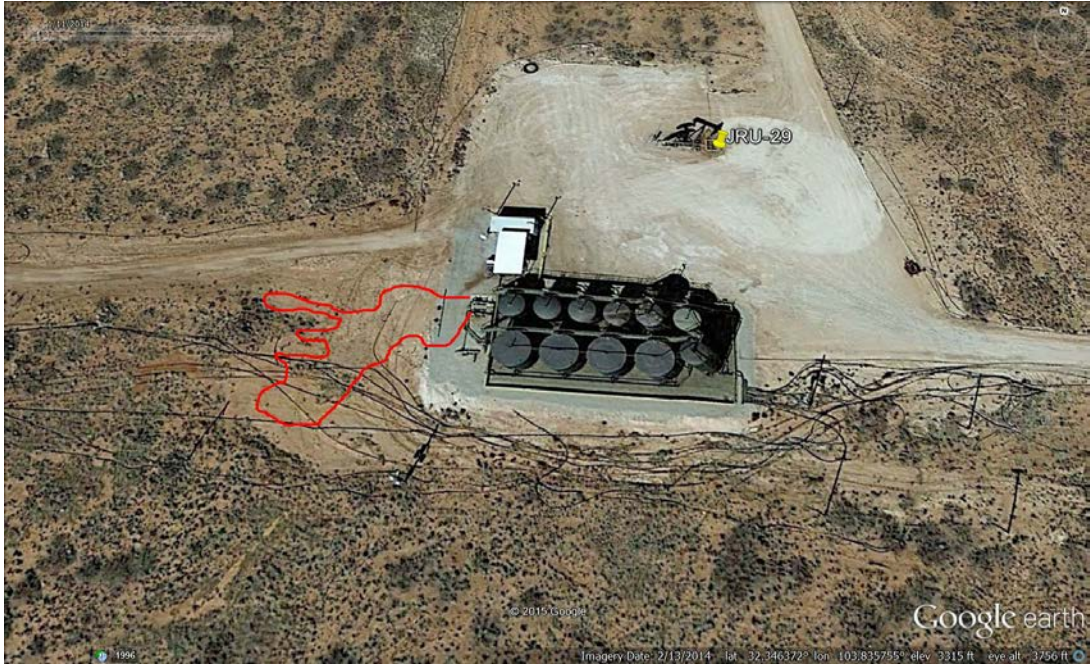
PICTURE ATTACHMENT:

A 4" by 2' threaded pipe connection cracked and parted along the threads where it connected to a T on the discharge side of the pump. NOTE: there was a piping stress issue corrected at the time the new fitting was installed on the discharge piping.

Vacuum truck recovered 20 bbls produced water from containment and 20 bbls produced water on ground. A portion of the impacted area was previously remediated and has a liner installed at a depth of approximately 3 feet. Remediation to be planned
