Reference: Remediation Work Plan

Operator: Devon Energy Production Company

Location: Belgain 15 Fed Com 1H

NM OCD: 2RP 4151

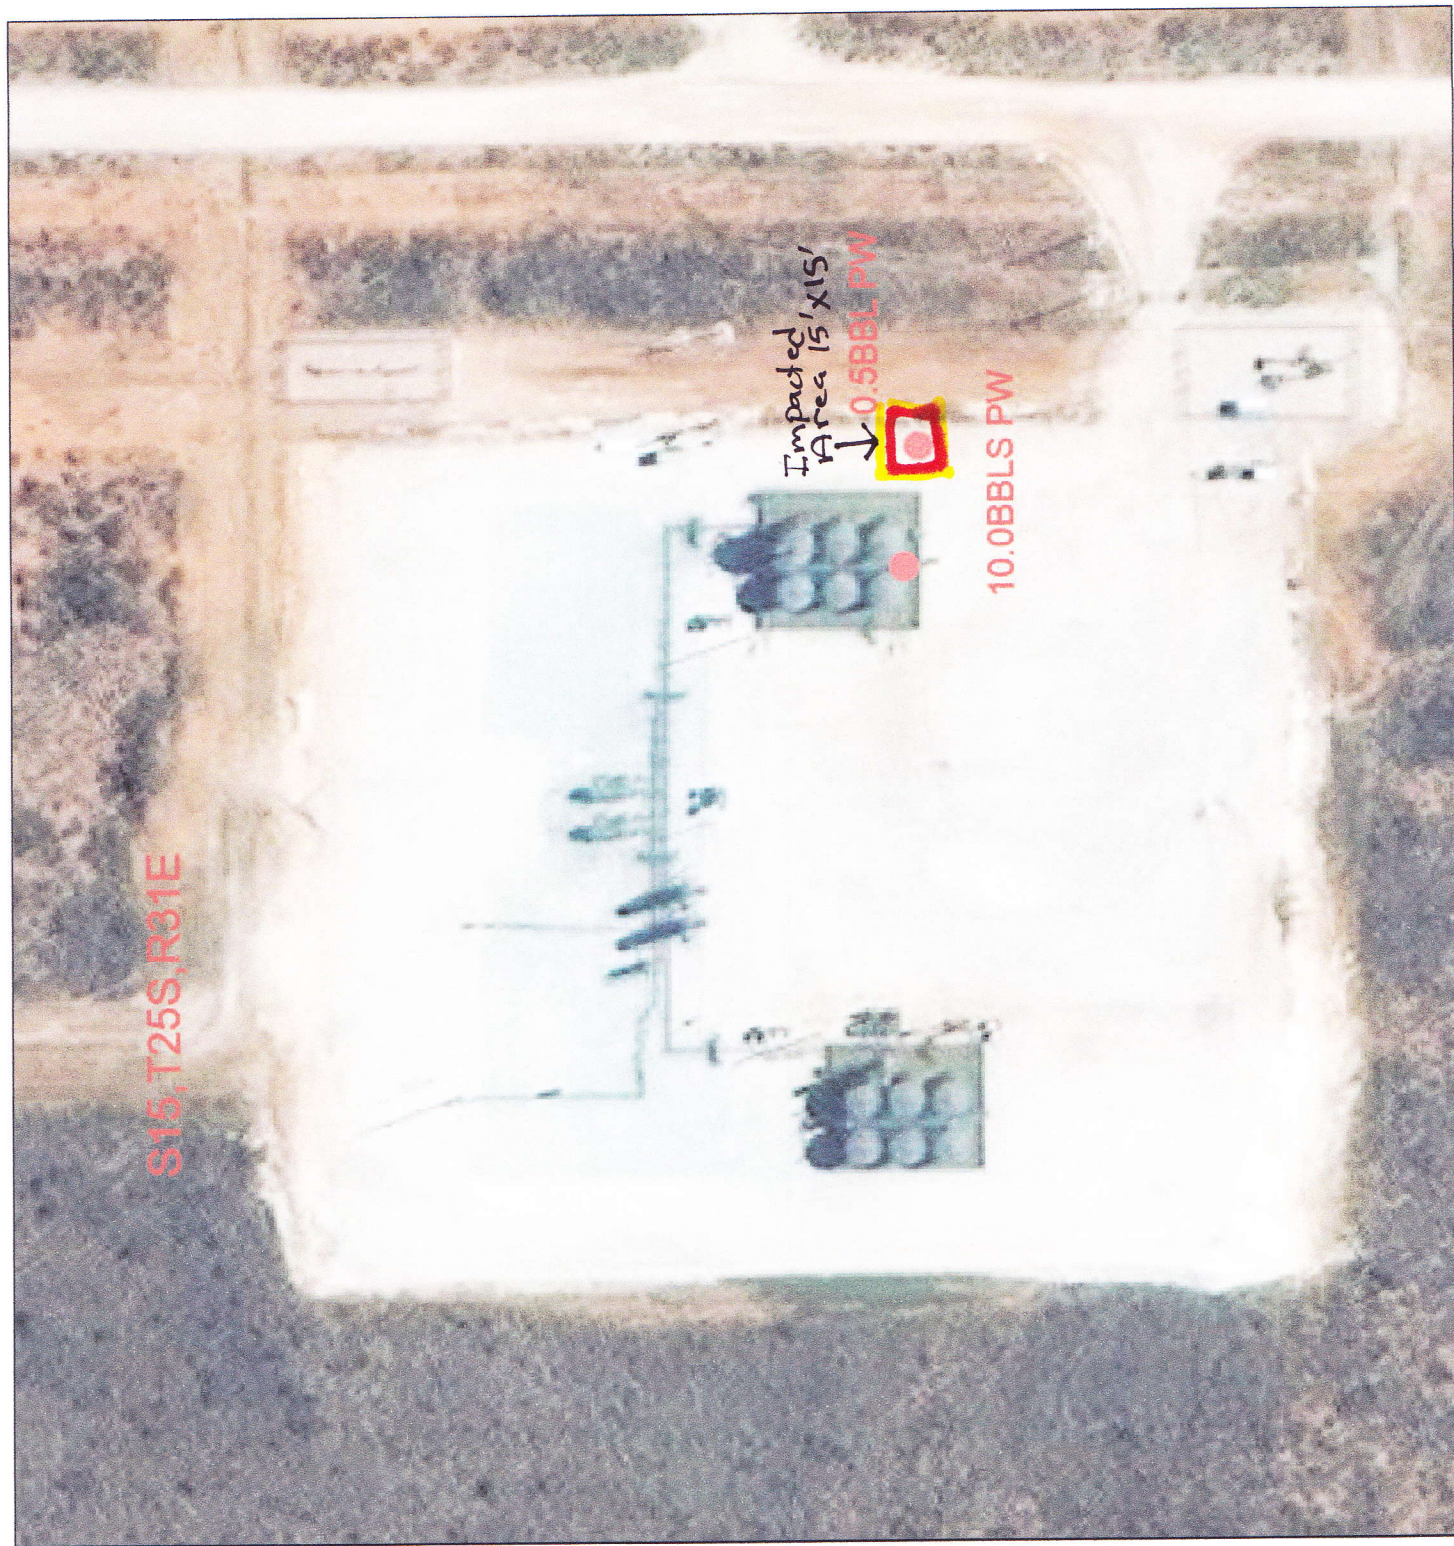
Impacted Area 15'x15'  
↓ 0.5BBL PW

10.0BBL PW
