Characterization Plan

Mucho Luck BBW Federal Com #2H

30-015-39348

2RP-4639

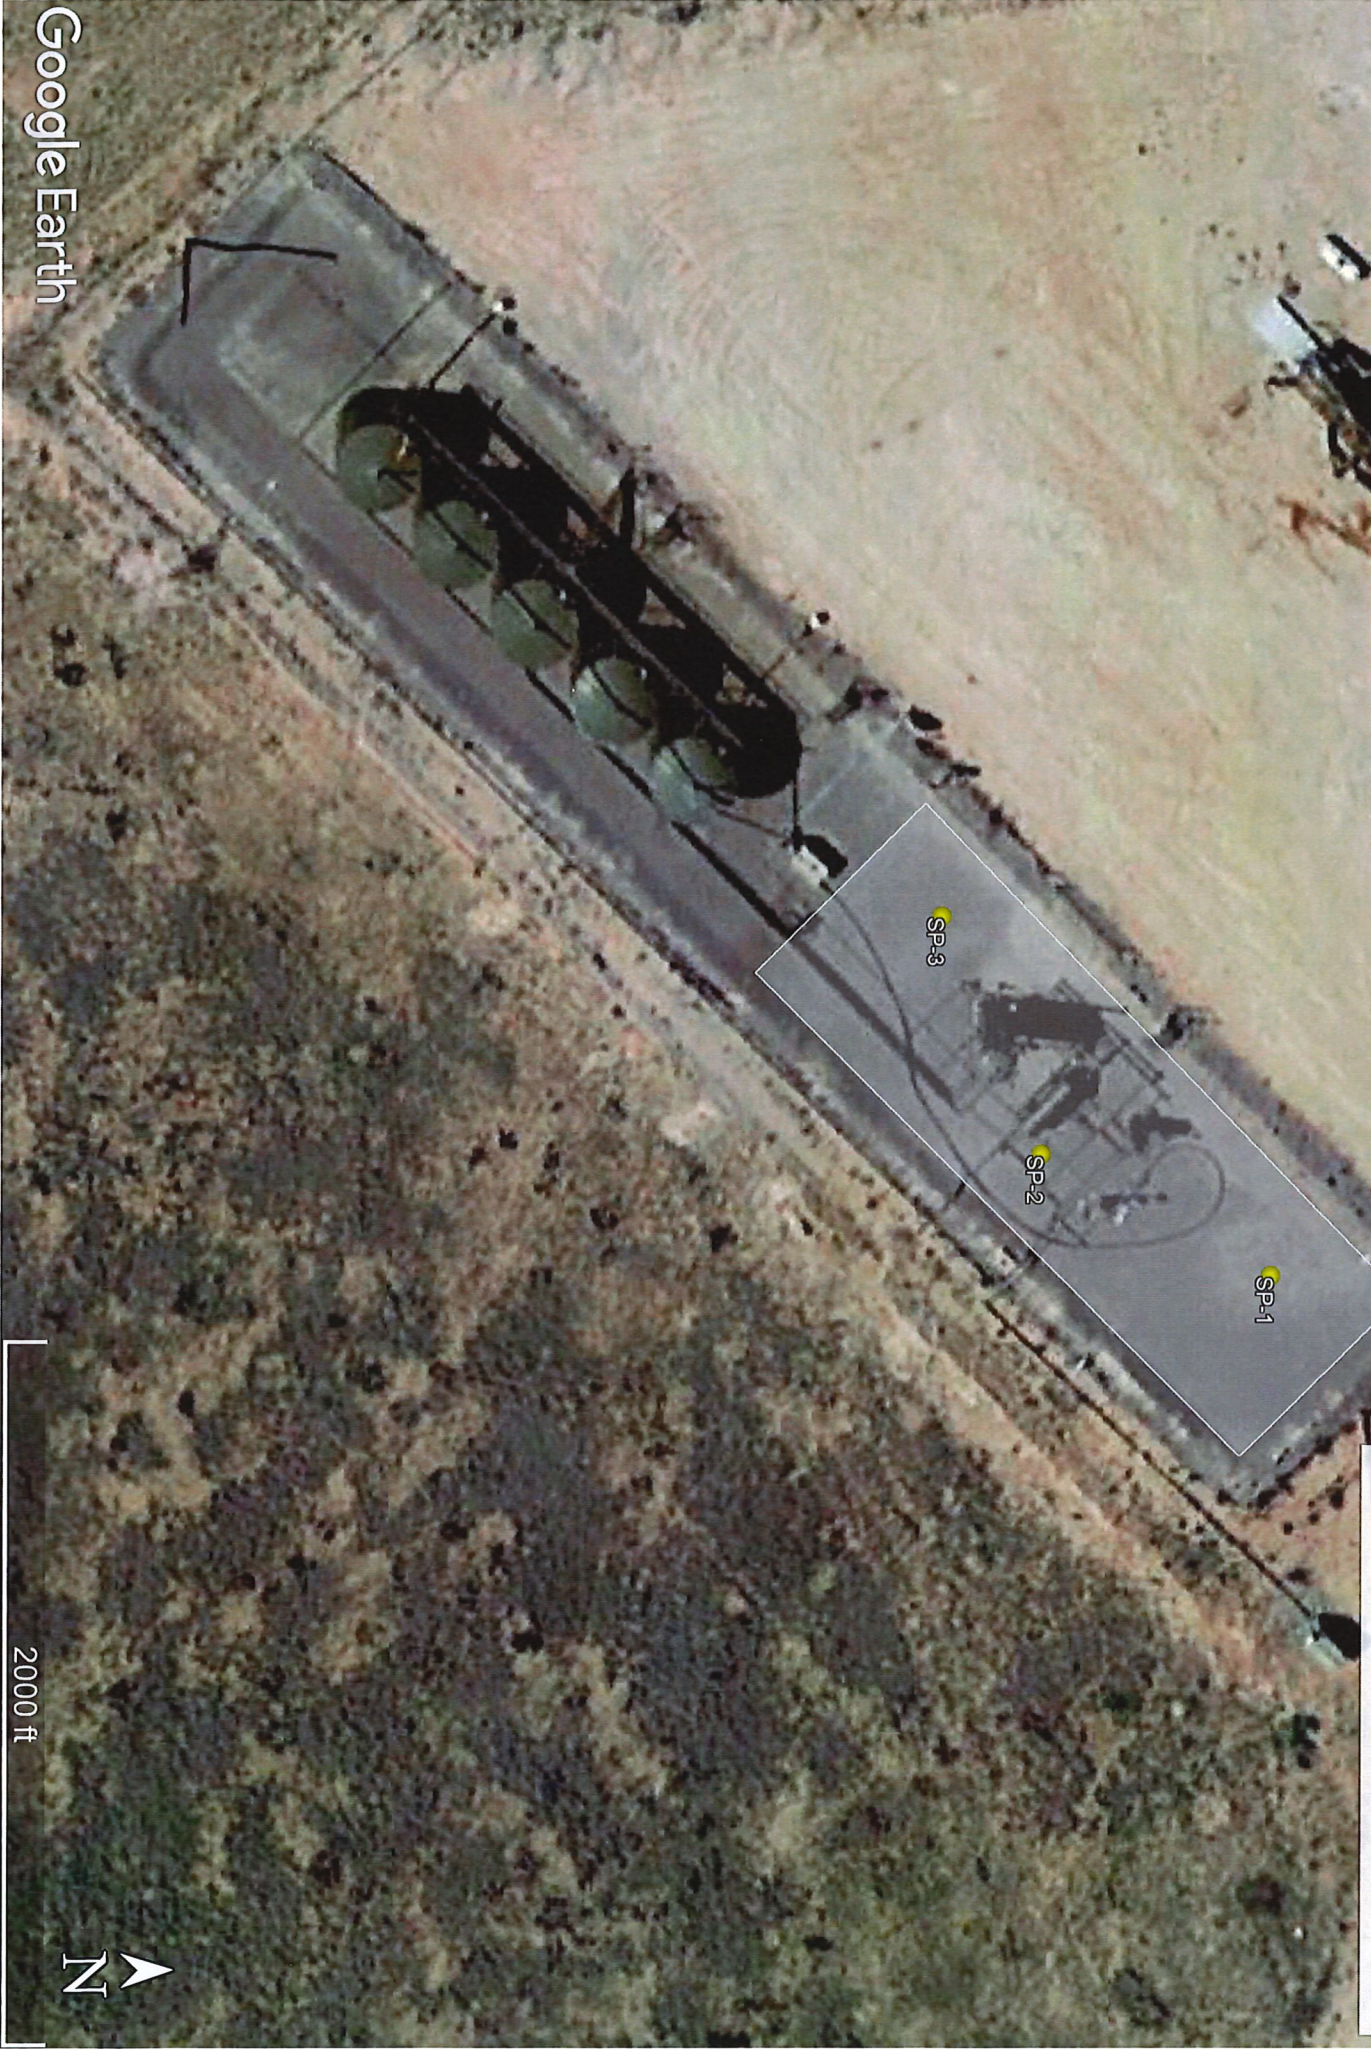
Figure 2

Vertical delineation samples (SP-1, SP-2 & SP-3) will be collected within the release area. Samples will be collected at 1', 2', 3', and 4' below grade surface (bgs) or when auger and or backhoe refusal is encountered. Due to the nature of the release (produced water), the vertical delineation soil samples will be analyzed for Benzene, BTEX, TPH extended (Chlorides for documentation, with no established RRAL's for chlorides). All samples will be sent to a NMOCD approved laboratory for analysis.

Vertical Sample Point(s)

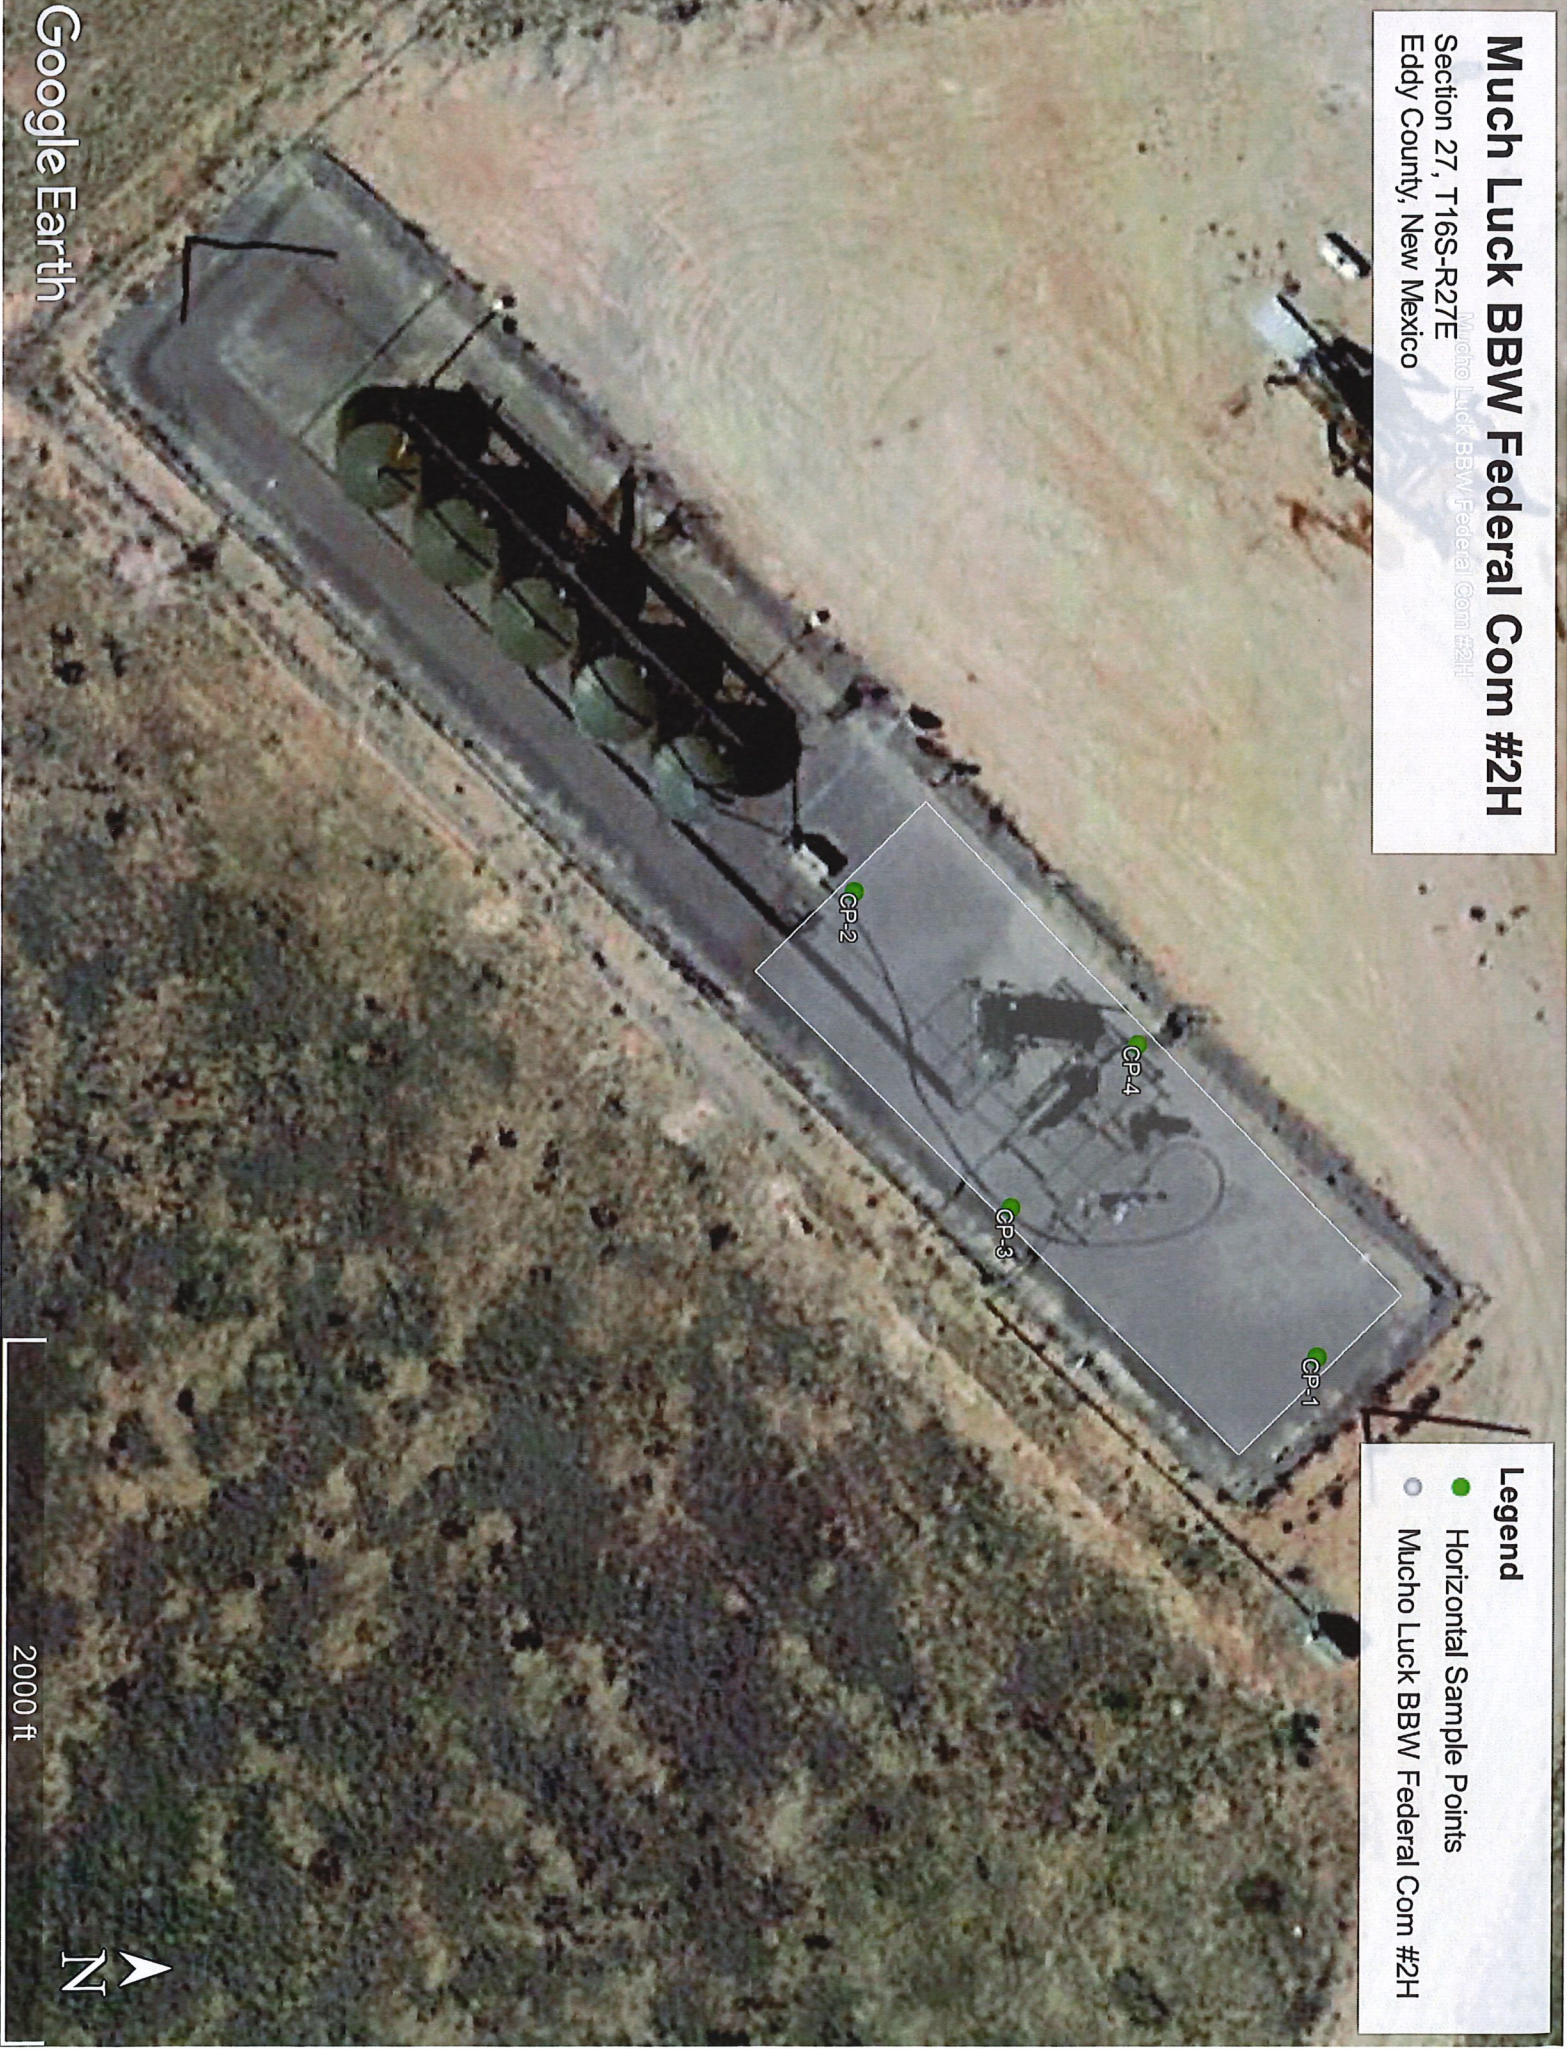
Figure 3

Horizontal delineation samples will be collected at the 4 cardinal point (CP1-CP4) at what is believed to be the outer edge of the release area. Samples will be collected at 1' below grade surface (bgs) or when auger and or backhoe refusal is encountered. If a sample point is determined to be impacted by the release, a new sample will be collected moving out further until an area without impaction is located. Once located, samples will be taken to collaborate the impaction path to the next sample point in the sequence. Due to the nature of the release (produced water), the vertical delineation soil samples will be analyzed for Benzene, BTEX, TPH extended (Chlorides for documentation). All samples will be sent to a NMOCD approved laboratory for analysis.

Horizontal Sample Point(s)

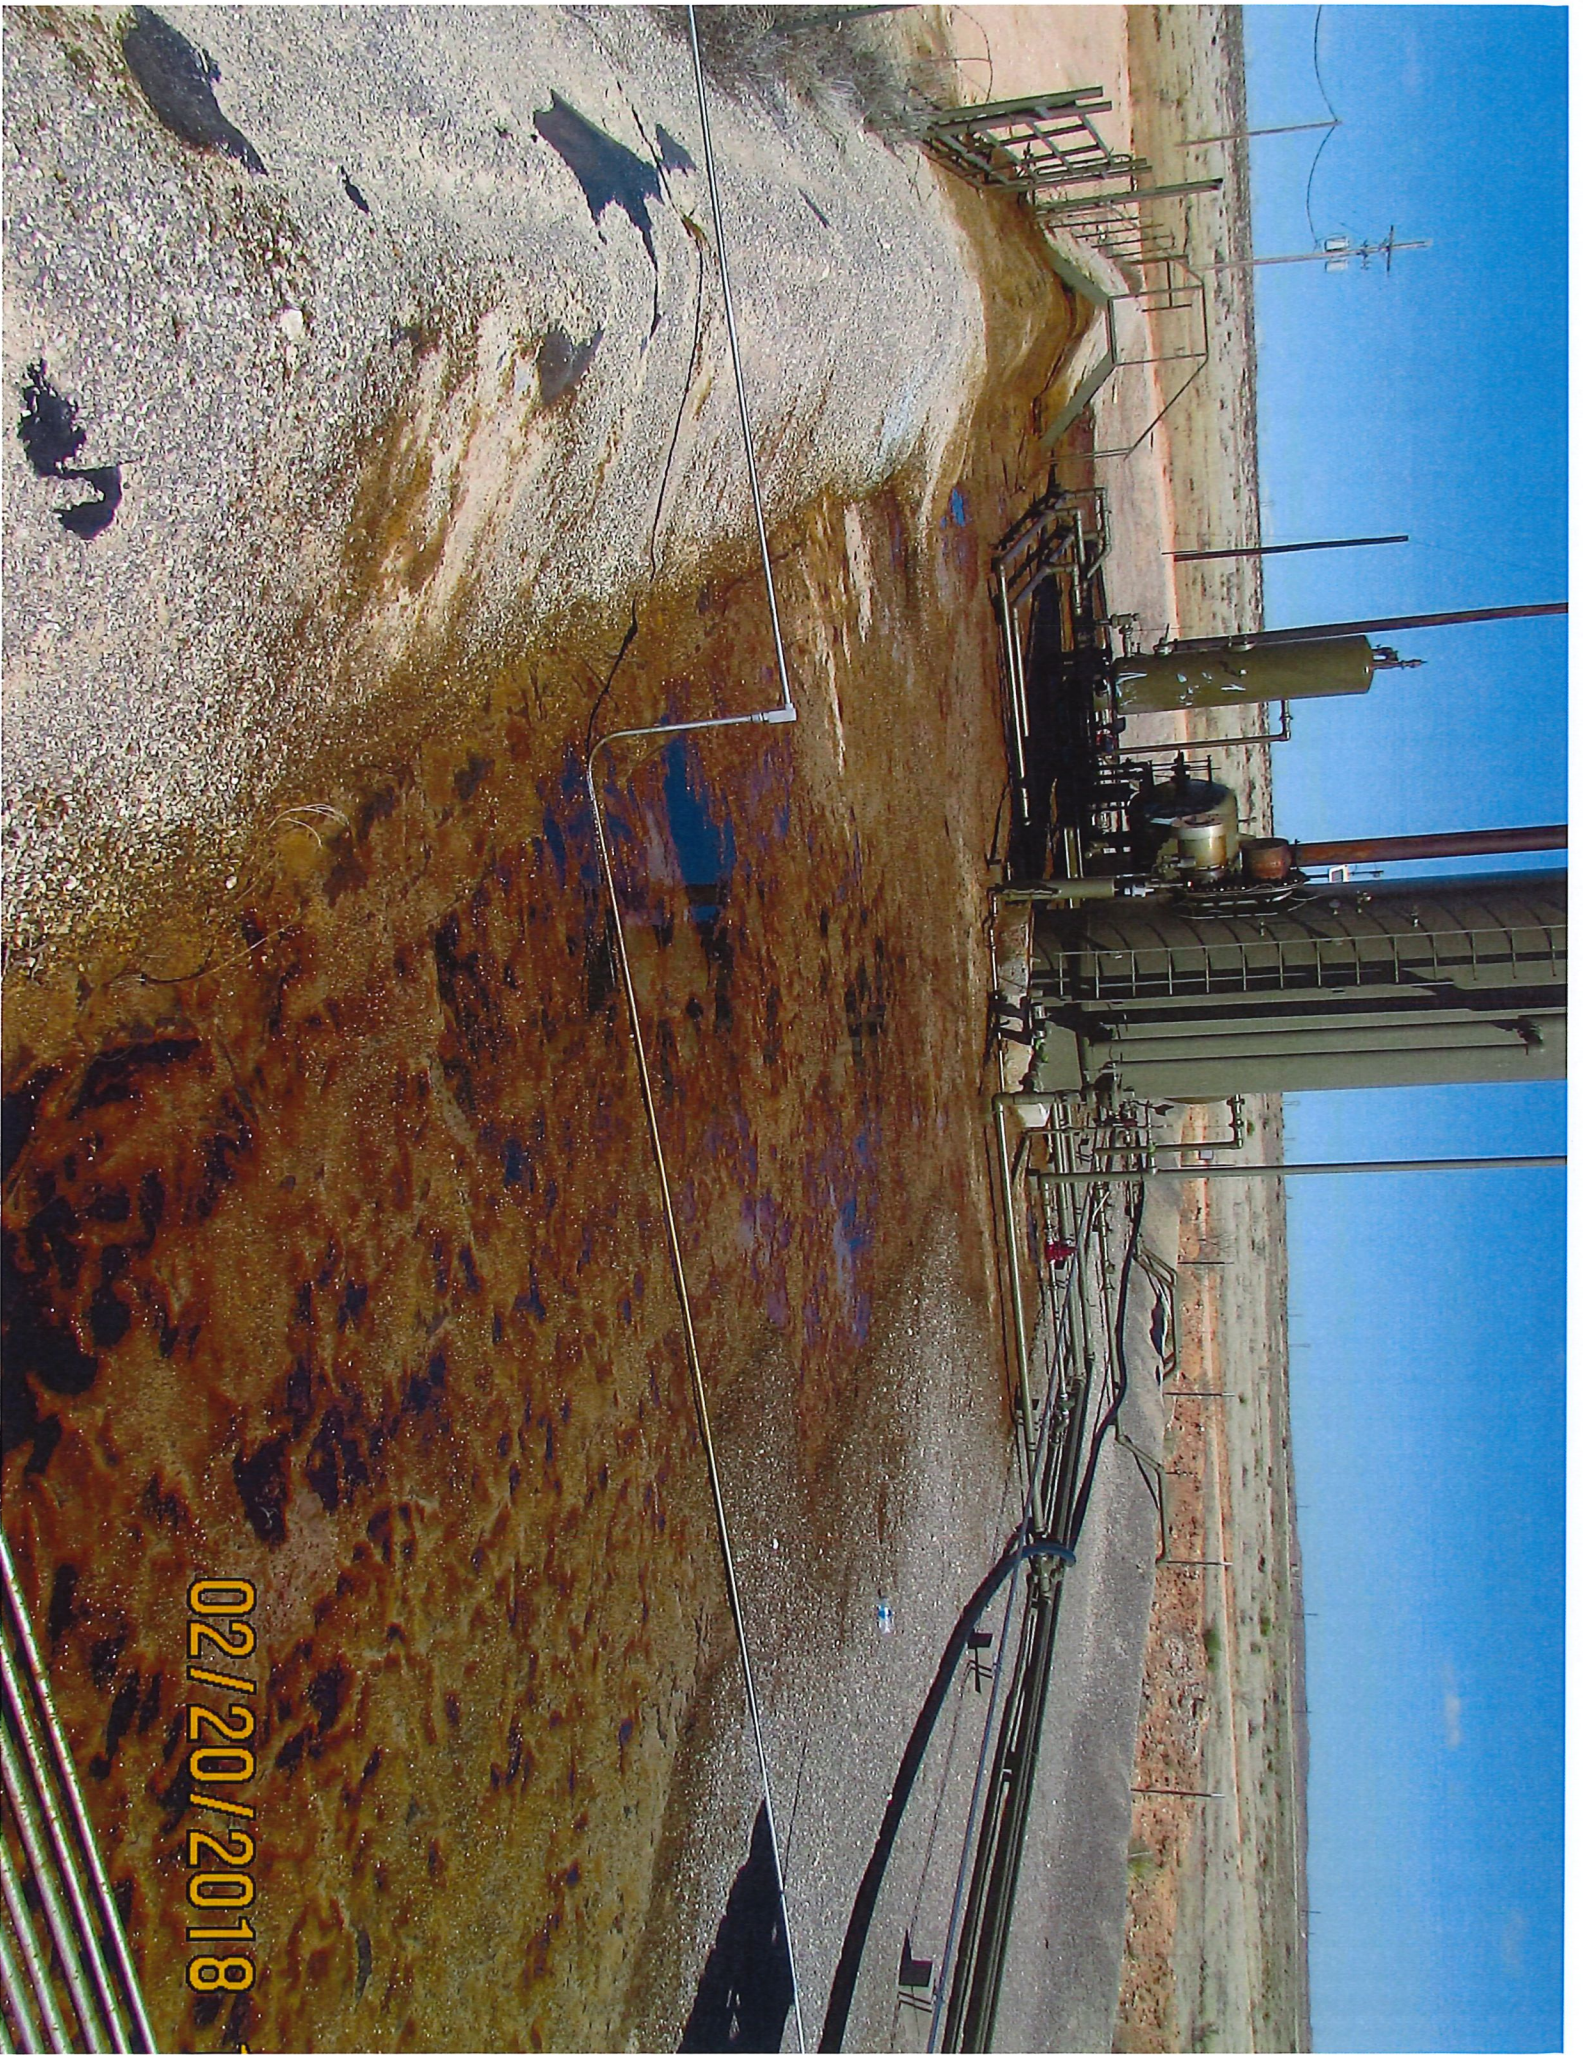
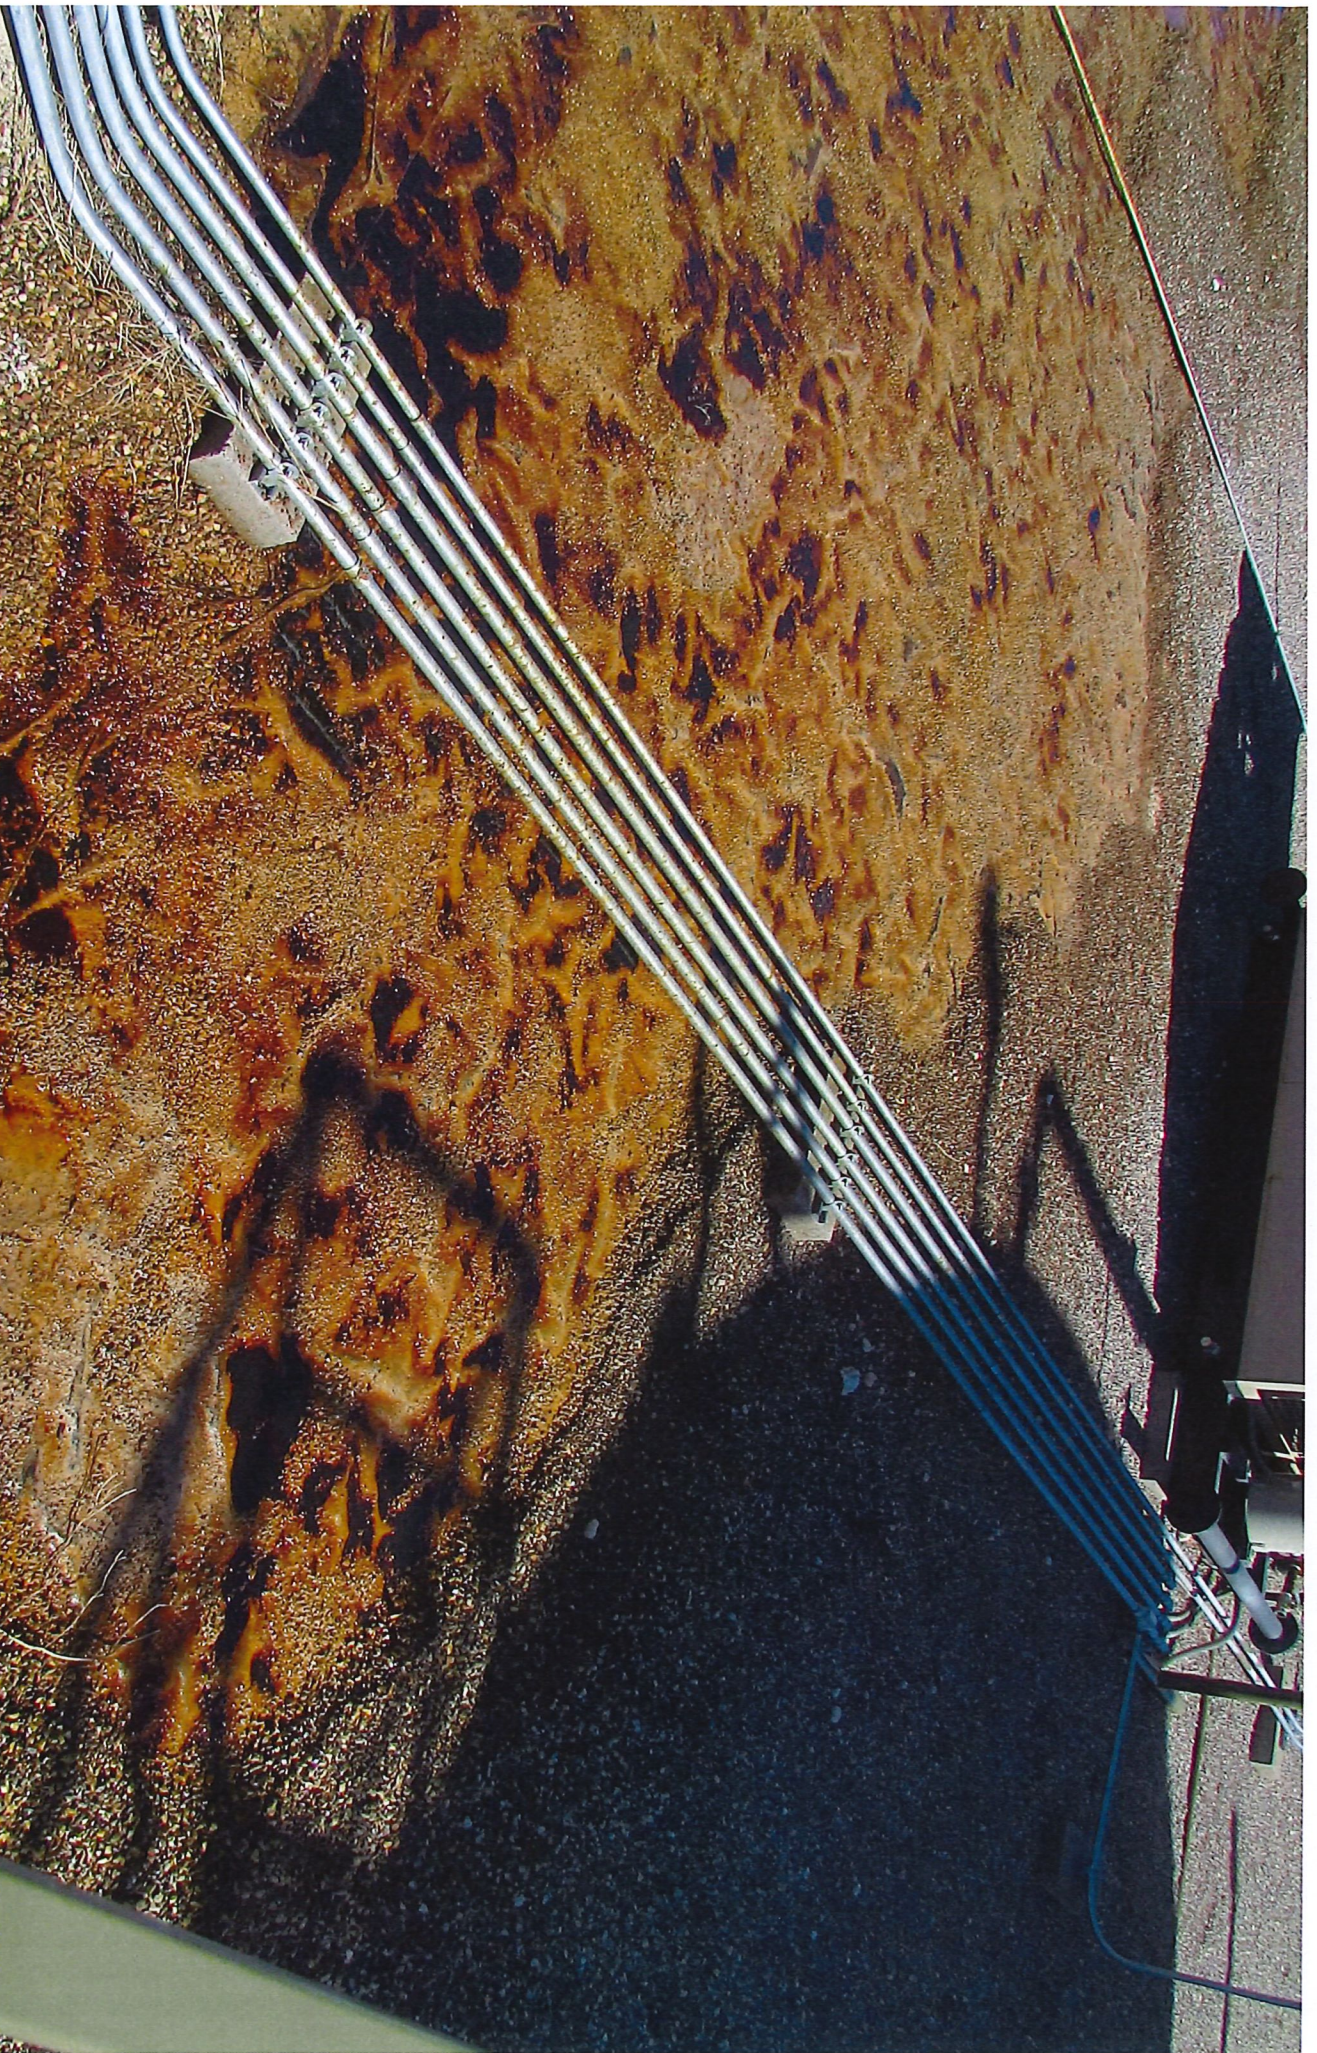
On February 28, 2018, EOG Y Resources, Inc. submitted to the NMOCD District I Office a Form C-141 for the release of 8 B/O with 7.5 B/O recovered (the remaining 0.5 B/O entrained within the gravel). The affected area is approximately 40' X 120' within the containment of the production facility and was contained within the bermed and lined battery. The release was caused by a fire tube gasket that failed. A vacuum truck was dispatched and recovered 94% of the released oil. A roustabout crew was dispatched, excavated the visibly impacted gravel and power washer the liner (after 2/20/2018 photos submitted with the Characterization Plan). The impacted gravel excavated was hauled to an NMOCD approved disposal facility.
