**Subject: El Paso Natural Gas Company, L.L.C., Florida Compressor Station Release OCD 2RP-5168**

EPNG is submitting the Closure Report in accordance with 19.15.29.10 NMAC for the facility referenced above.

## **Appendix A**

## **Appendix C**

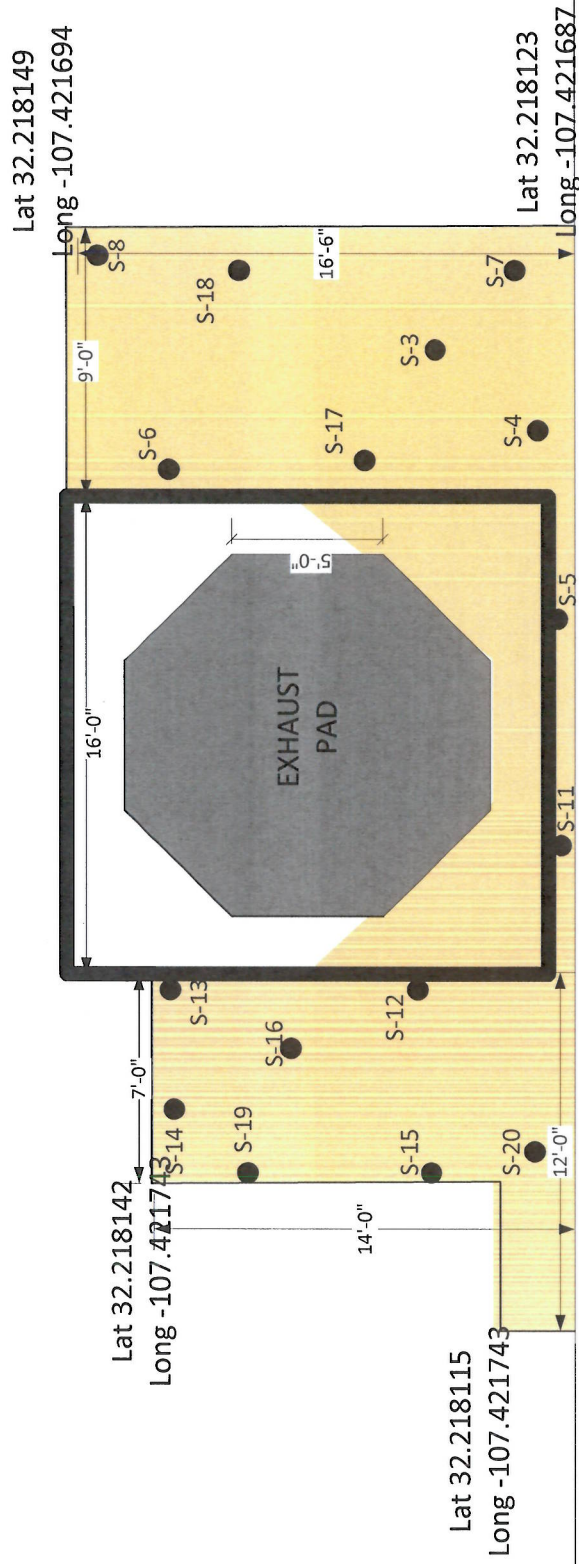
SITE MAP WITH  
SAMPLE LOCATIONS

Impacted Area

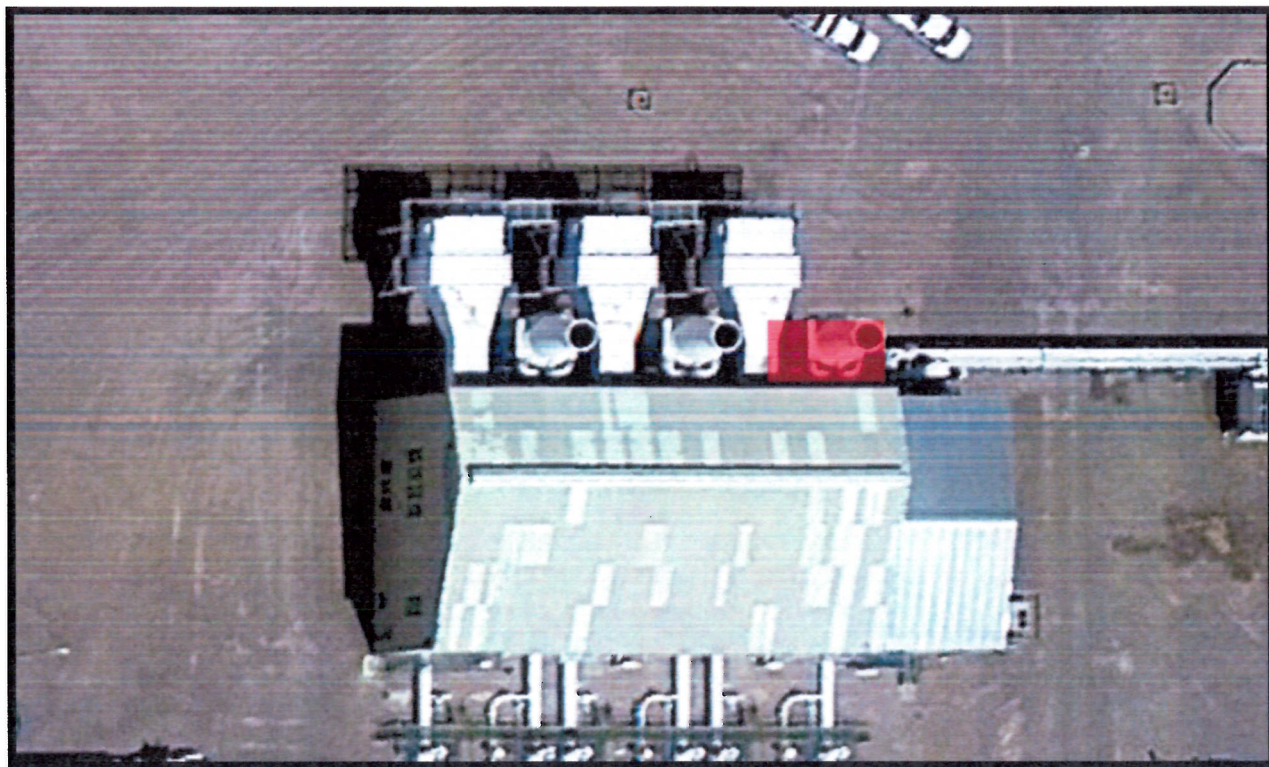
Release location

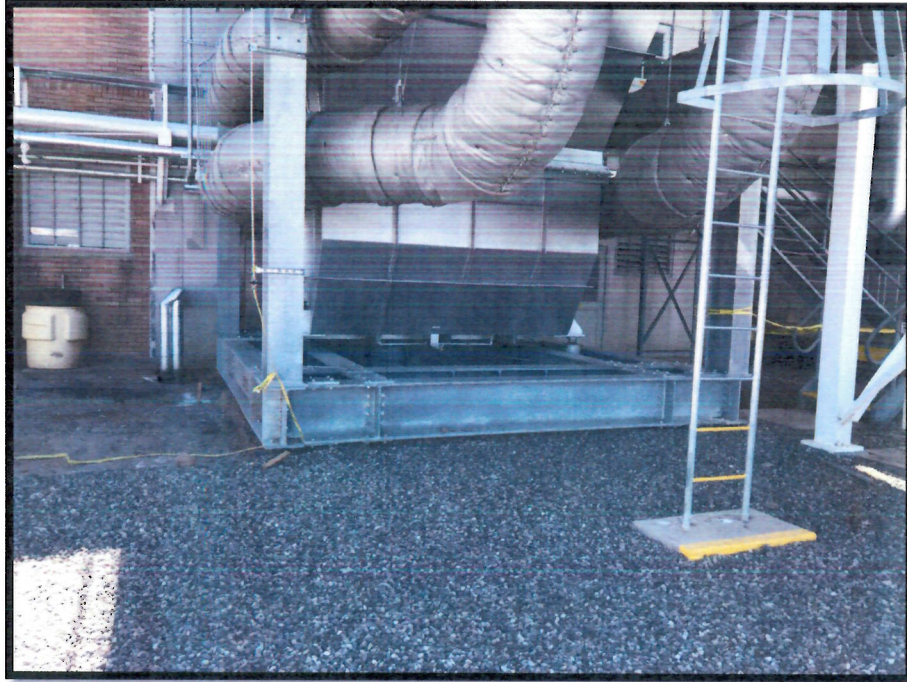
Spill Area

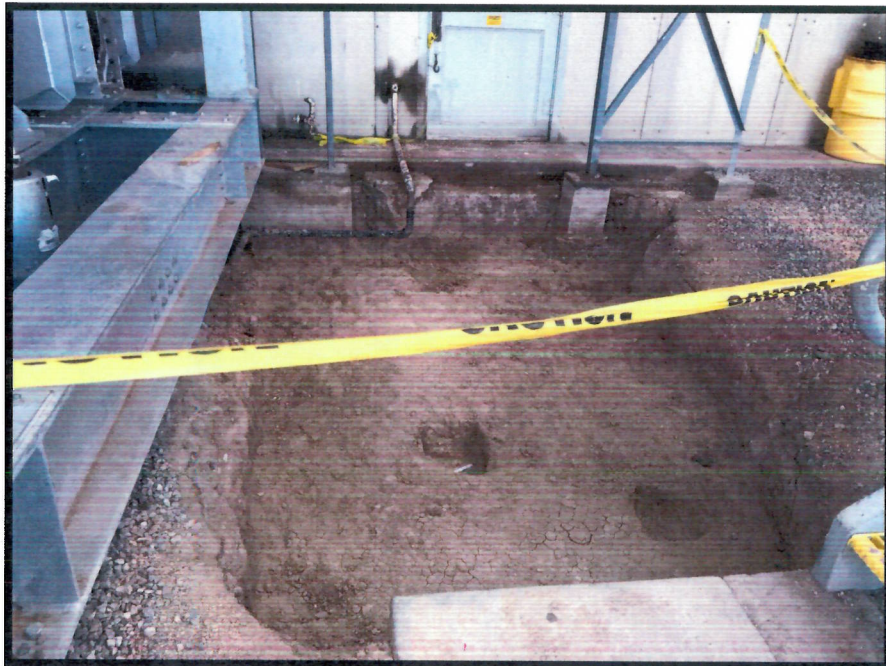
Spill area excavated 1 ft. deep

The depth of the contamination has been established at 1 foot; EPNG excavated and collected the contaminated soils for disposal. A grab sample of each sample point showing contamination above the limits were collected and analyzed in accordance with Table I of 19.15.29.12 NMAC.

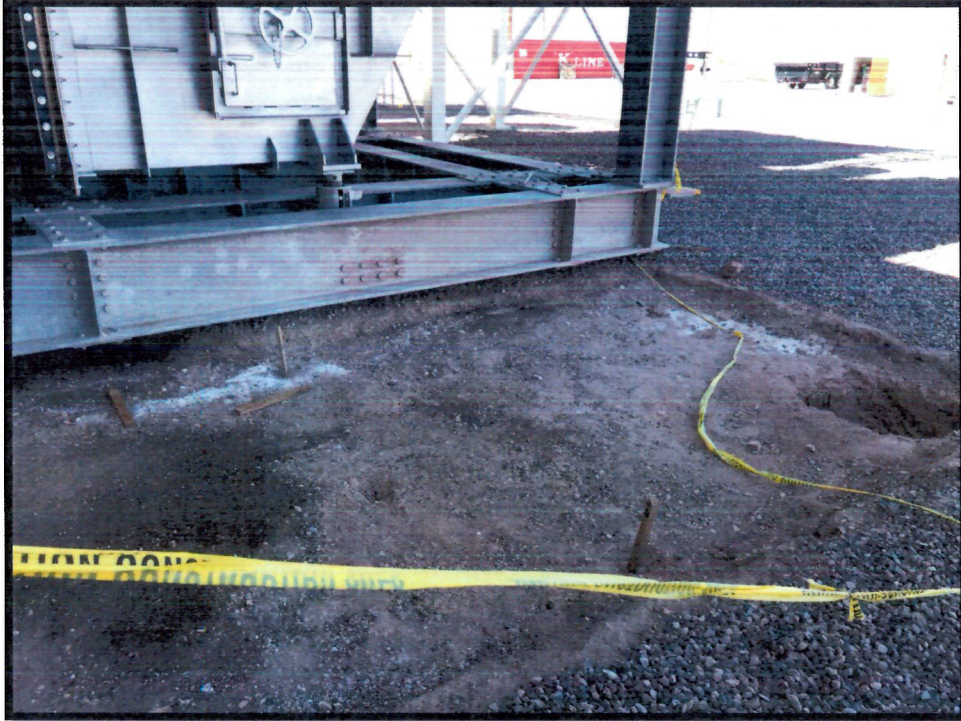
Sample area S-8 excavated 1 ft deep

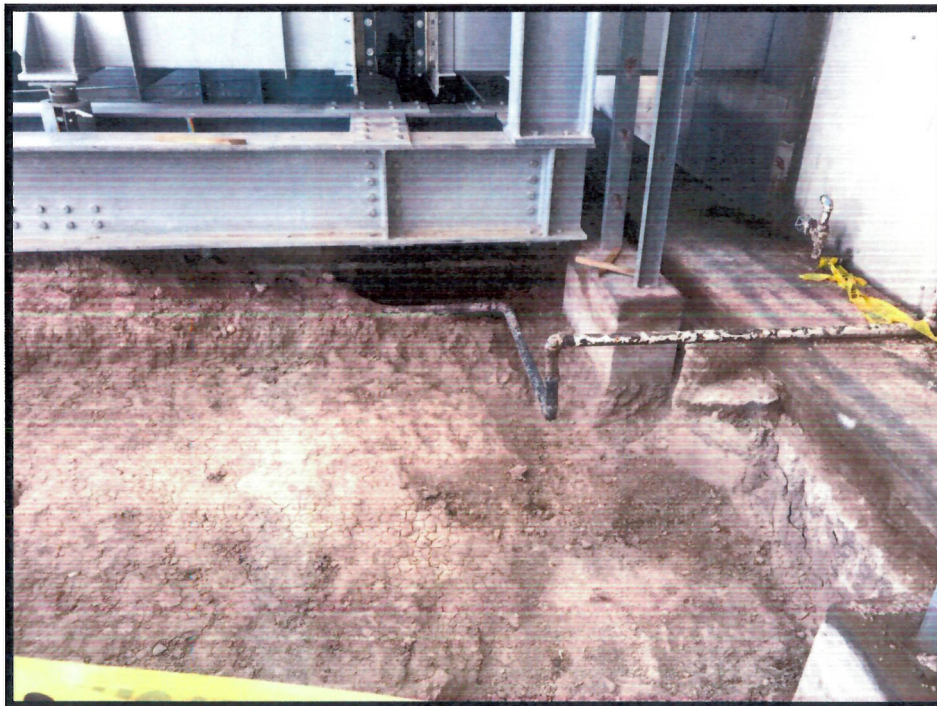
difficult to excavate due to equipment and piping in the area. The Agency requested additional samples at Sample locations S-5 and S-11. Lab results are attached on Appendix D.

Area between compressor building and exhaust pad

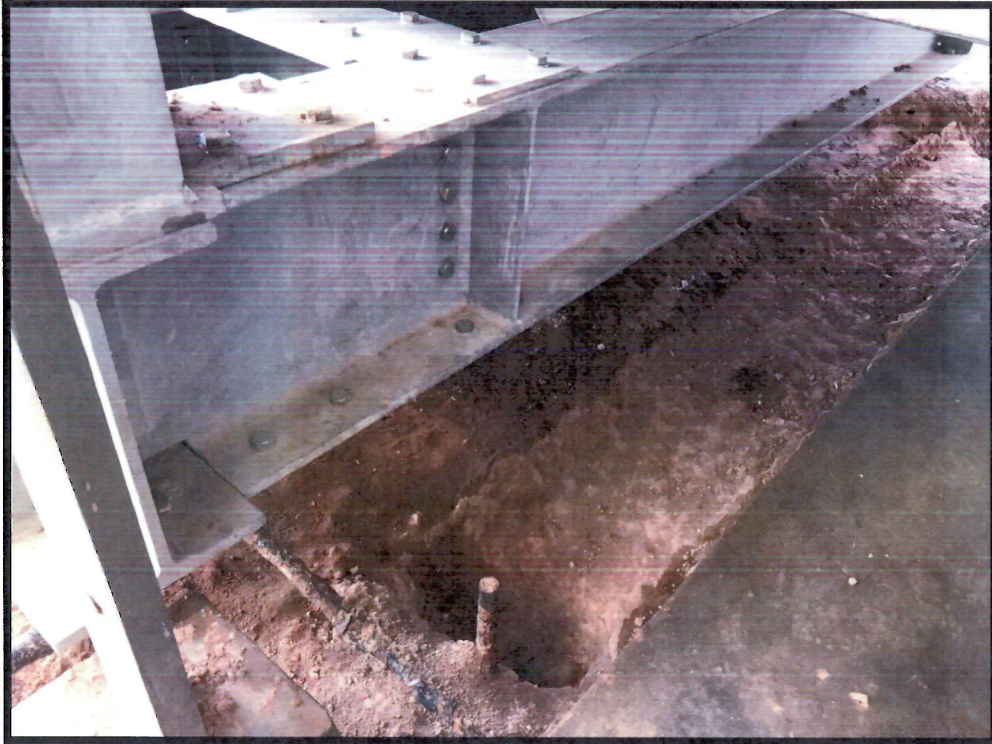
The results of S-5 and S-11 at 3 feet deep are attached, EPNG only gathered the samples at this two location, we were not able to excavate the near areas and collect the contaminated soil.

Samples gathered at 3 ft. deep
