Closure Report
East Pecos Federal 22 #009H
2RP-5506
API #: 30-015-43349
Eddy County, New Mexico

This report presents the findings of the liner inspection conducted by HRL Compliance Solutions at the East Pecos Federal 22 #009H Production Facility on August 21, 2019. The objective of the liner inspection was to demonstrate the liner integrity and verify that it remained intact and had the ability to contain the produced water release that occurred within the tank battery secondary containment on June 10, 2019. This report is also intended to serve as a final closure report to obtain approval from New Mexico Oil Conservation Division (NM OCD) for closure of the release.

Appendix C: Liner Inspection Photos

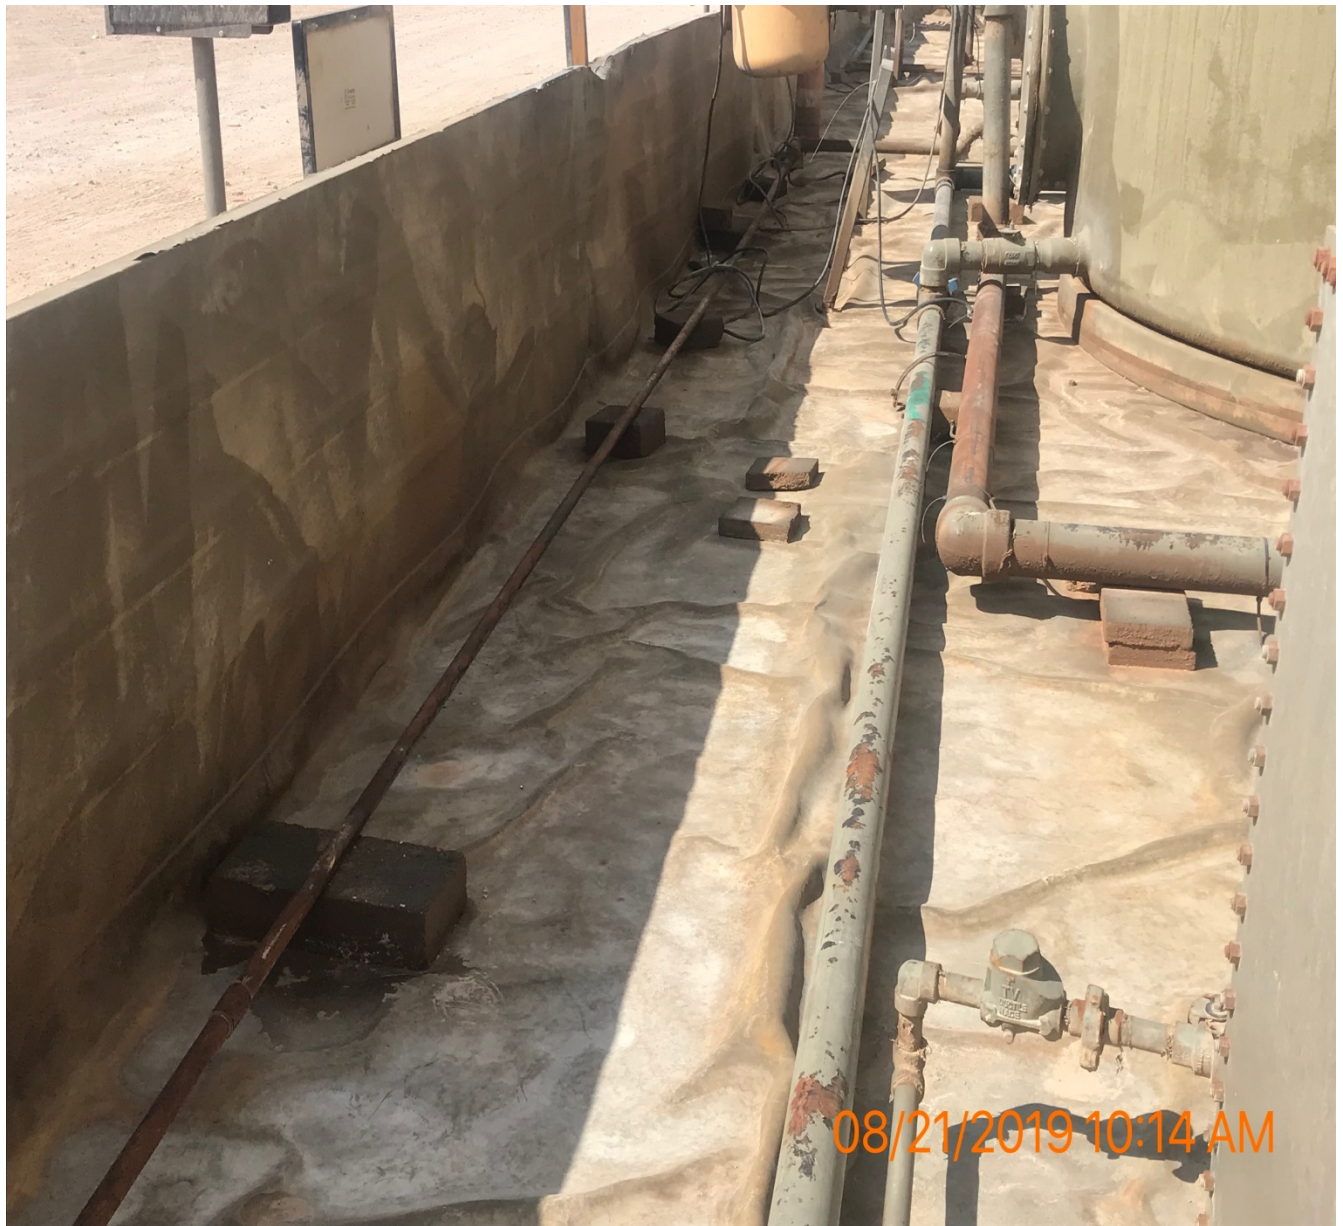
Containment: South of Tanks

The steel framed secondary containment at the East Pecos Federal 22 #009H Production Facility consists of a polyurea spray-in-liner. The liner that was investigated appeared to be in good condition and fully intact with no tears, cracks, or signs of damage. No structural deficiencies were identified throughout the containment foundation. Visual staining was not present on the well pad surface surrounding the secondary containment. Therefore the integrity of the containment was not compromised as a result of the release that occurred on June 10, 2019. All liner certification requirements outlined in Subsection A of 19.15.29.12 NMAC have been met. Photos of the liner and secondary containment are included in Appendix C.
