# Liner Inspection

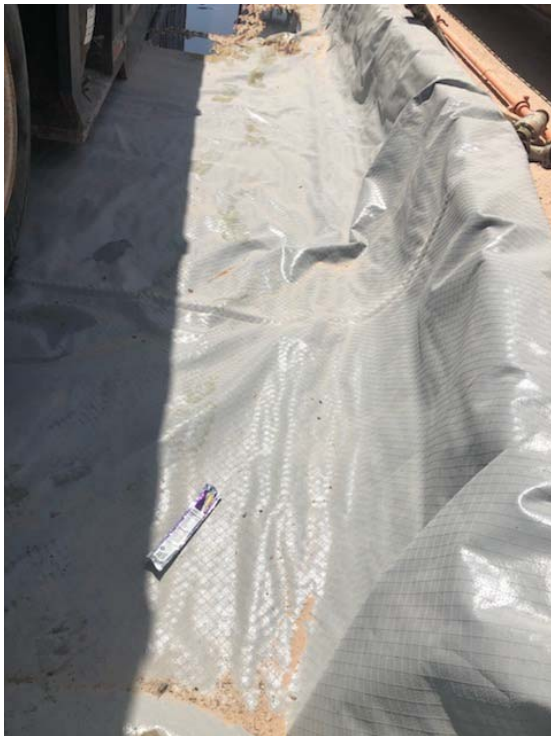
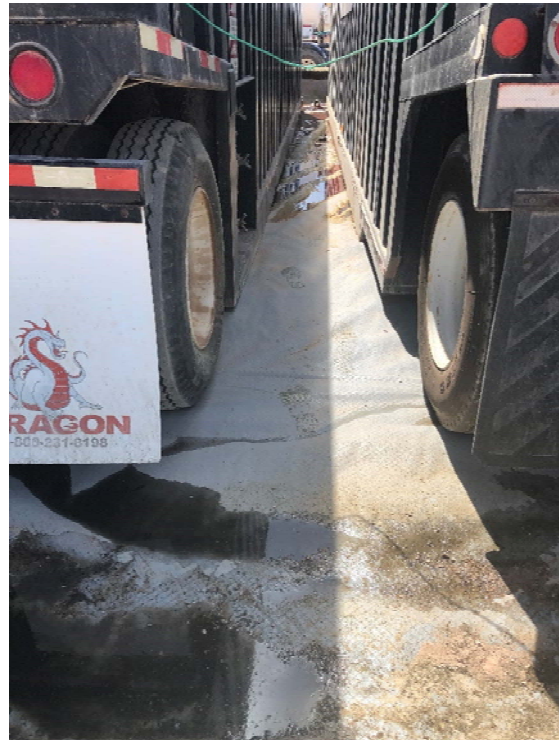
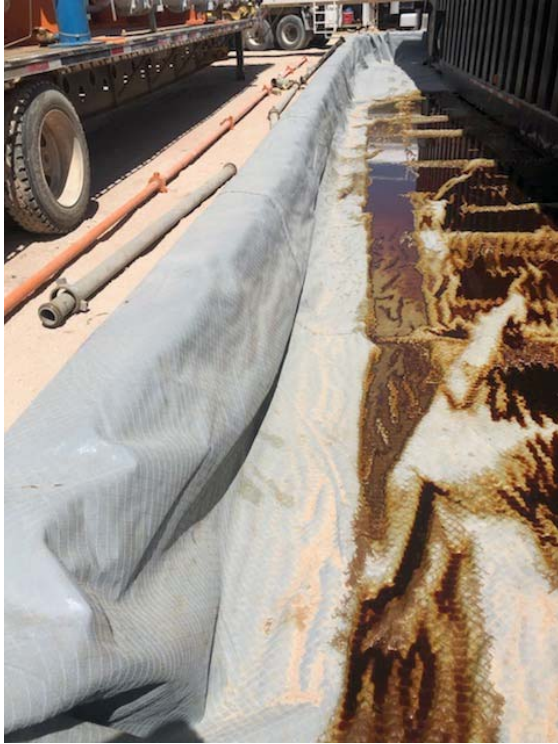
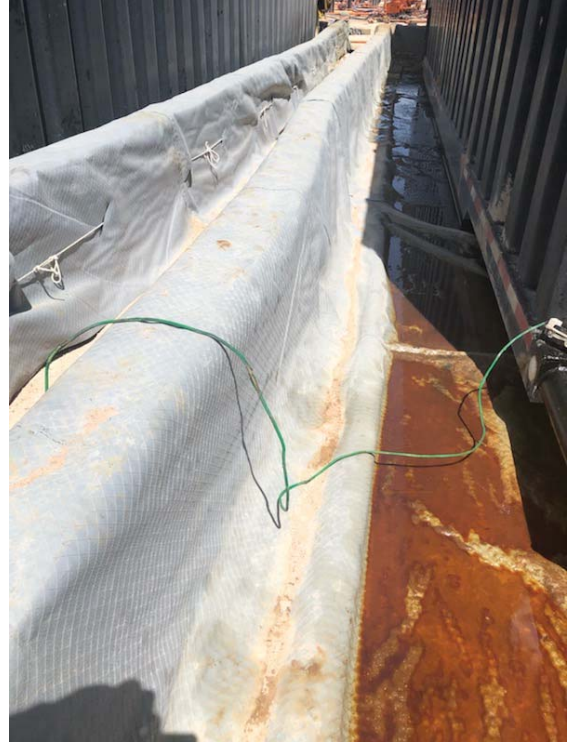
Remediation Activities: Standing fluids were recovered via vac truck. Liner maintained integrity. This spill happened from a temporary frac tank and this is a temporary secondary containment.
