July 22, 2019

SMA #5E28395, BG4

**RE: LINER INSPECTION REPORT
STARCASTER 18 FED COM TANK BATTERY (1RP-5444)**

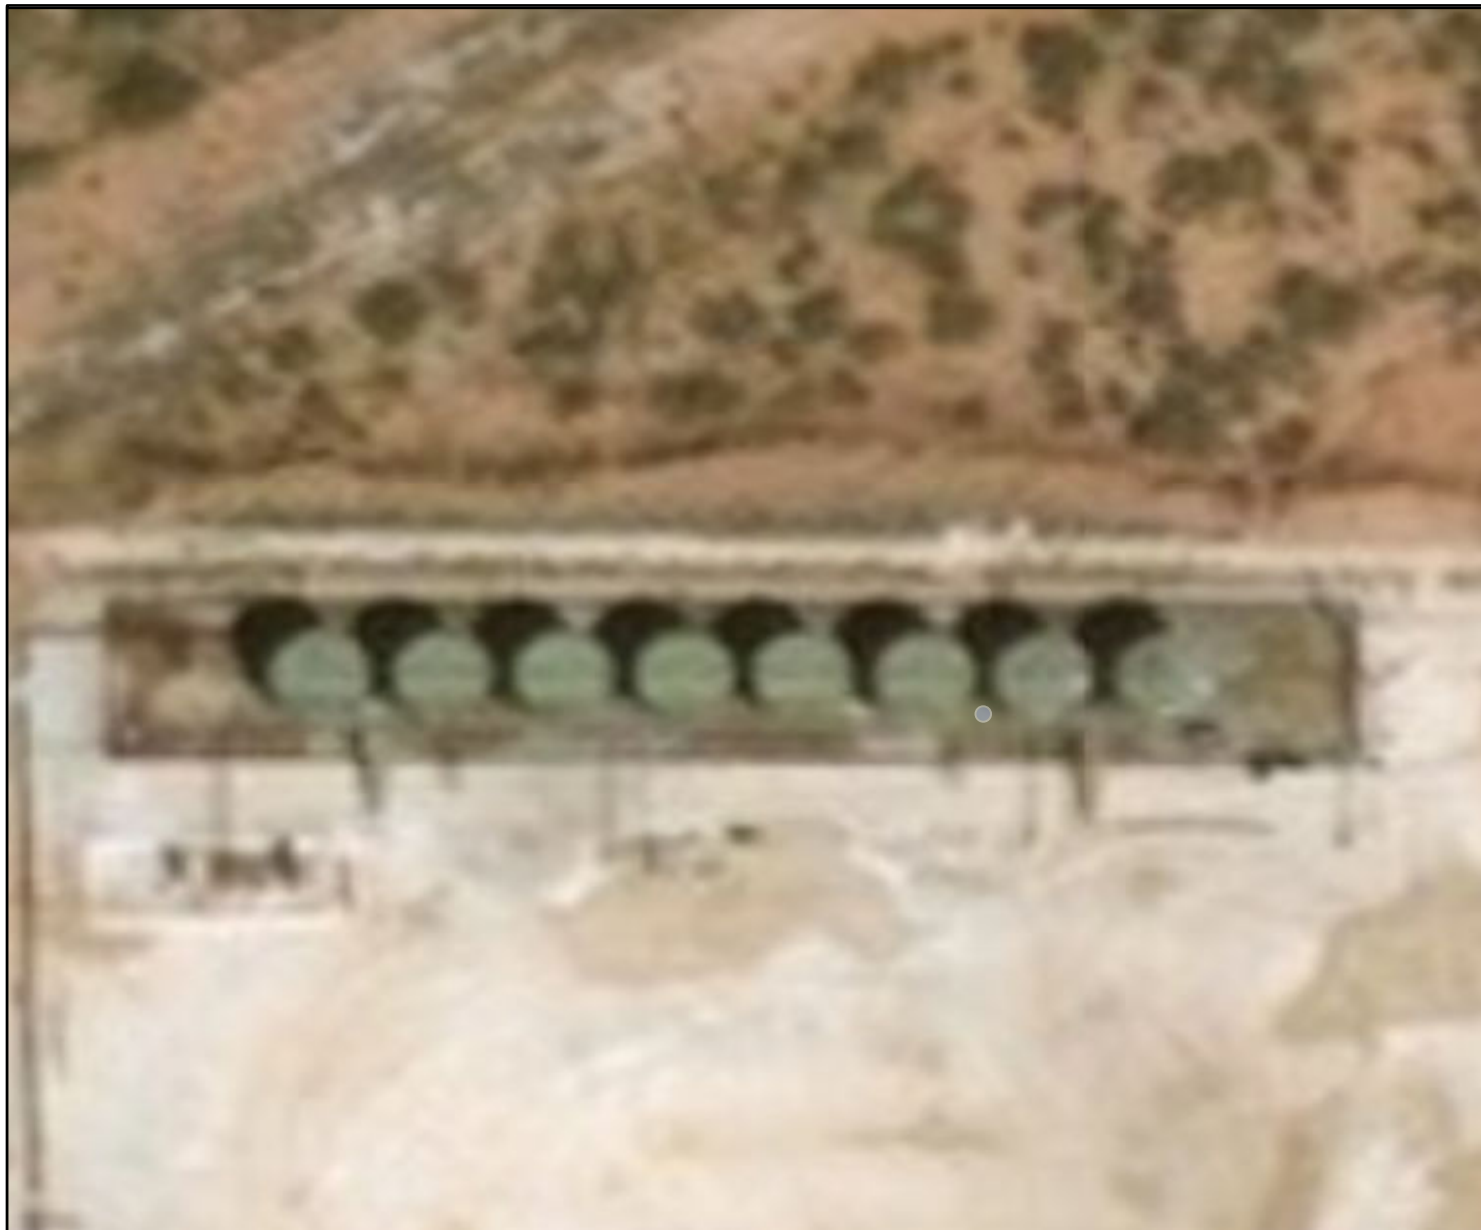
Figure 2

• Point of Release

Site and Sample Locations
 Starcaster 18 Fed Com Tank Battery- BTA Oil Producer, LLC
 Lea County, New Mexico

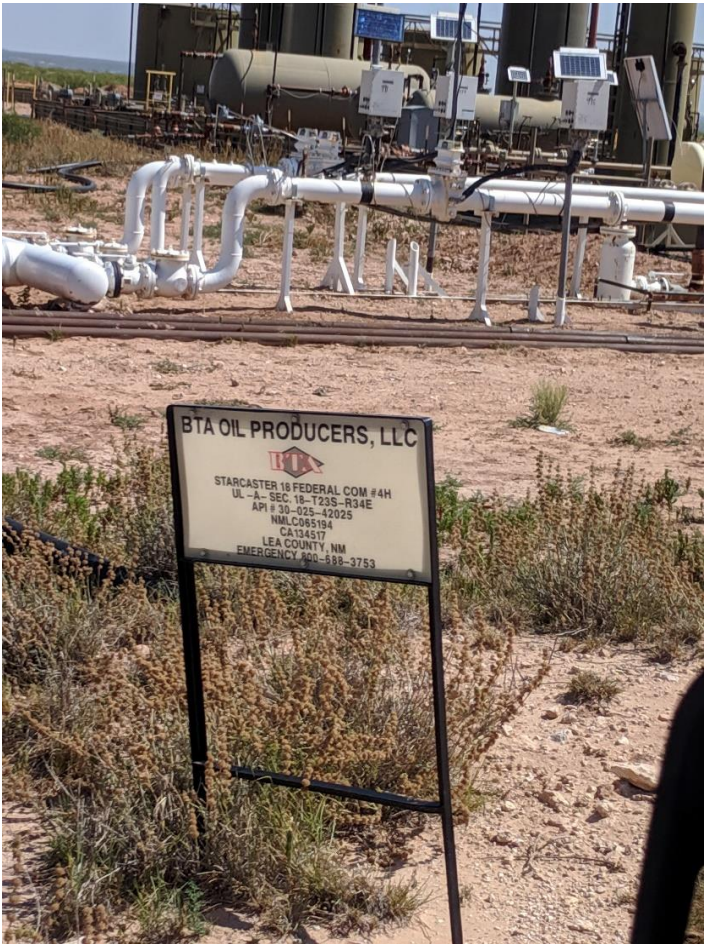
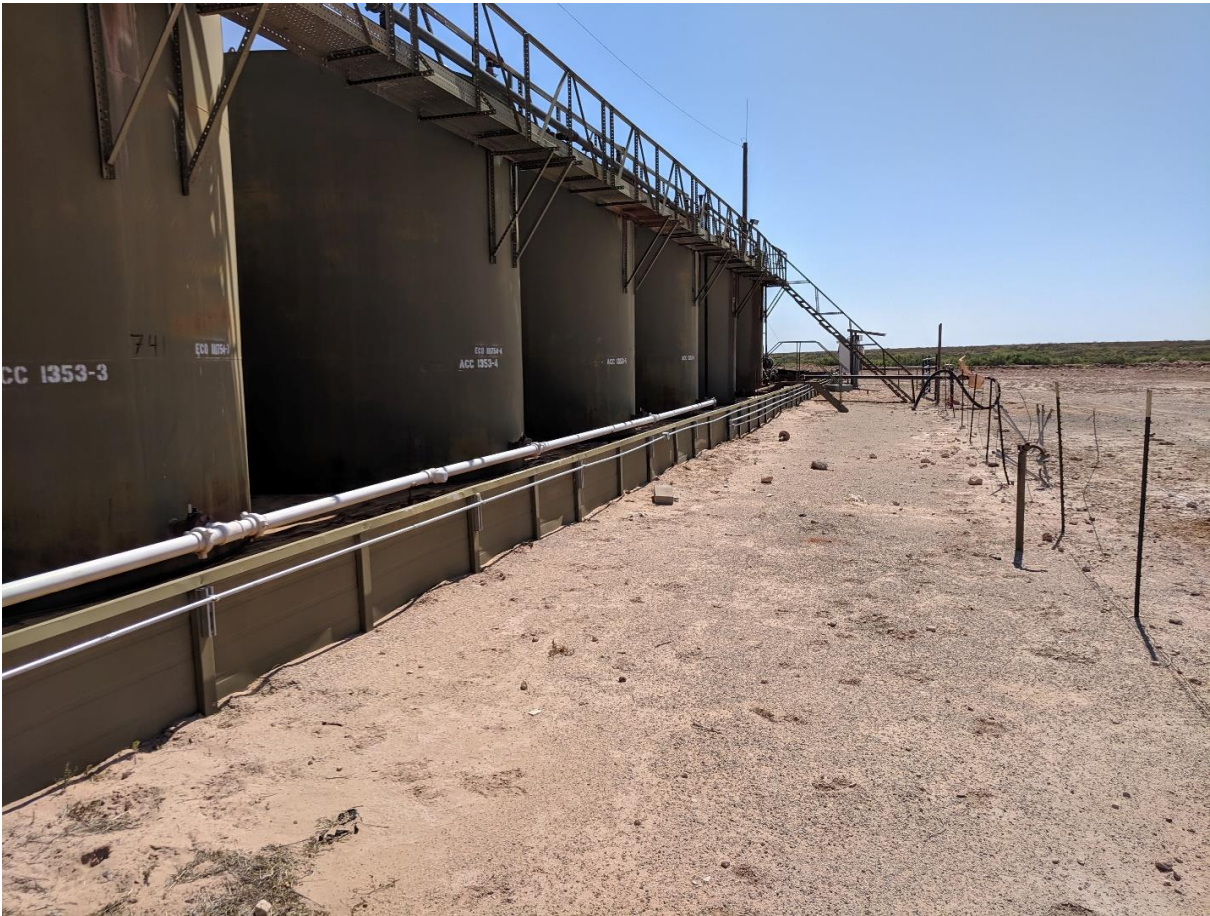
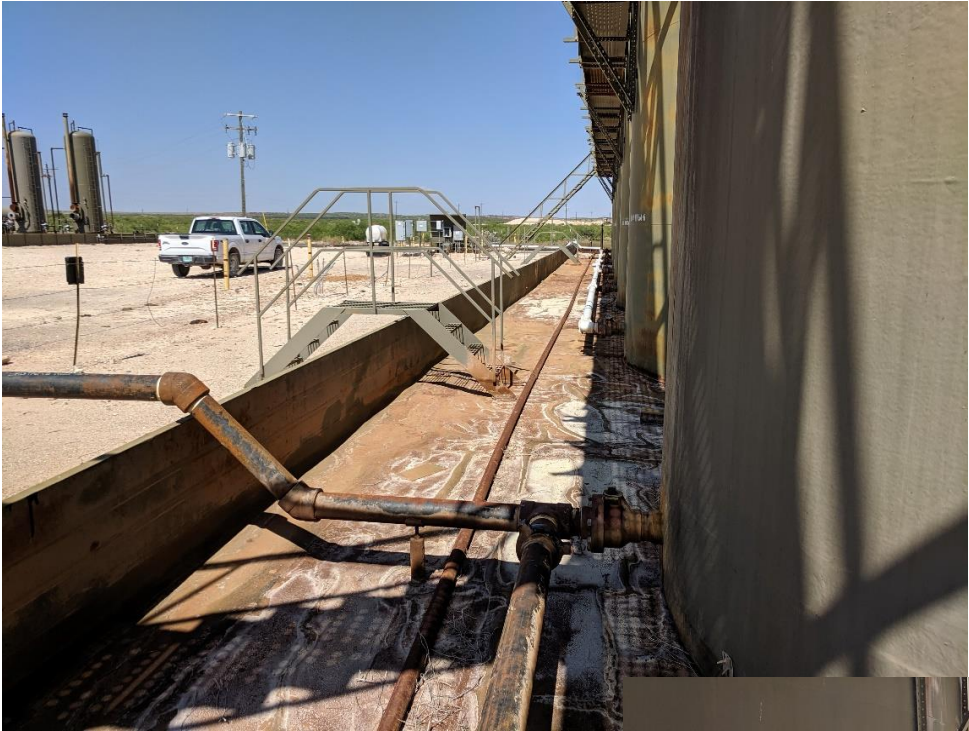
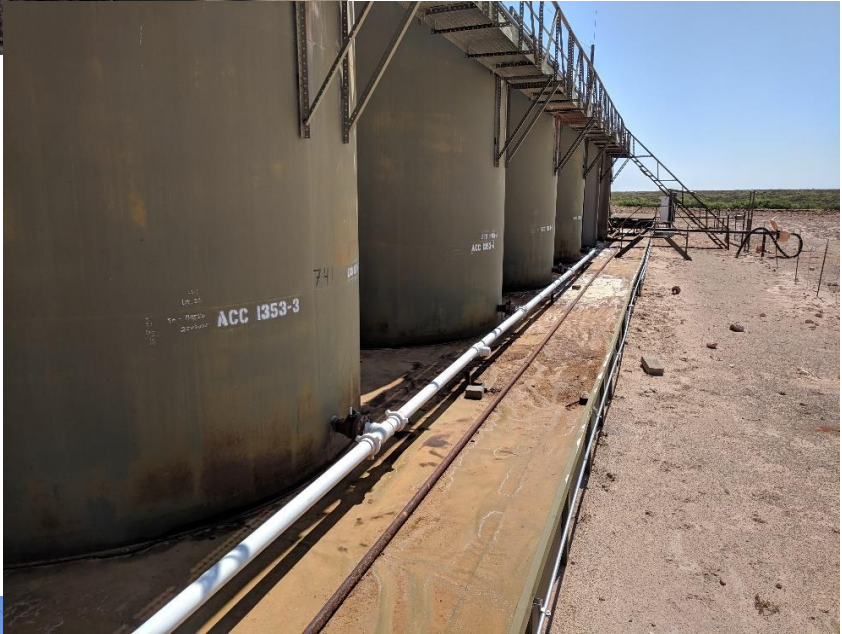
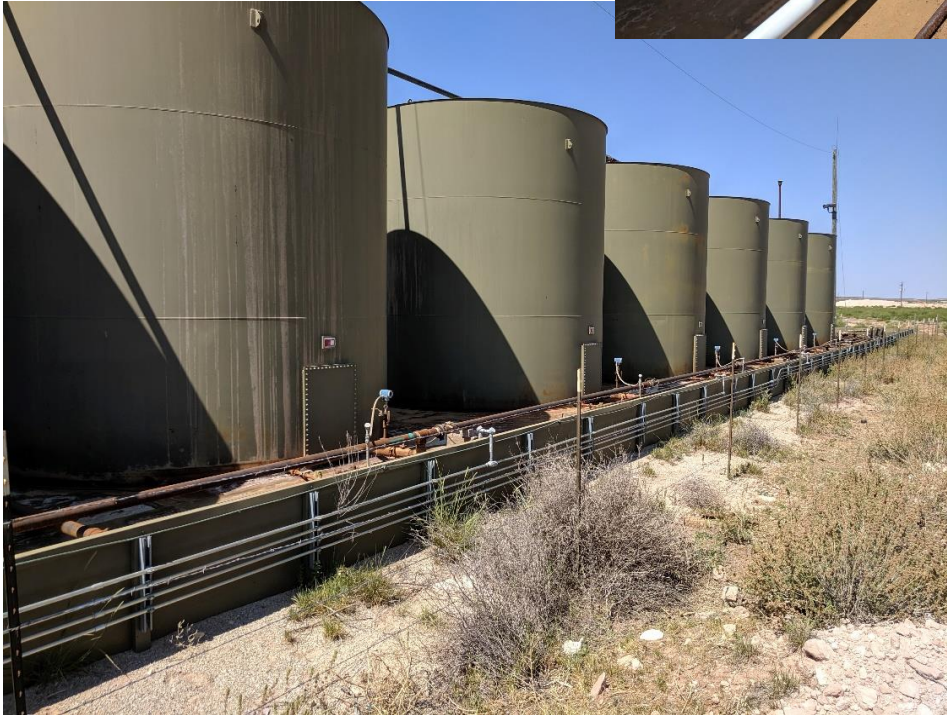
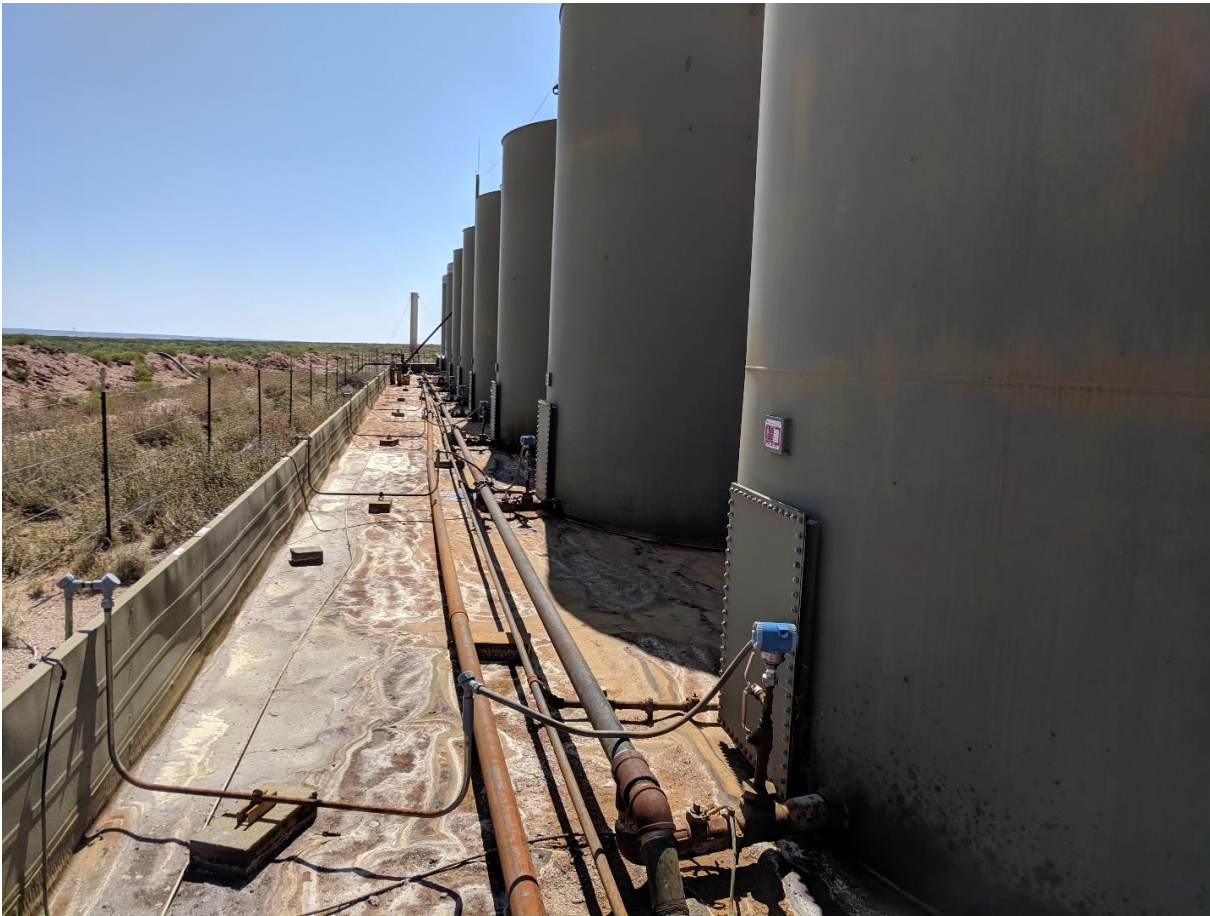
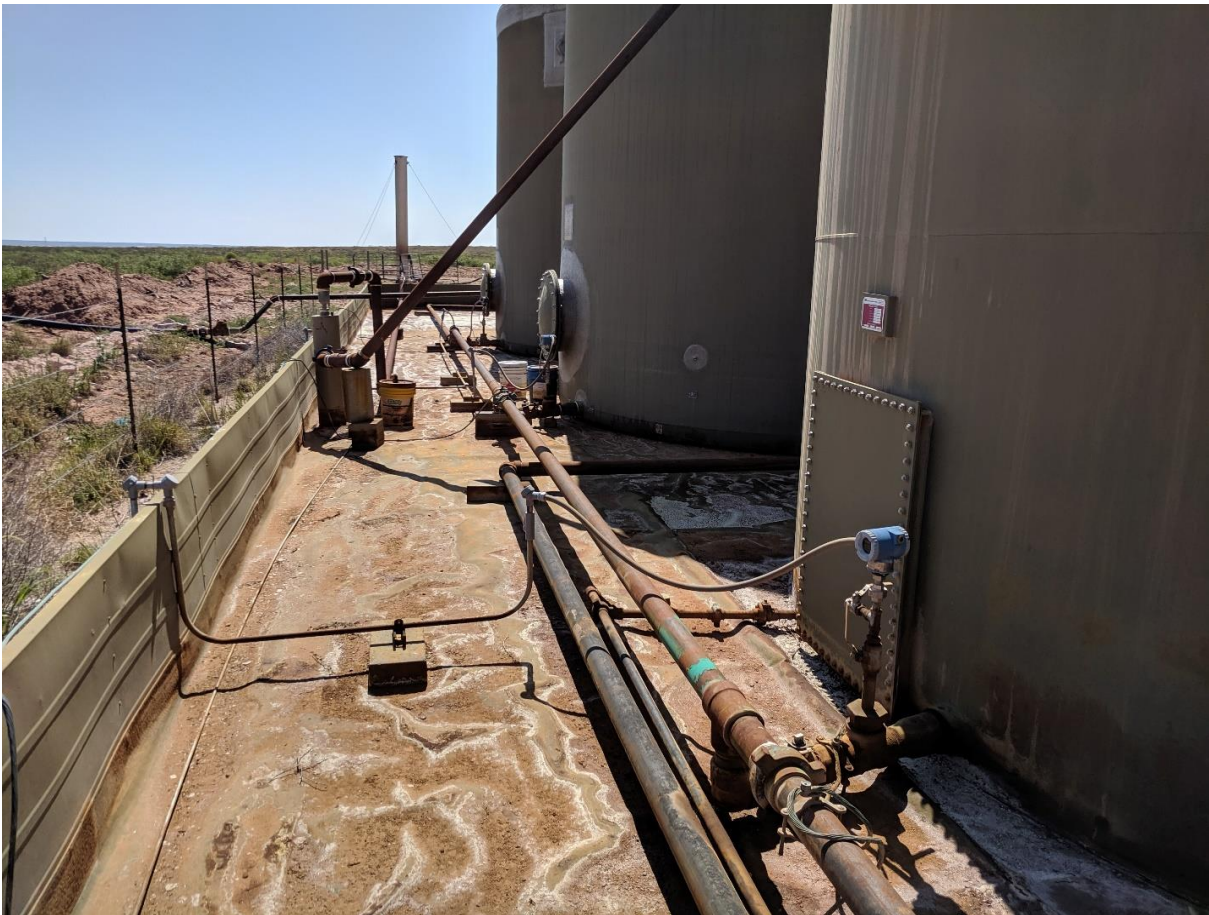
Appendix A
PHOTO LOG & FIELD NOTES

At the request of BTA, SMA conducted a liner integrity inspection per the requirements of 19.15.29.11.A(5)(a) NMAC. NMOCD was notified on July 8, 2019 that the liner inspection was to occur and SMA conducted the inspection on July 11, 2019. After a thorough visual inspection of the liner within the tank battery containment, the liner appeared to be intact and had the ability to contain the leak in question. The tank from which the release occurred was identified, and SMA verified that the release did not occur outside of the lined containment. A photo log and field notes of the inspection is included in Appendix A.

SMA recommends no further action for this release.
