Subject: Closure Report  
2RP-5633  
Longview Federal 12 #015H  
Eddy County, New Mexico

This report presents the methods and results of the liner inspection conducted by HRL Compliance Solutions, Inc. (HRL) at the Longview Federal 12 #015H production facility on December 26, 2019. The objective of the liner inspection was to demonstrate the liner integrity and verify that it remained intact and had the ability to contain the produced water release that occurred on August 16, 2019. The purpose of the report is to obtain approval from the New Mexico Oil Conservation Division (NMOCD) for the closure of the release.

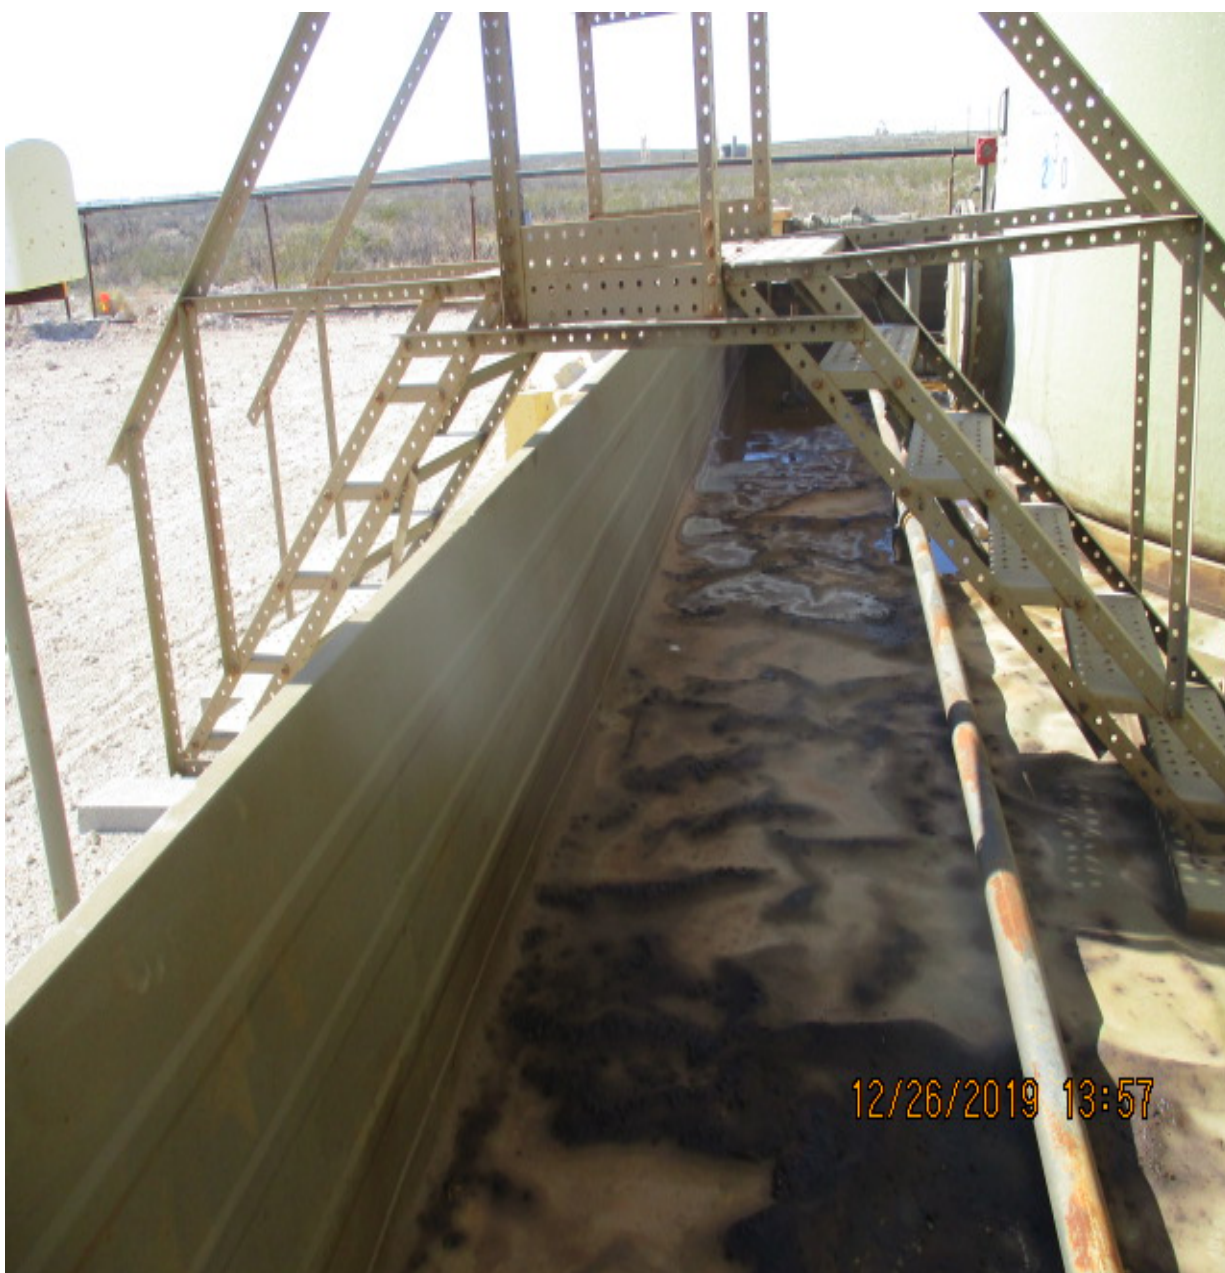
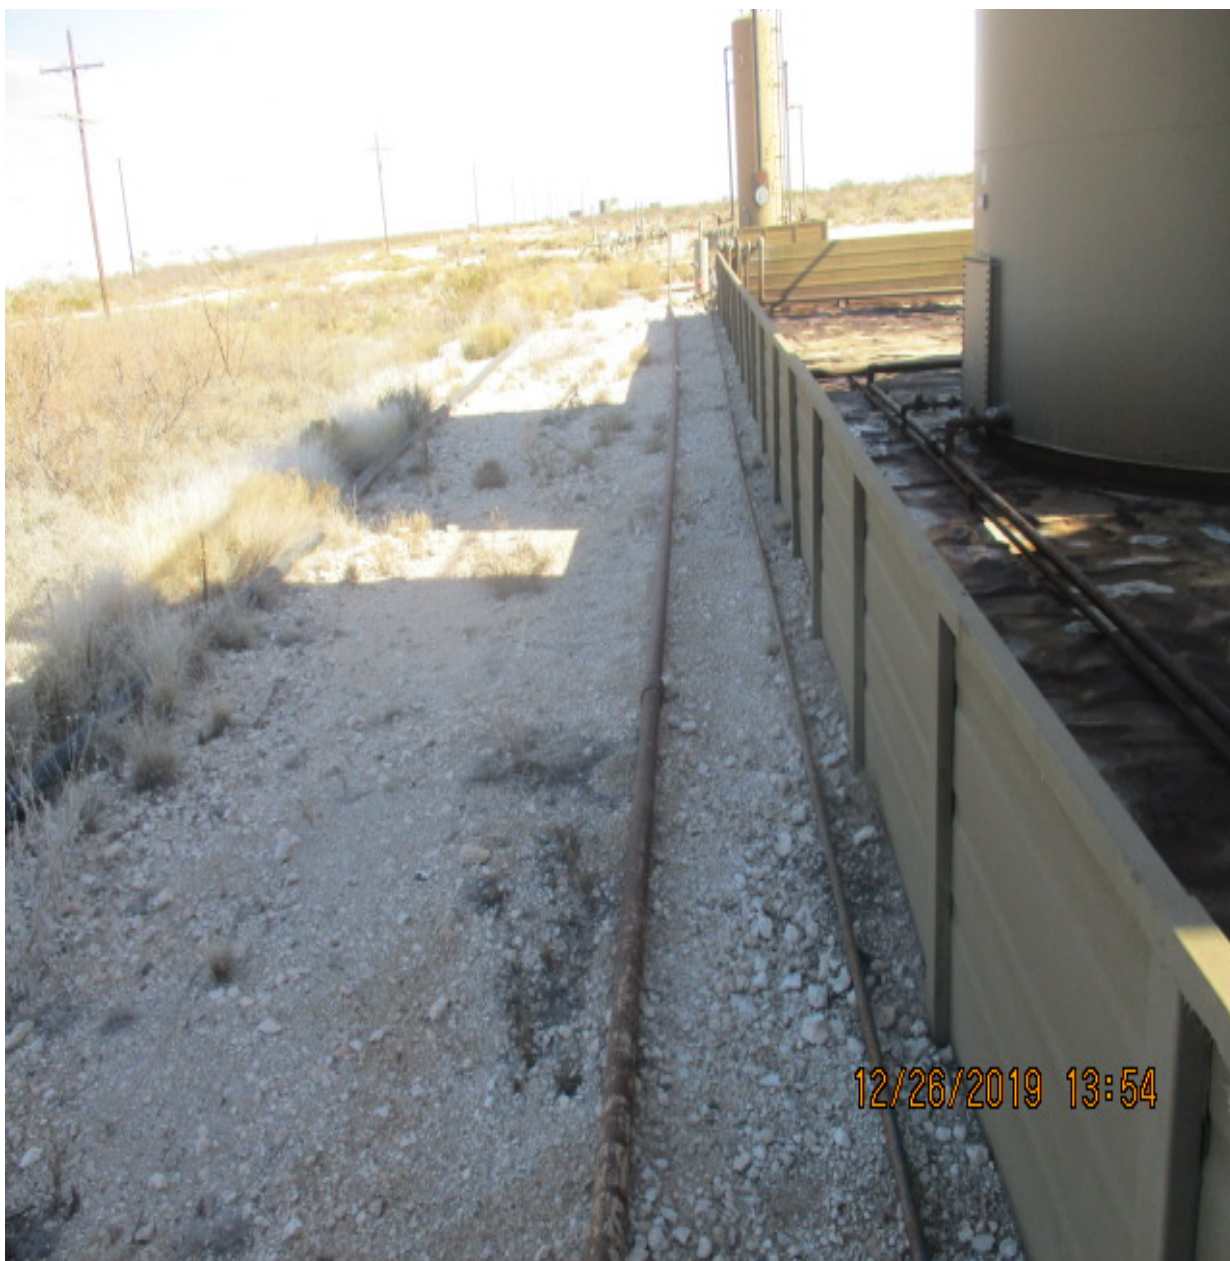
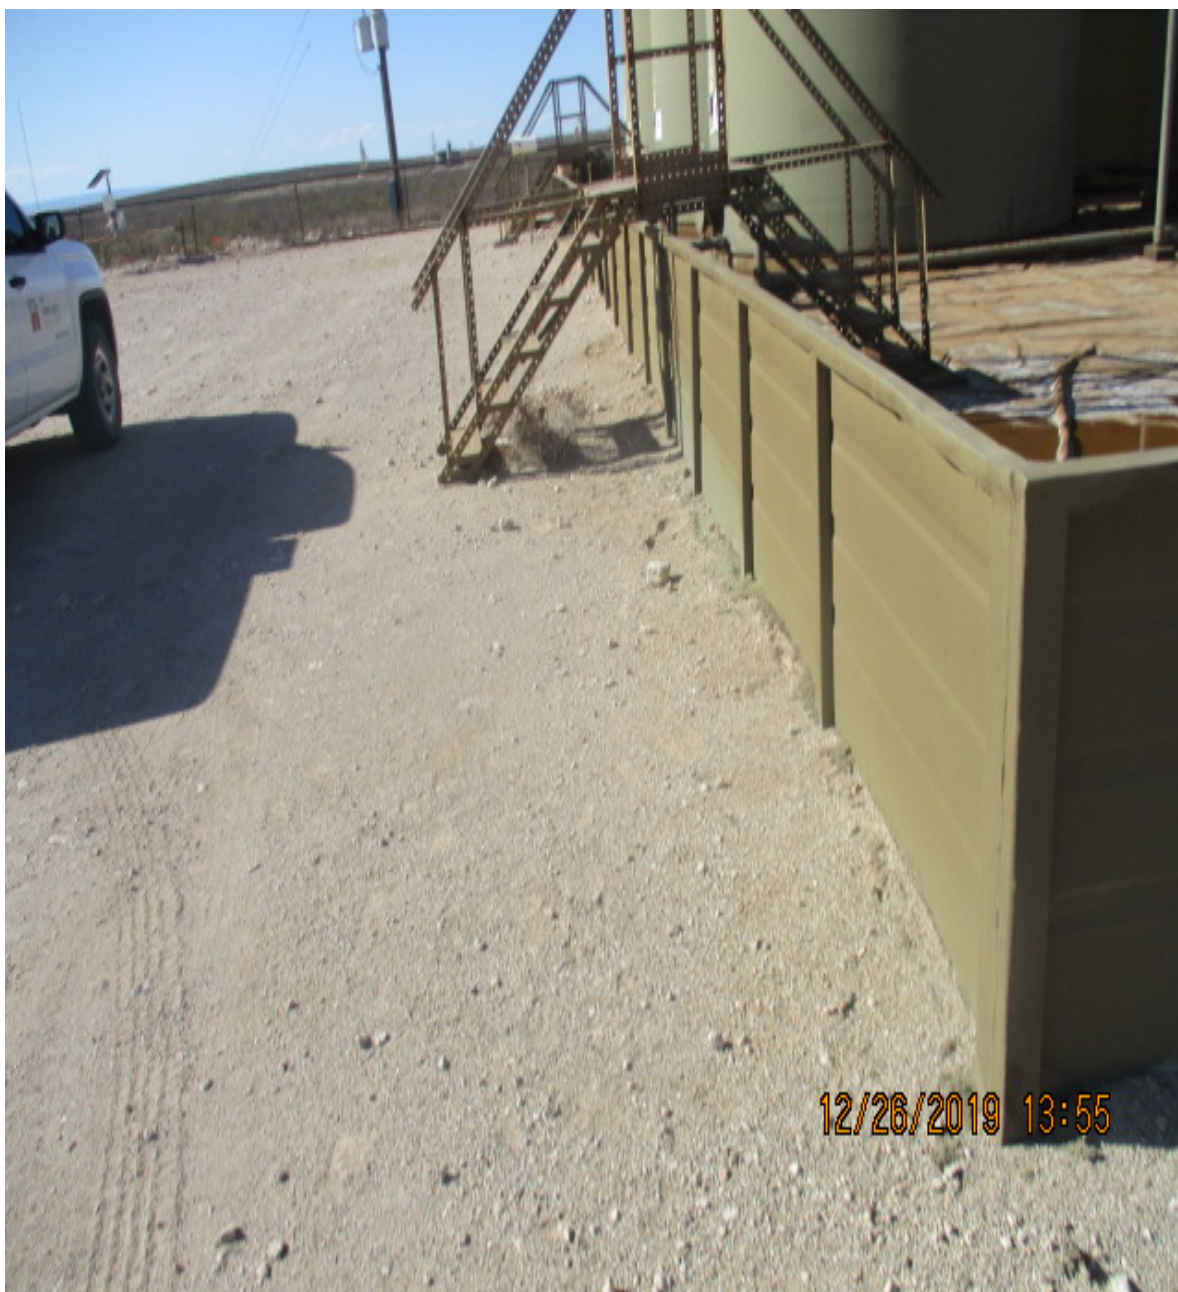
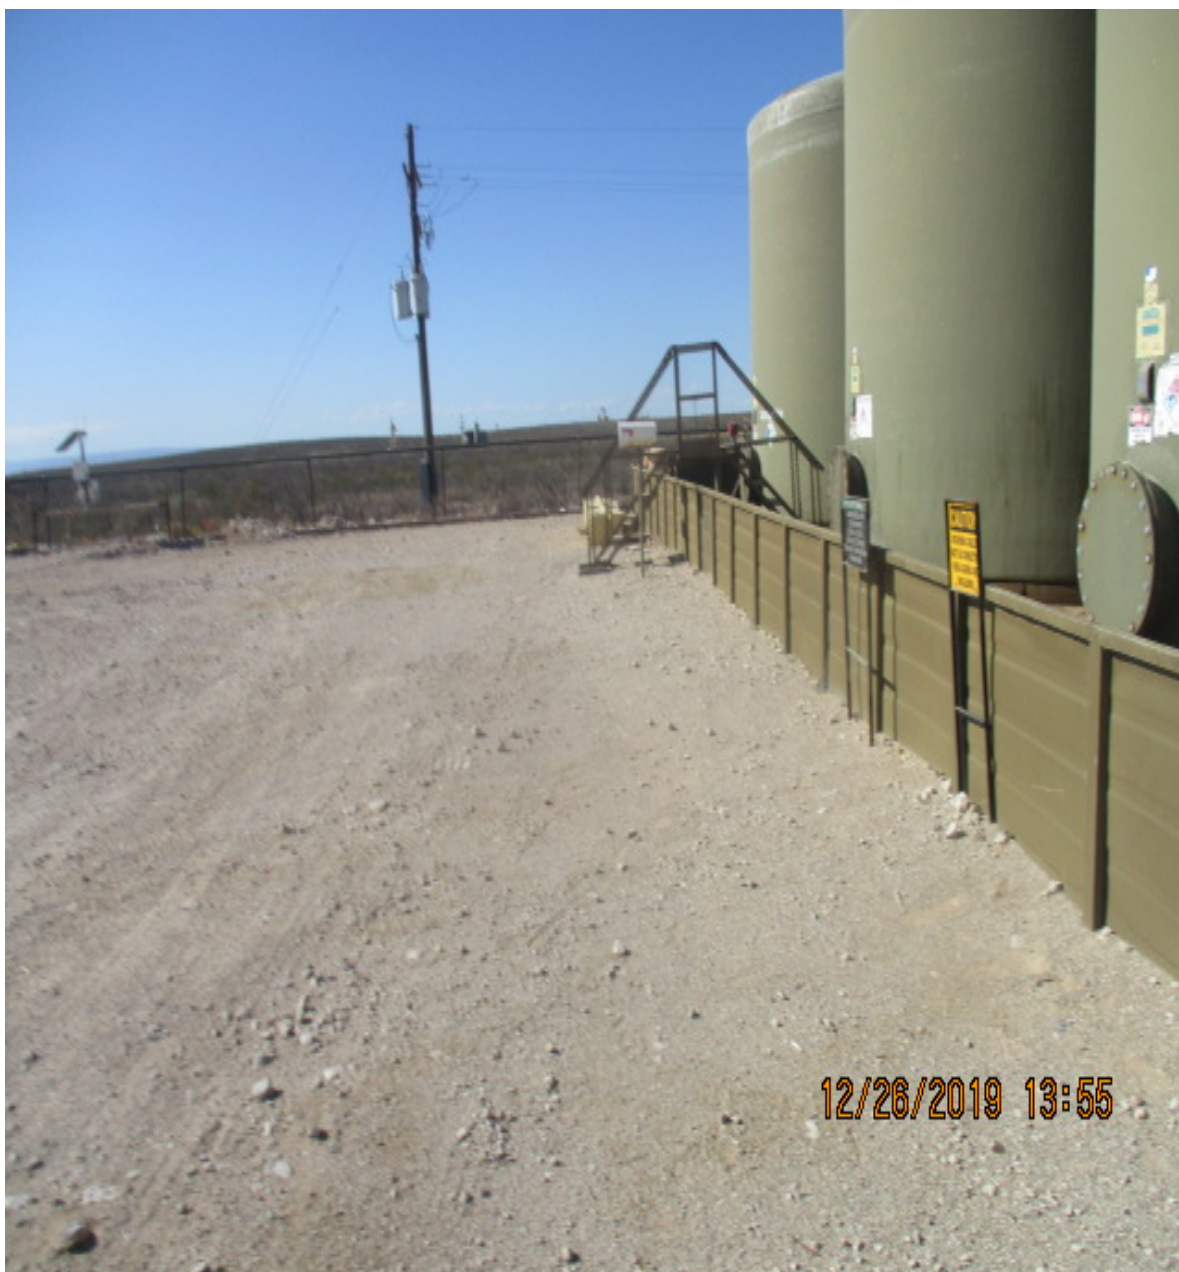
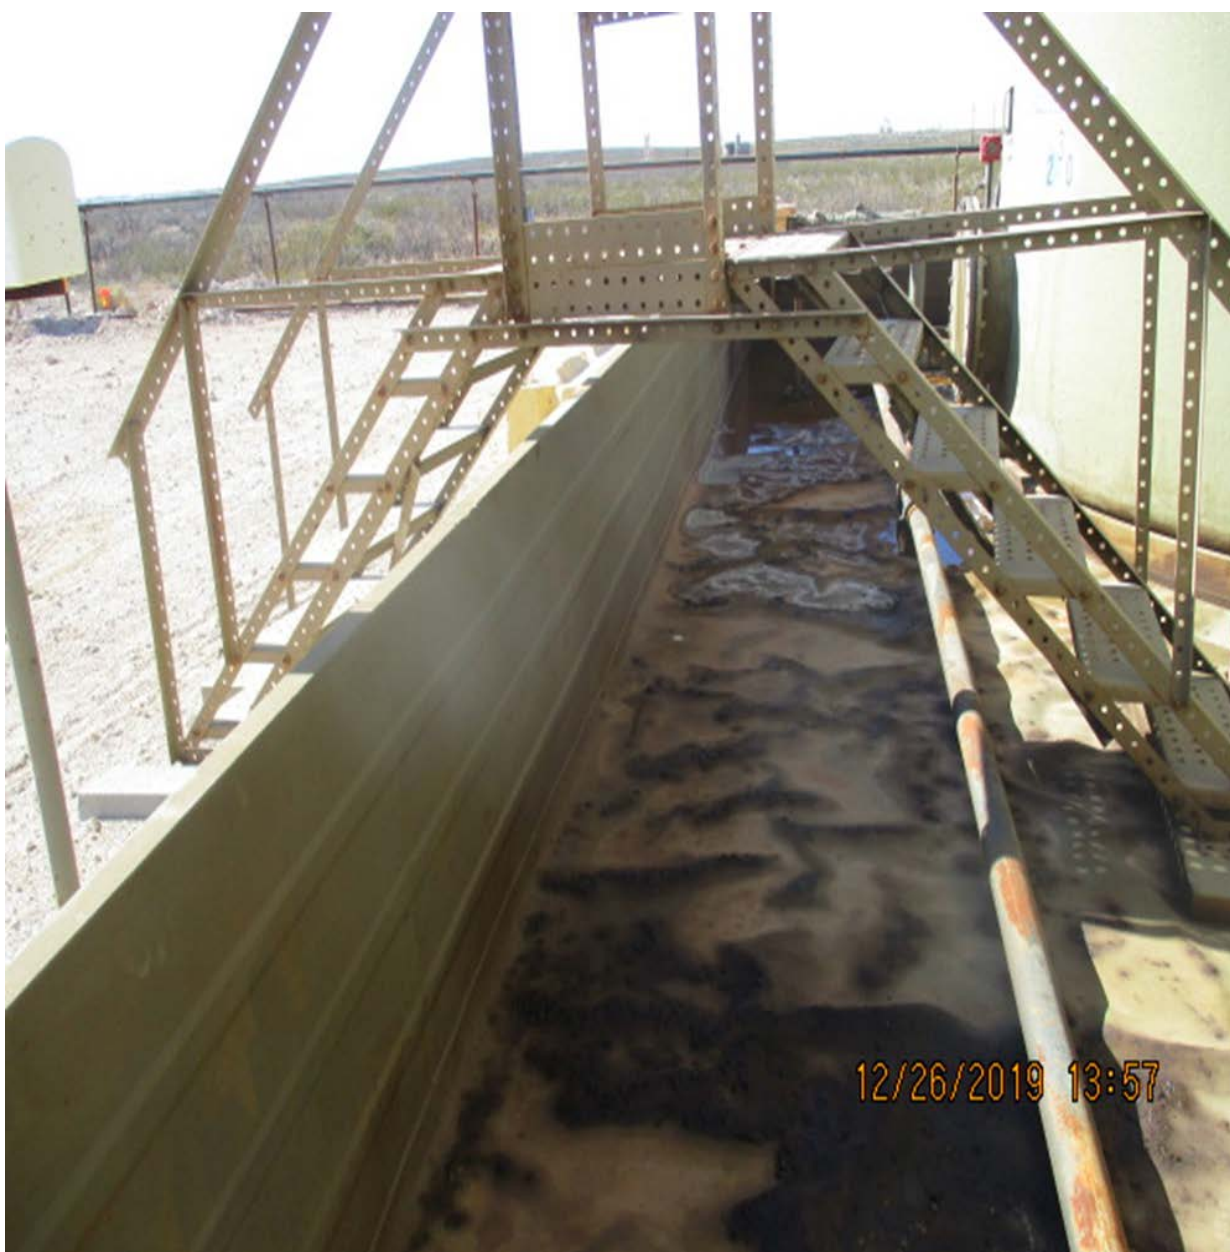
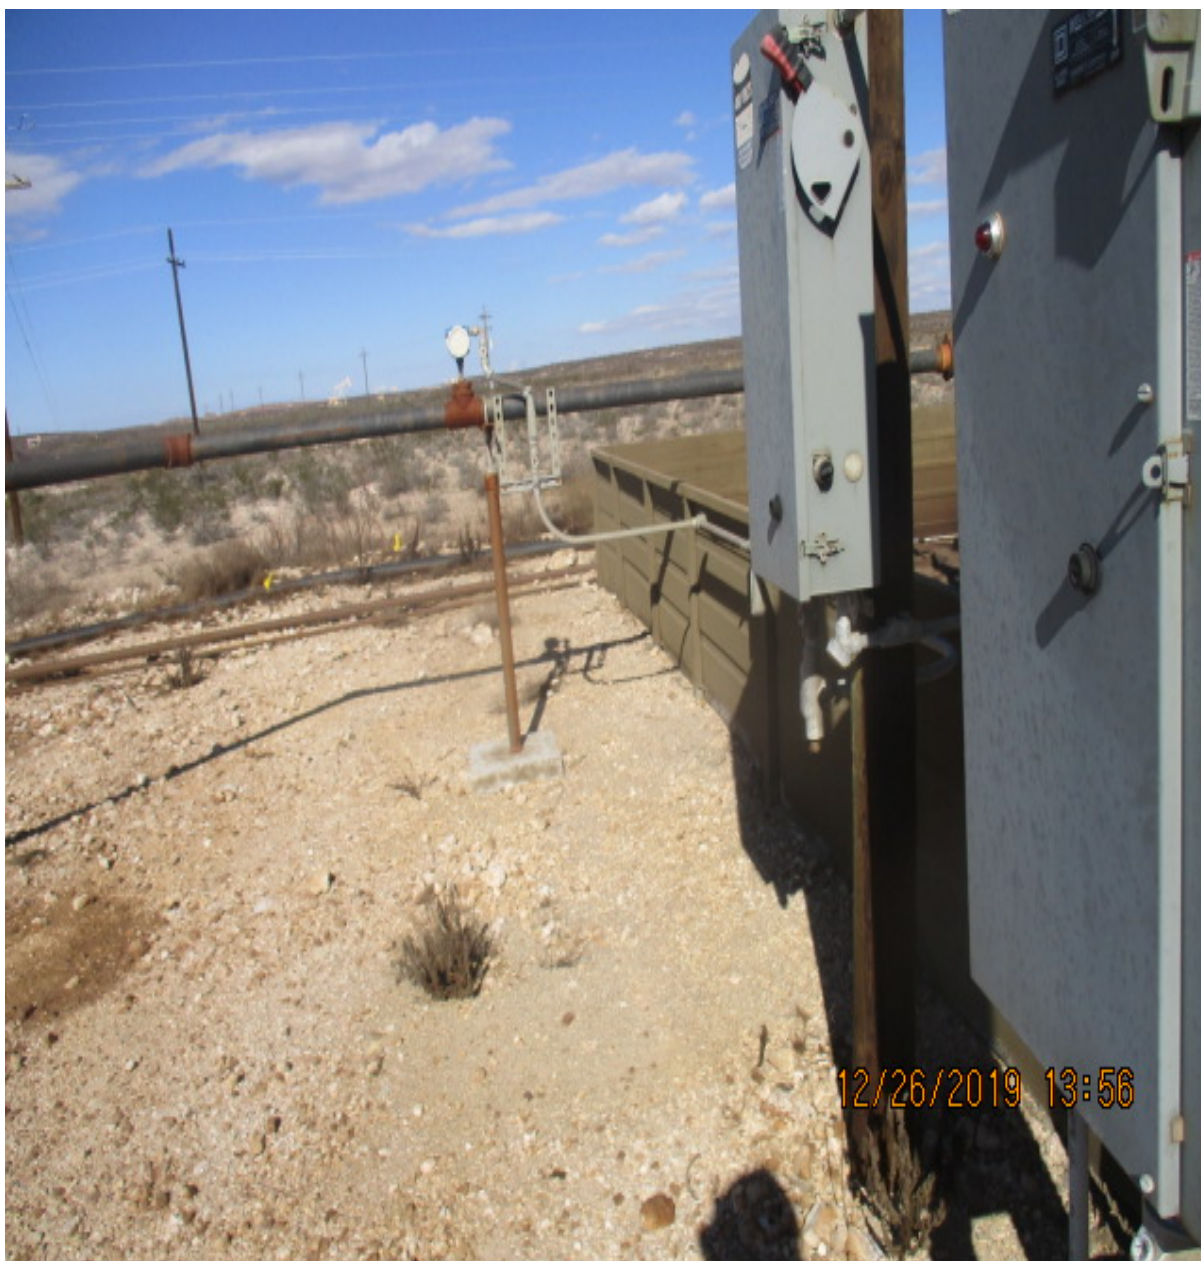
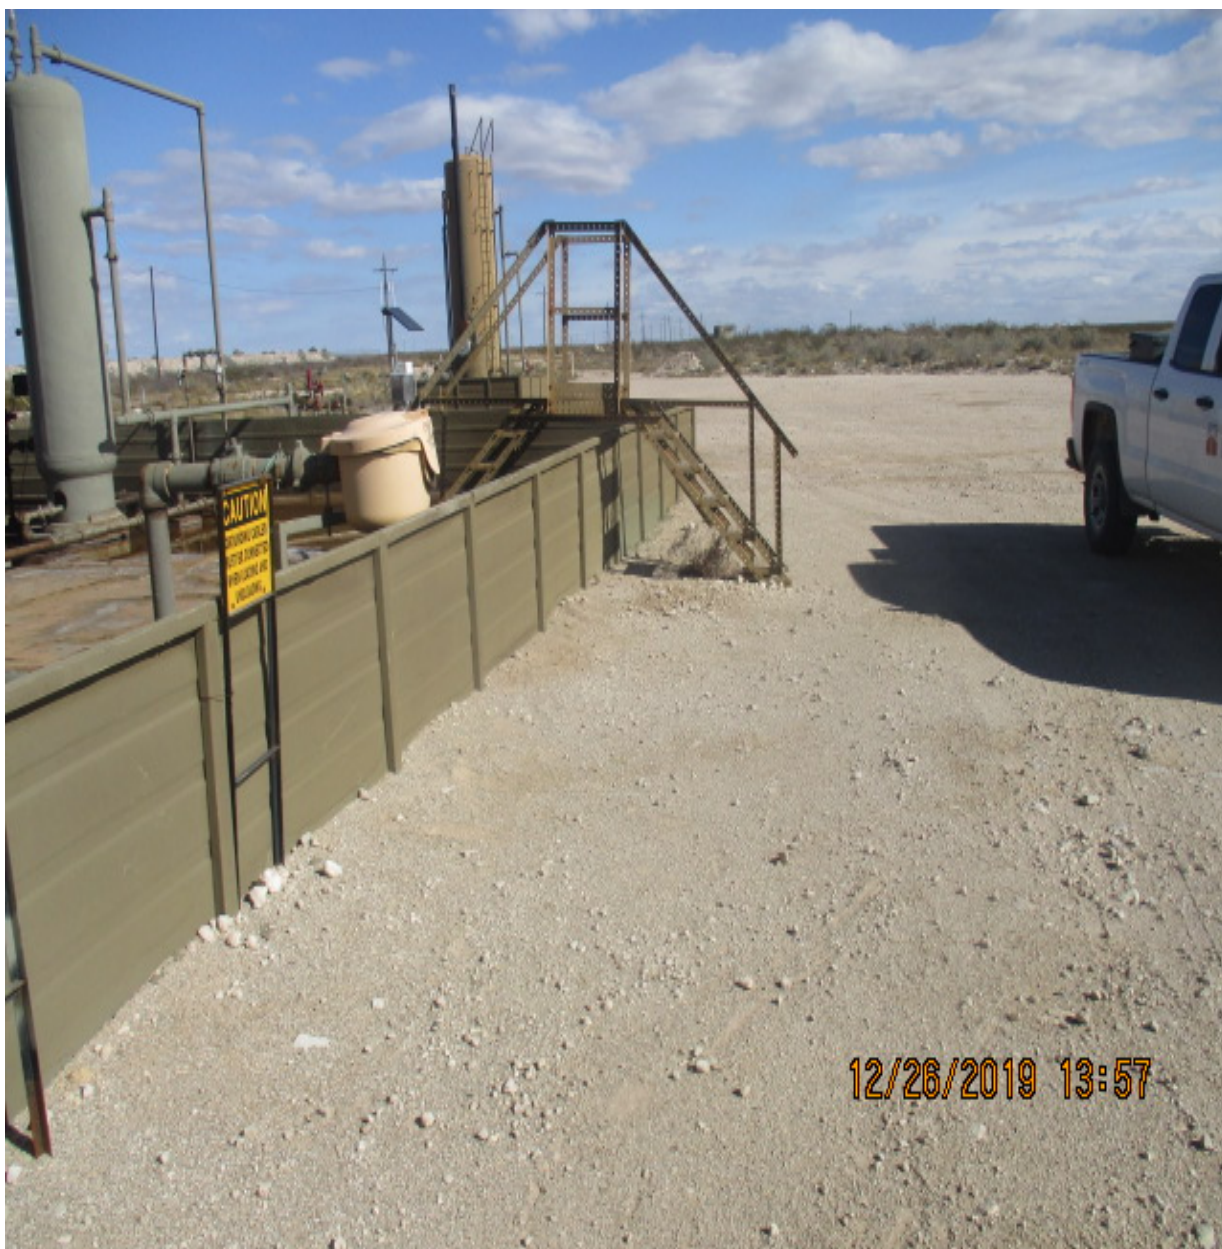
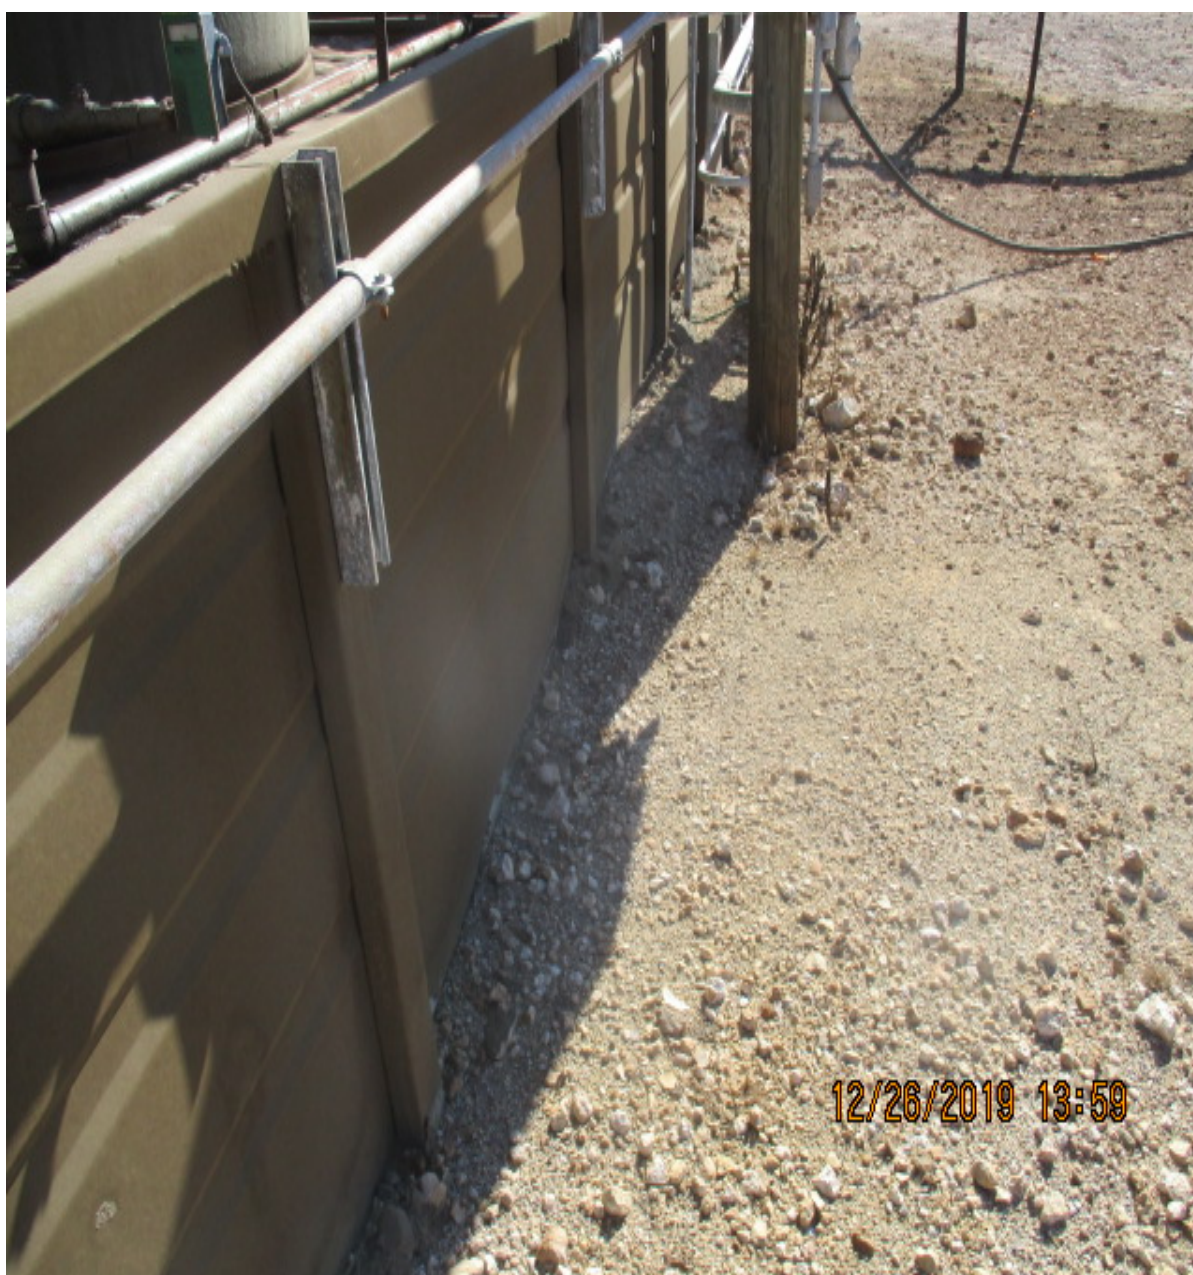
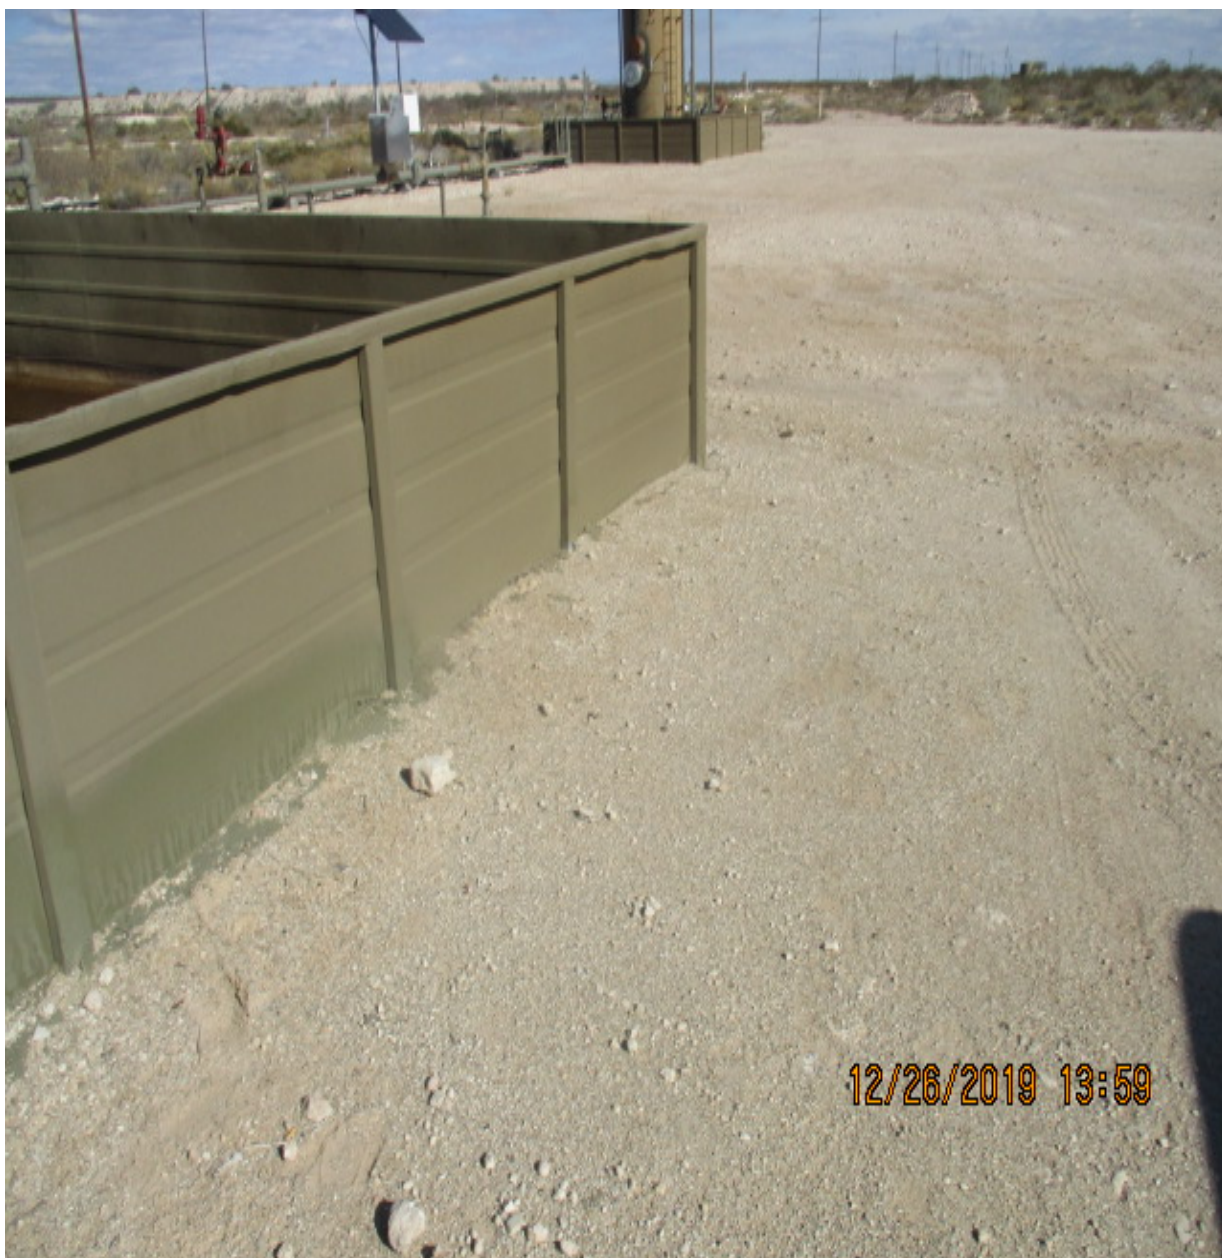
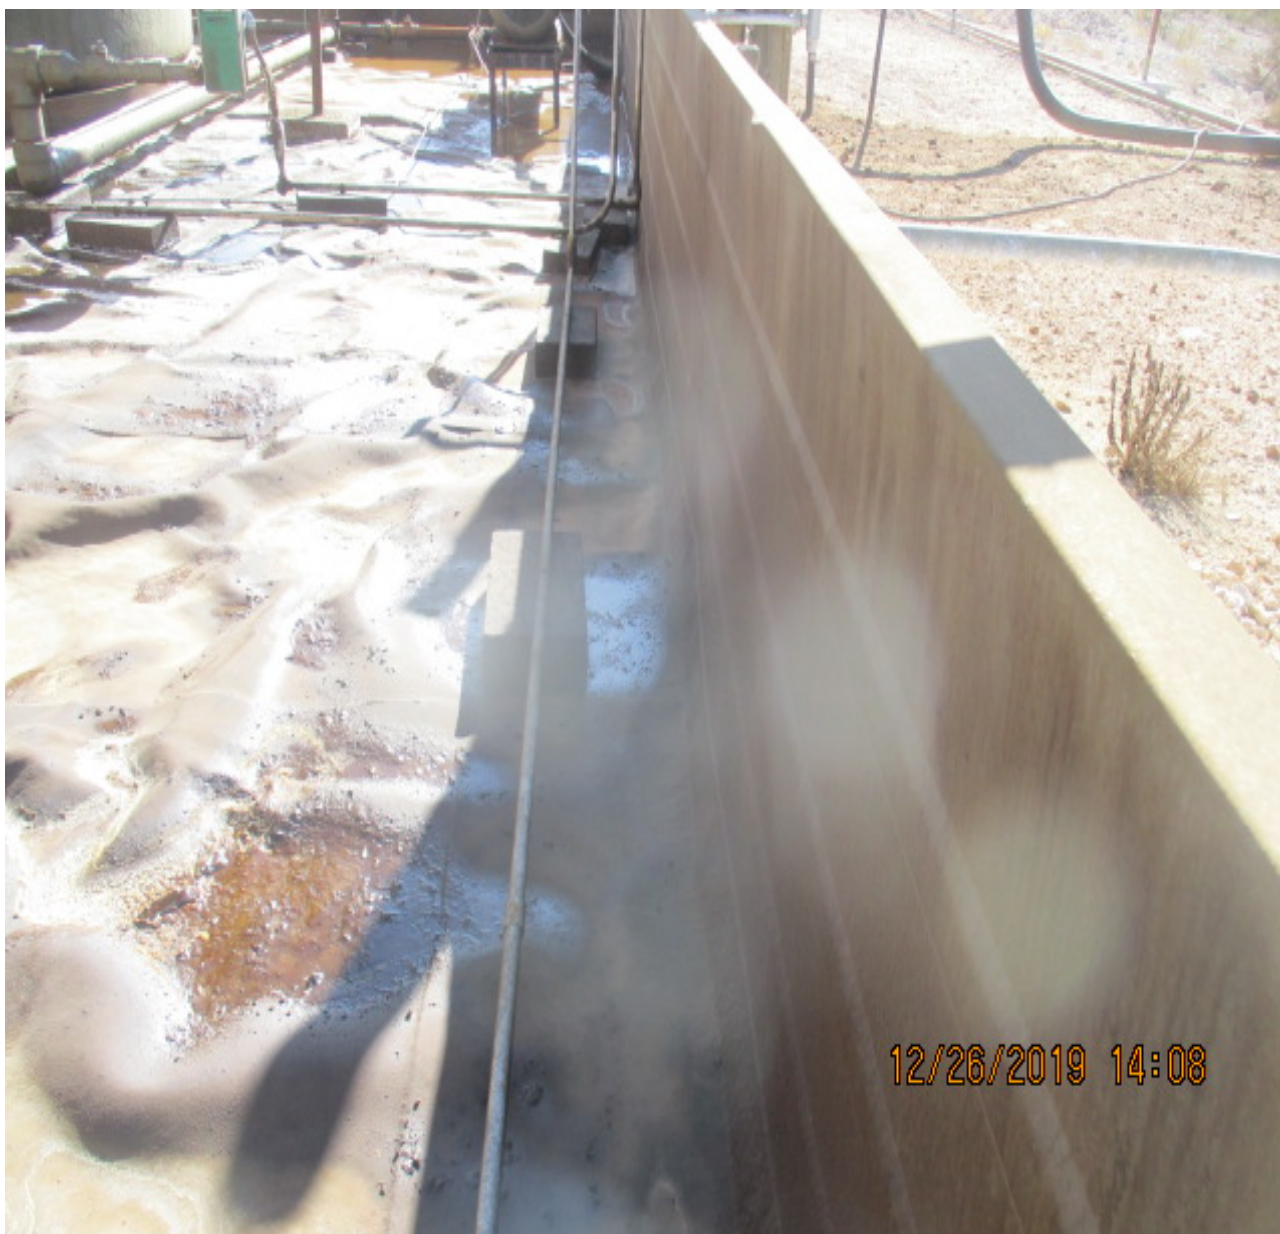
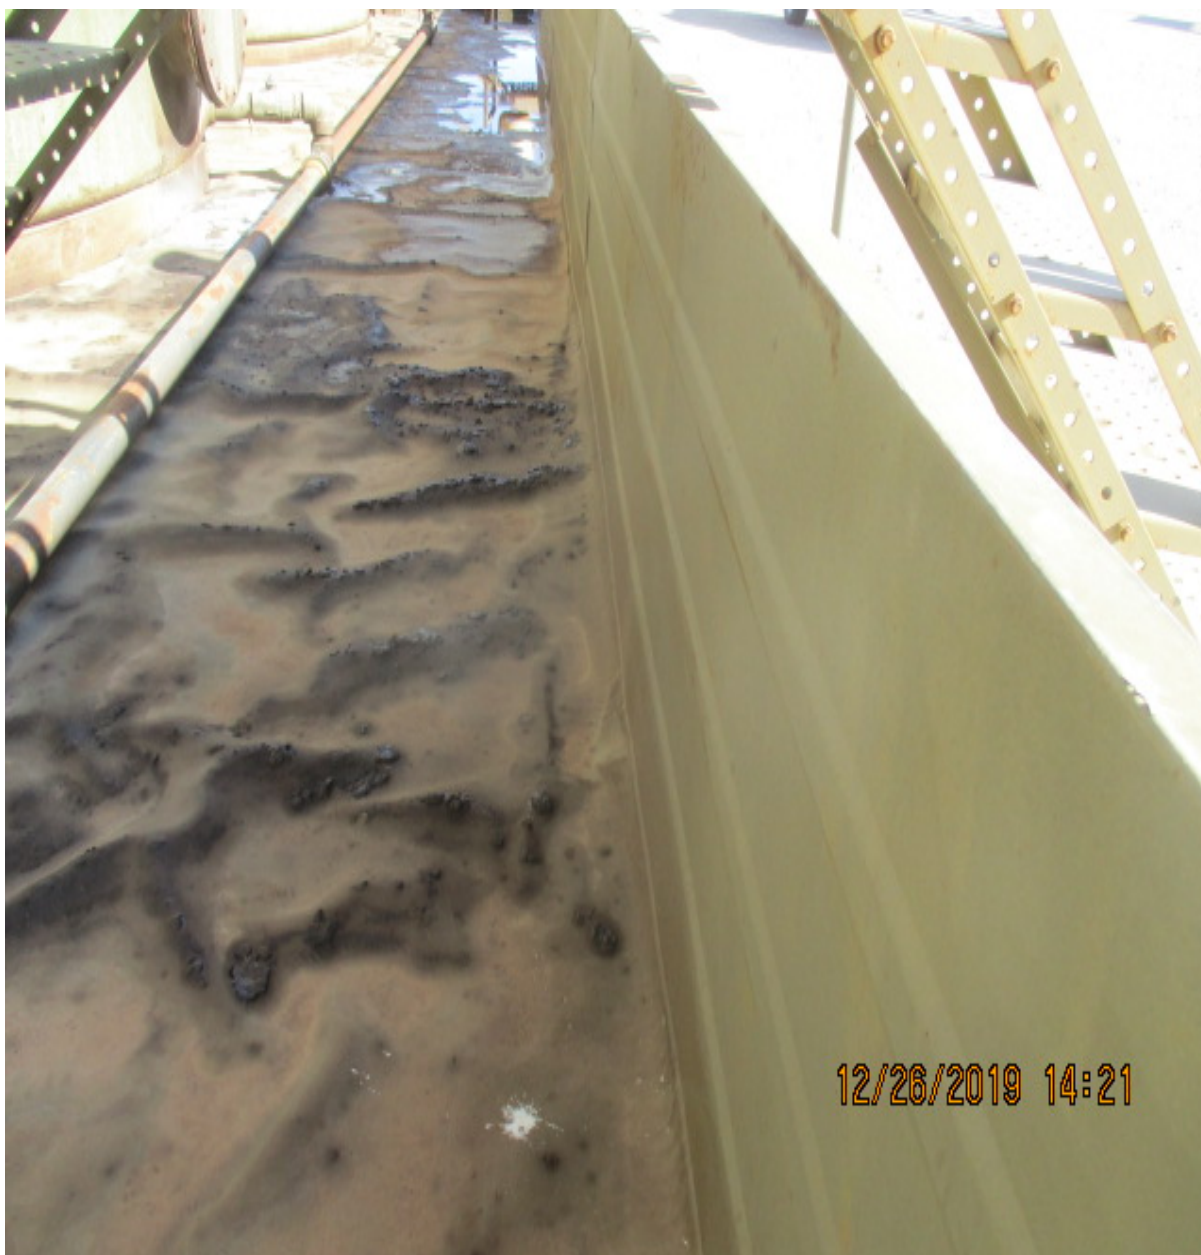
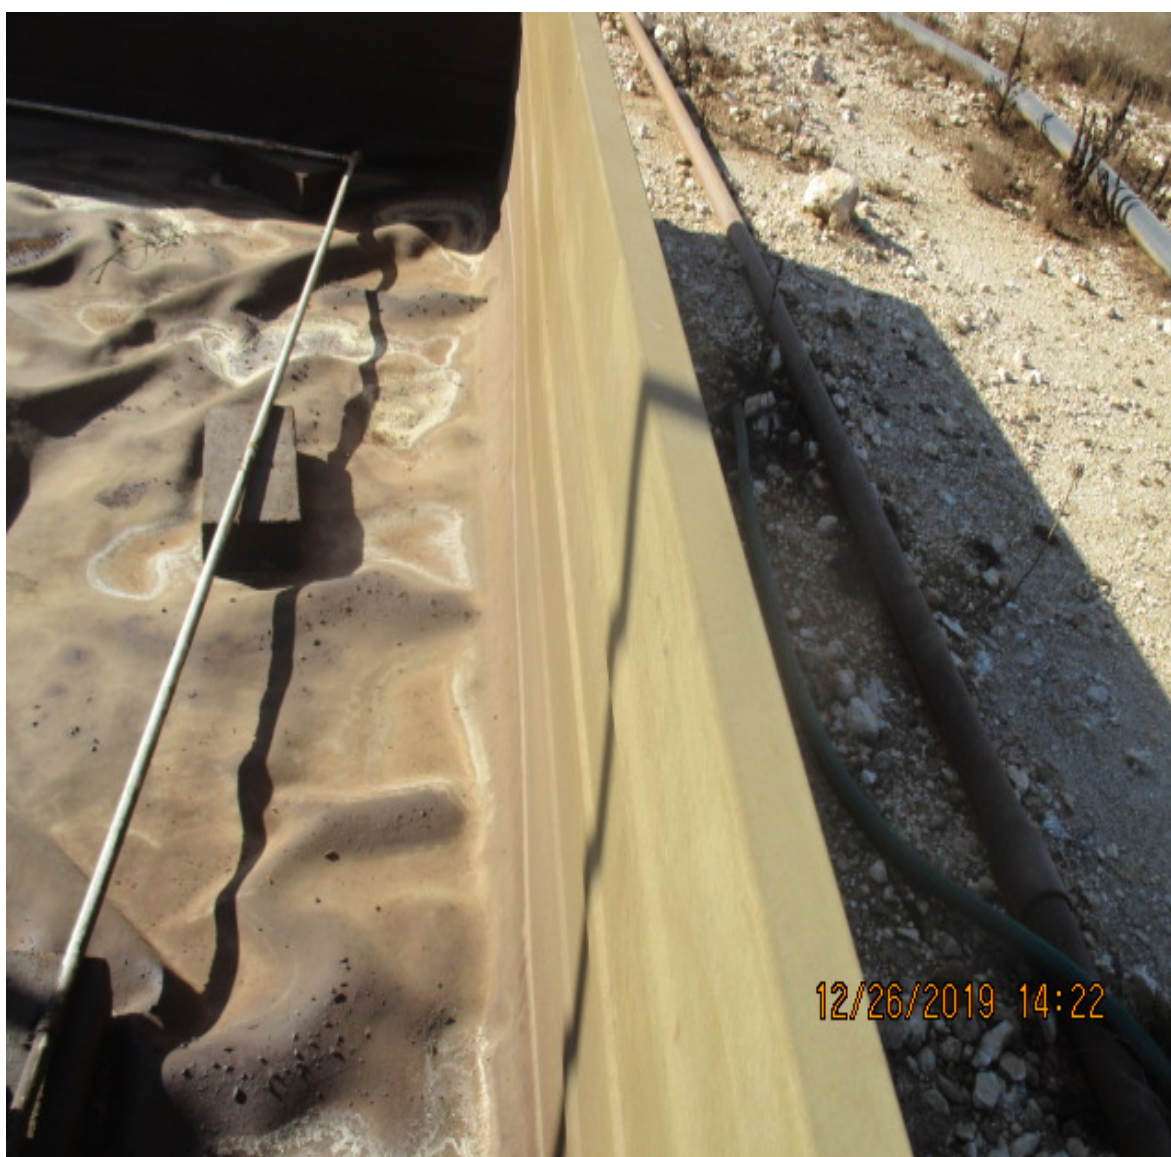
Following remediation of the impacted area from the unrelated release, HRL conducted a second liner inspection on December 26, 2019 at approximately 12:00 P.M. The steel-framed secondary containment at the Longview Federal 12 #015H production facility consists of a polyurea spray-in-liner. The liner that was investigated appeared to be in good condition and fully intact with no tears, cracks, or signs of damage. No structural deficiencies were identified throughout the containment foundation. Visual staining was not present on the well pad surface surrounding the secondary containment. Therefore, the integrity of the containment was not compromised by the release that occurred on August 16, 2019.

On December 26, 2019 following remediation of the unrelated release HRL conducted a second liner inspection. The liner was found to be fully intact and in good condition showing no visible signs of damage or deterioration. The liner requirements outlined in Subsection A of 19.15.29.12 NMAC were fully met. HRL recommends that Incident 2RP-5633 be closed.
