Remediation Summary Closure Request

Date of request: 07/27/2020
Site Name: Willow 17 ST SWD
Terracon Project No: AR207122
Site GPS: Latitude 32.12439°
Longitude -104.10300°

Solaris Midstream ■ Willow 17 ST SWD
July 27, 2020 ■ AR207122

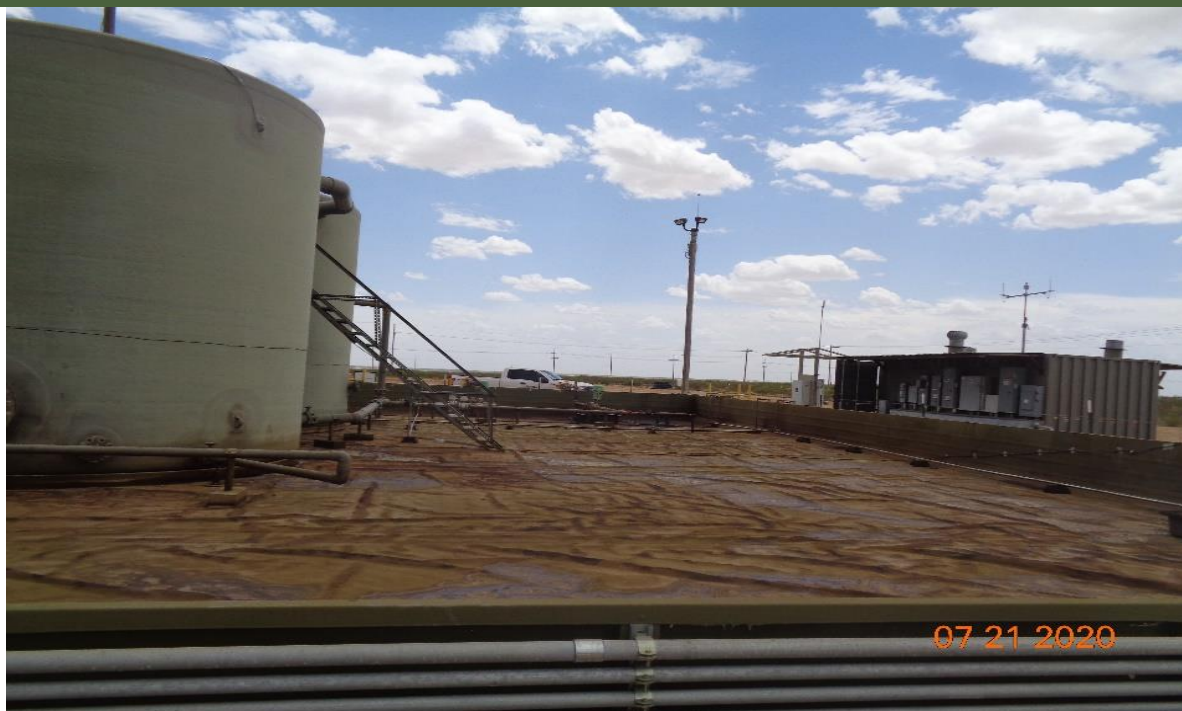
PHOTO 1: Typical view of the interior of the berm at the site. 7/21/2020

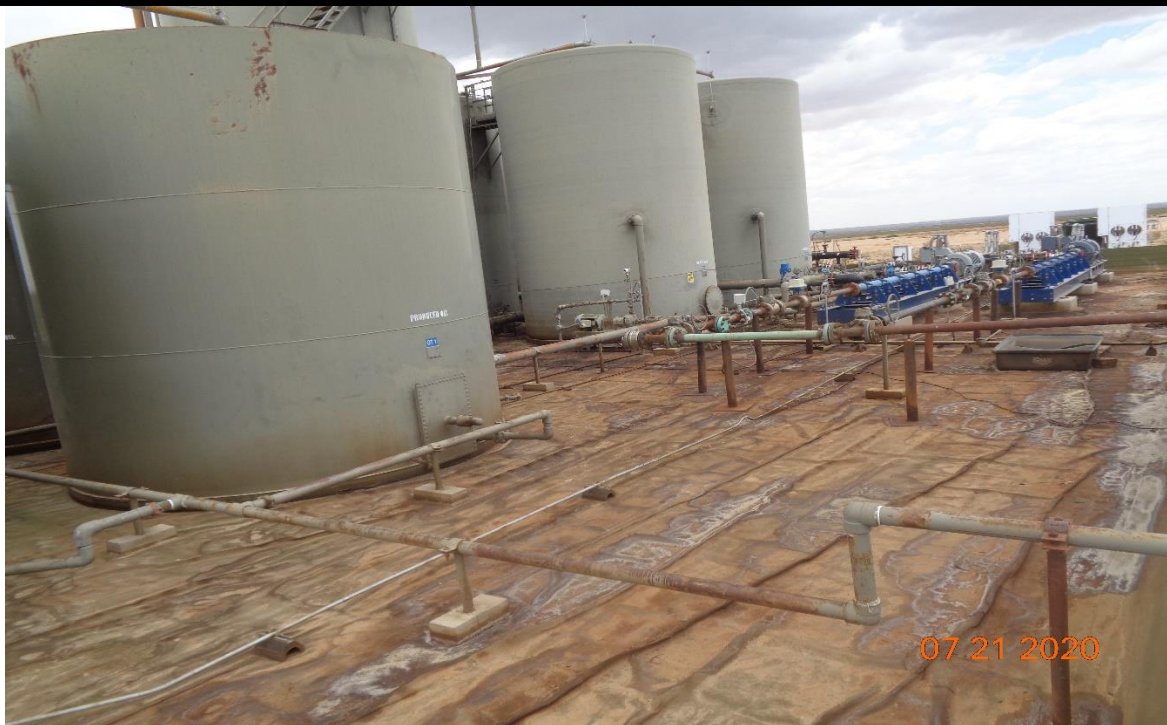
PHOTO 2: Typical view of the interior of the berm at the site. 7/21/2020
