**RE: LINER INSPECTION REPORT  
THISTLE UNIT 109H**

Souder, Miller & Associates (SMA) is pleased to submit this letter report on behalf of Devon Energy Production Company (Devon) summarizing the liner inspection that occurred at the Thistle Unit 22 BS Central Tank Battery (CTB) release that is associated with the Thistle Unit 109H well. The site is located in Unit Letter: B & C in Section 22, T23S, R33E (N32.295239/W-103.560141) Lea County, New Mexico, on BLM land.

Devon Energy Production Company  
Thistle Unit 109H

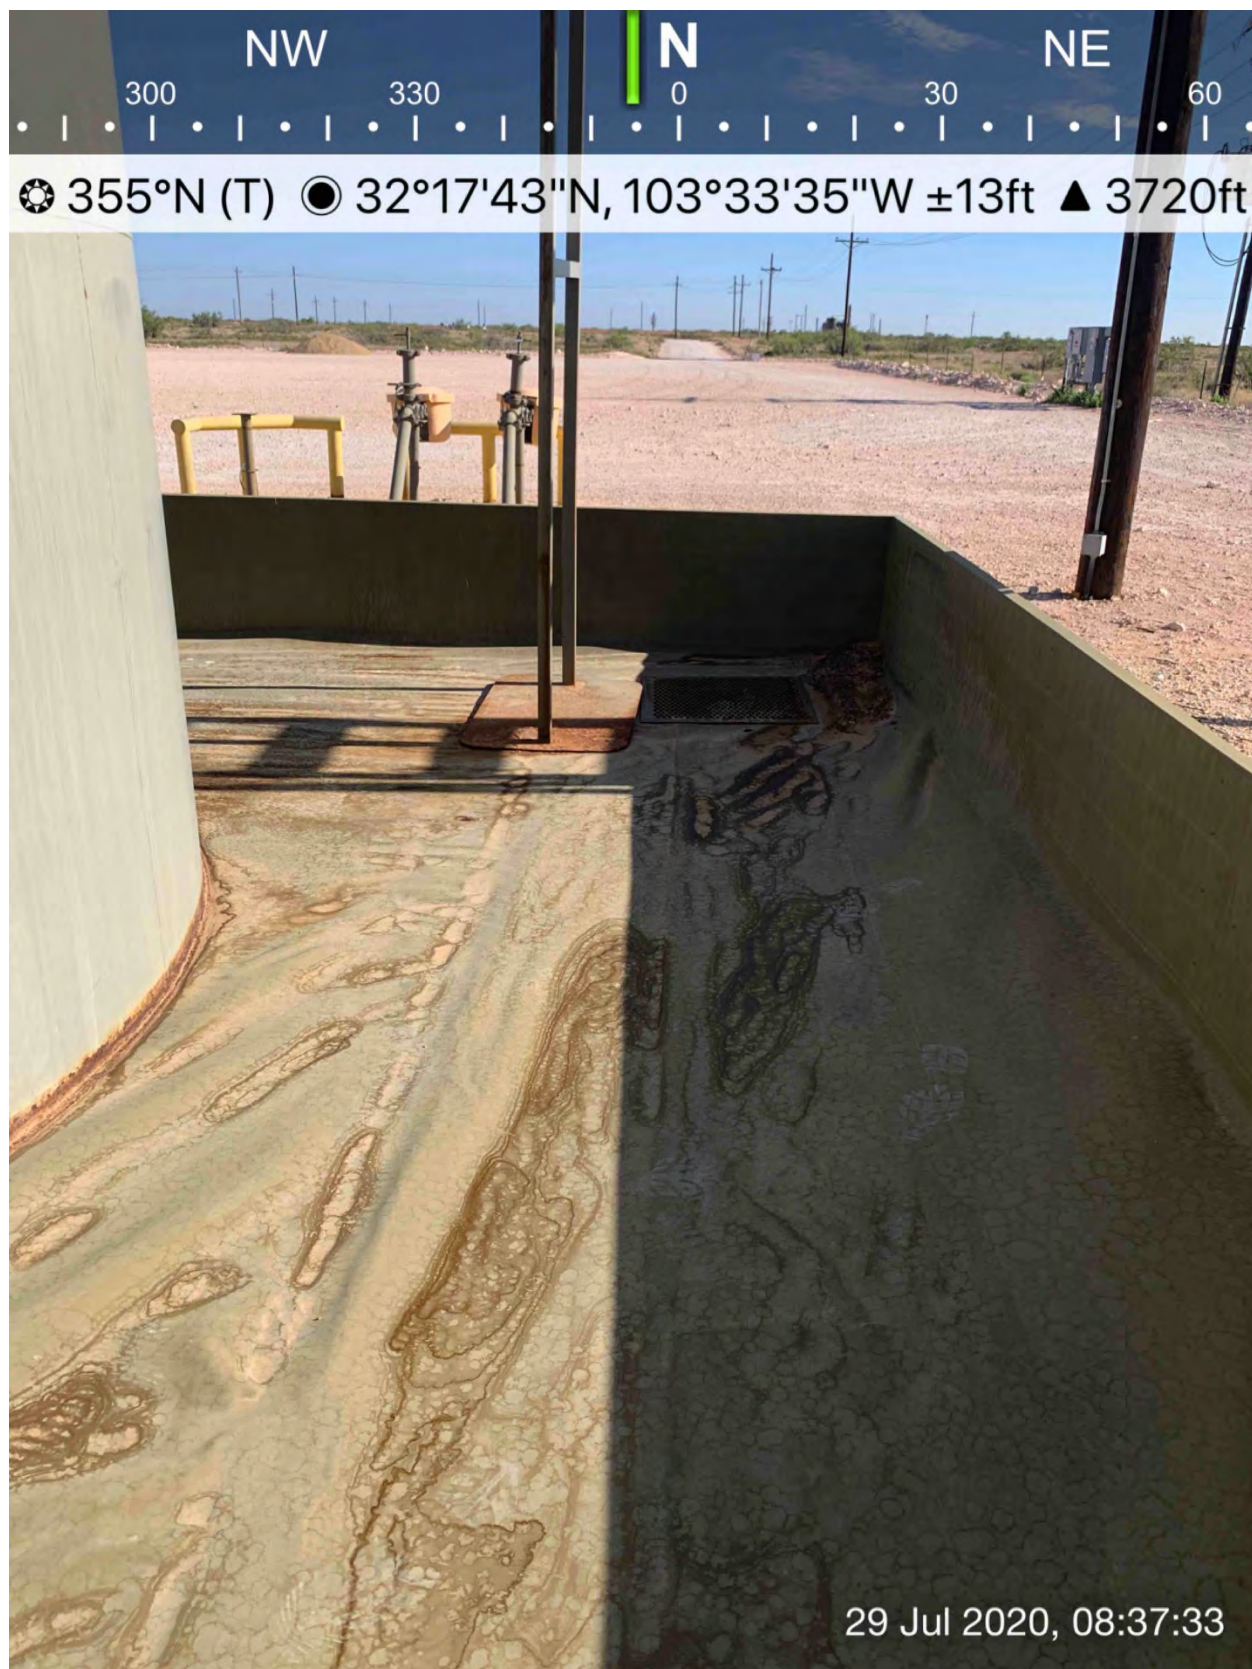
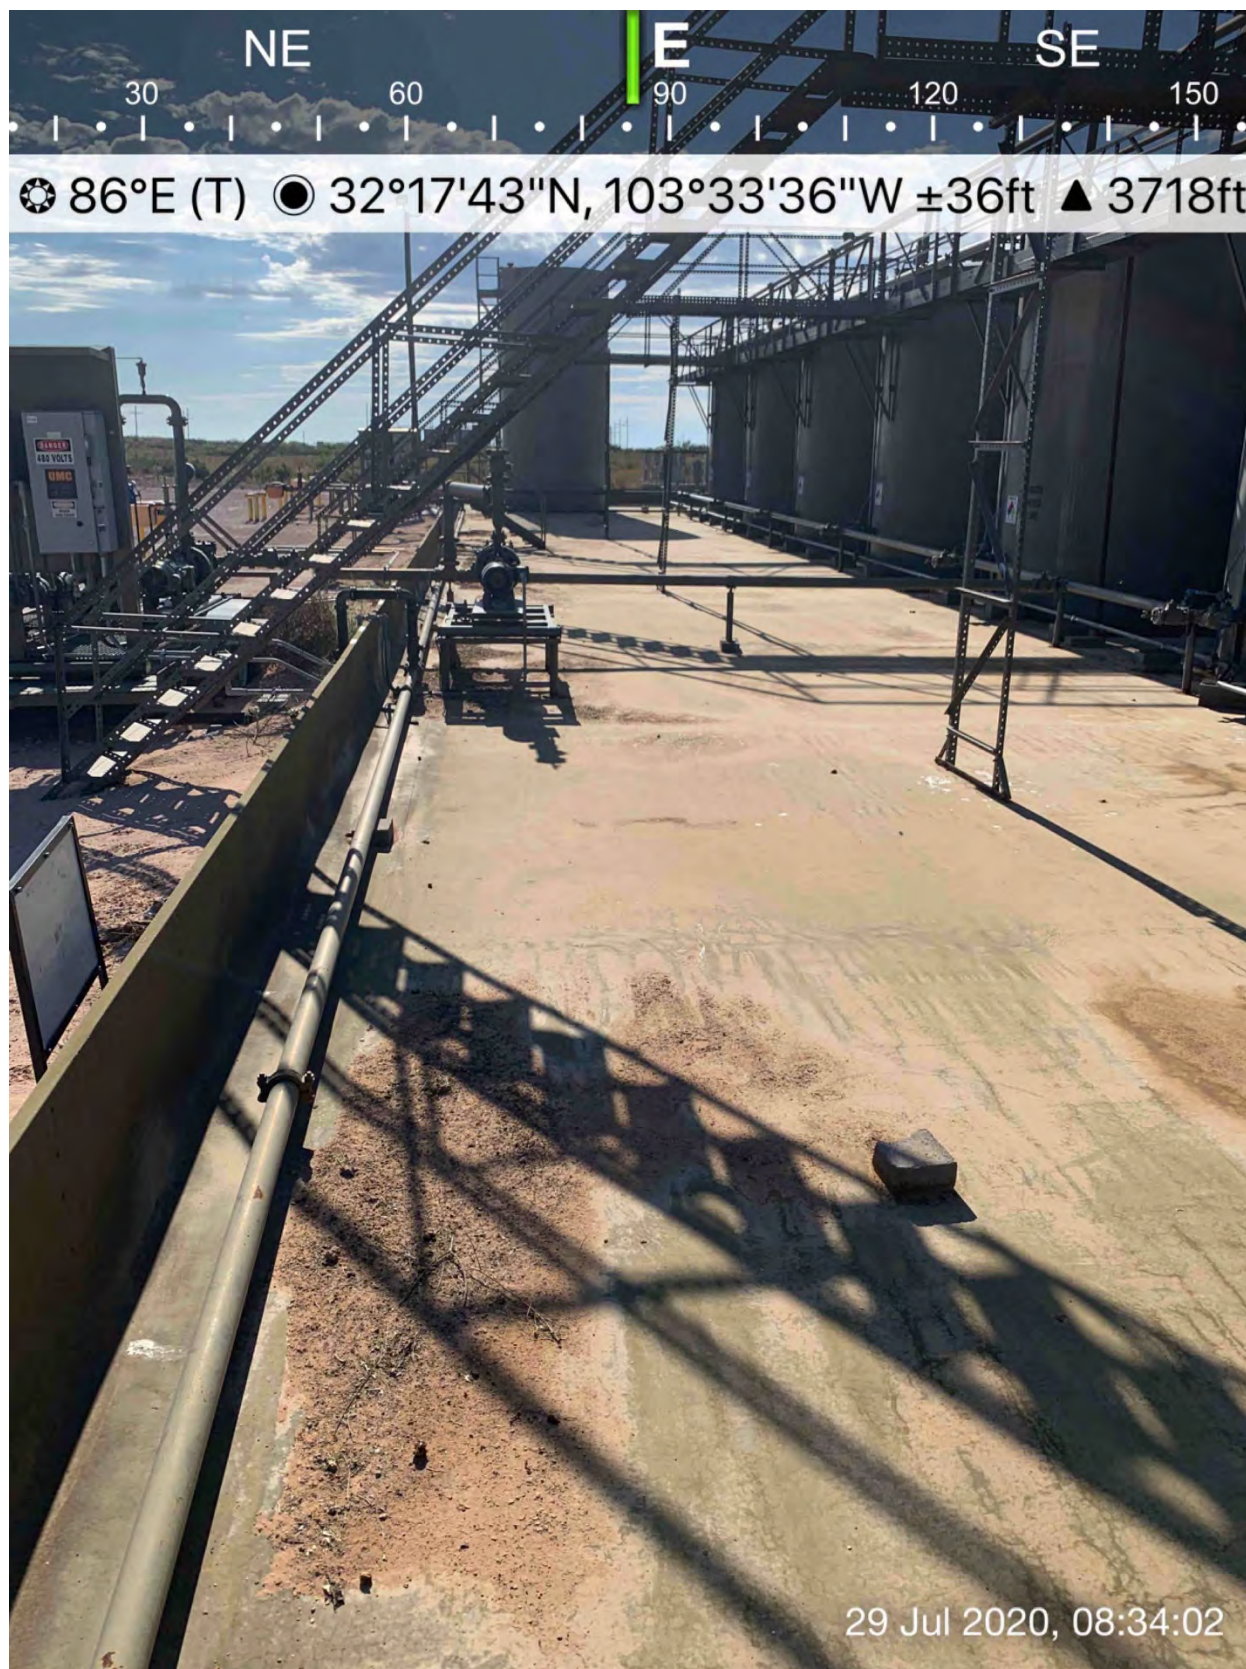
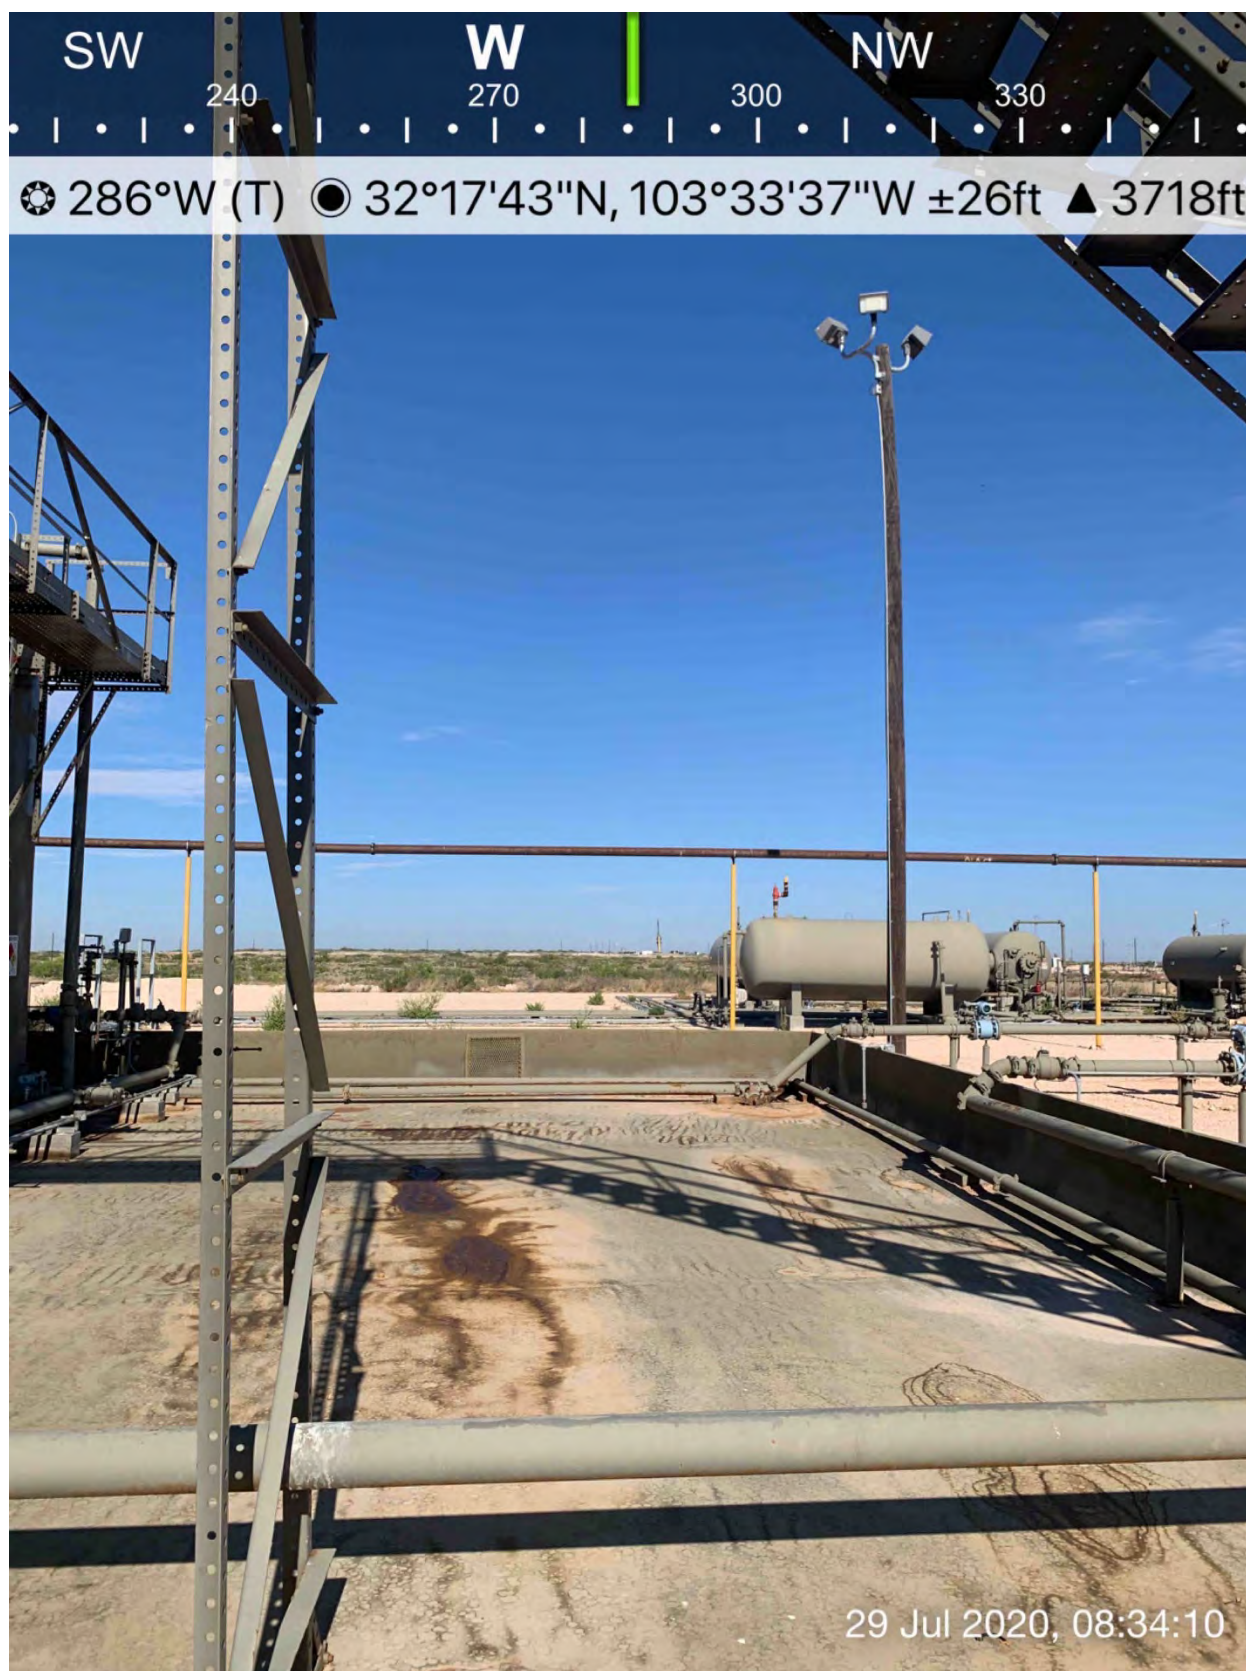
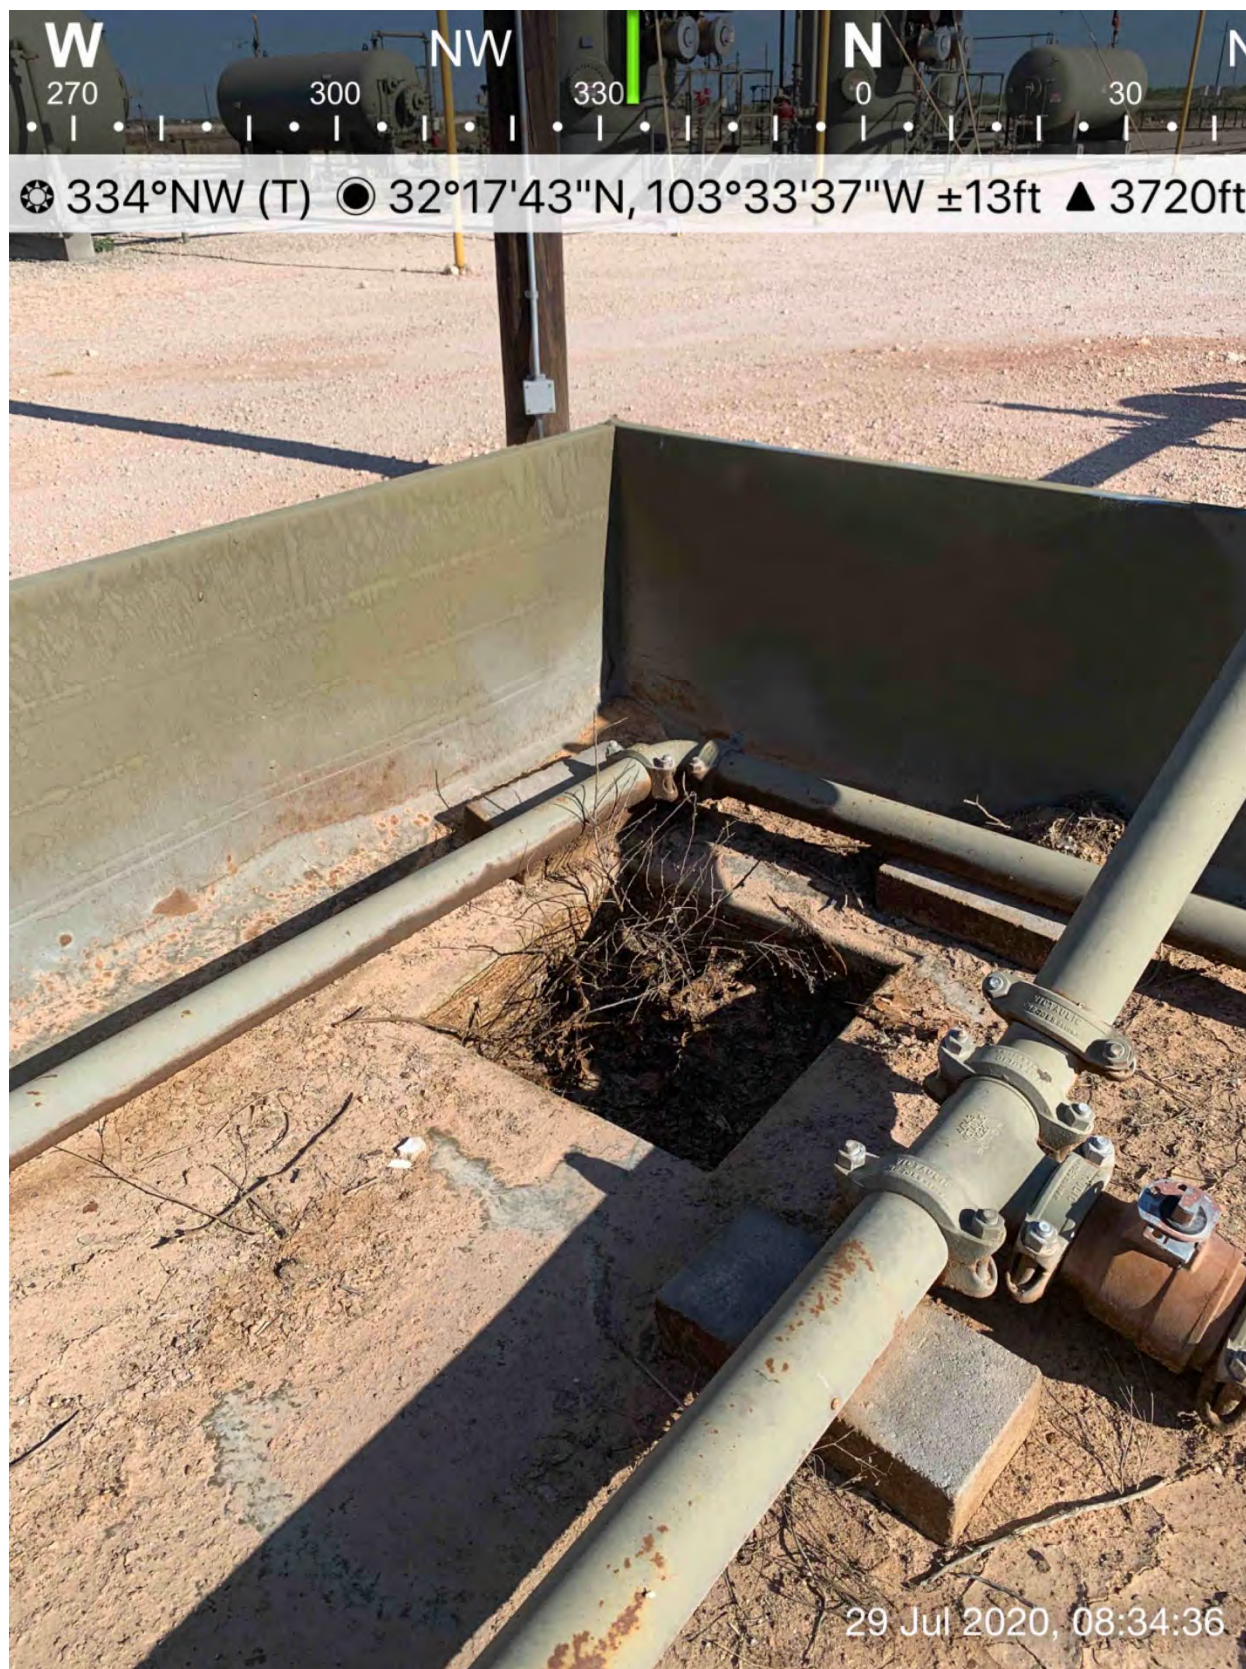
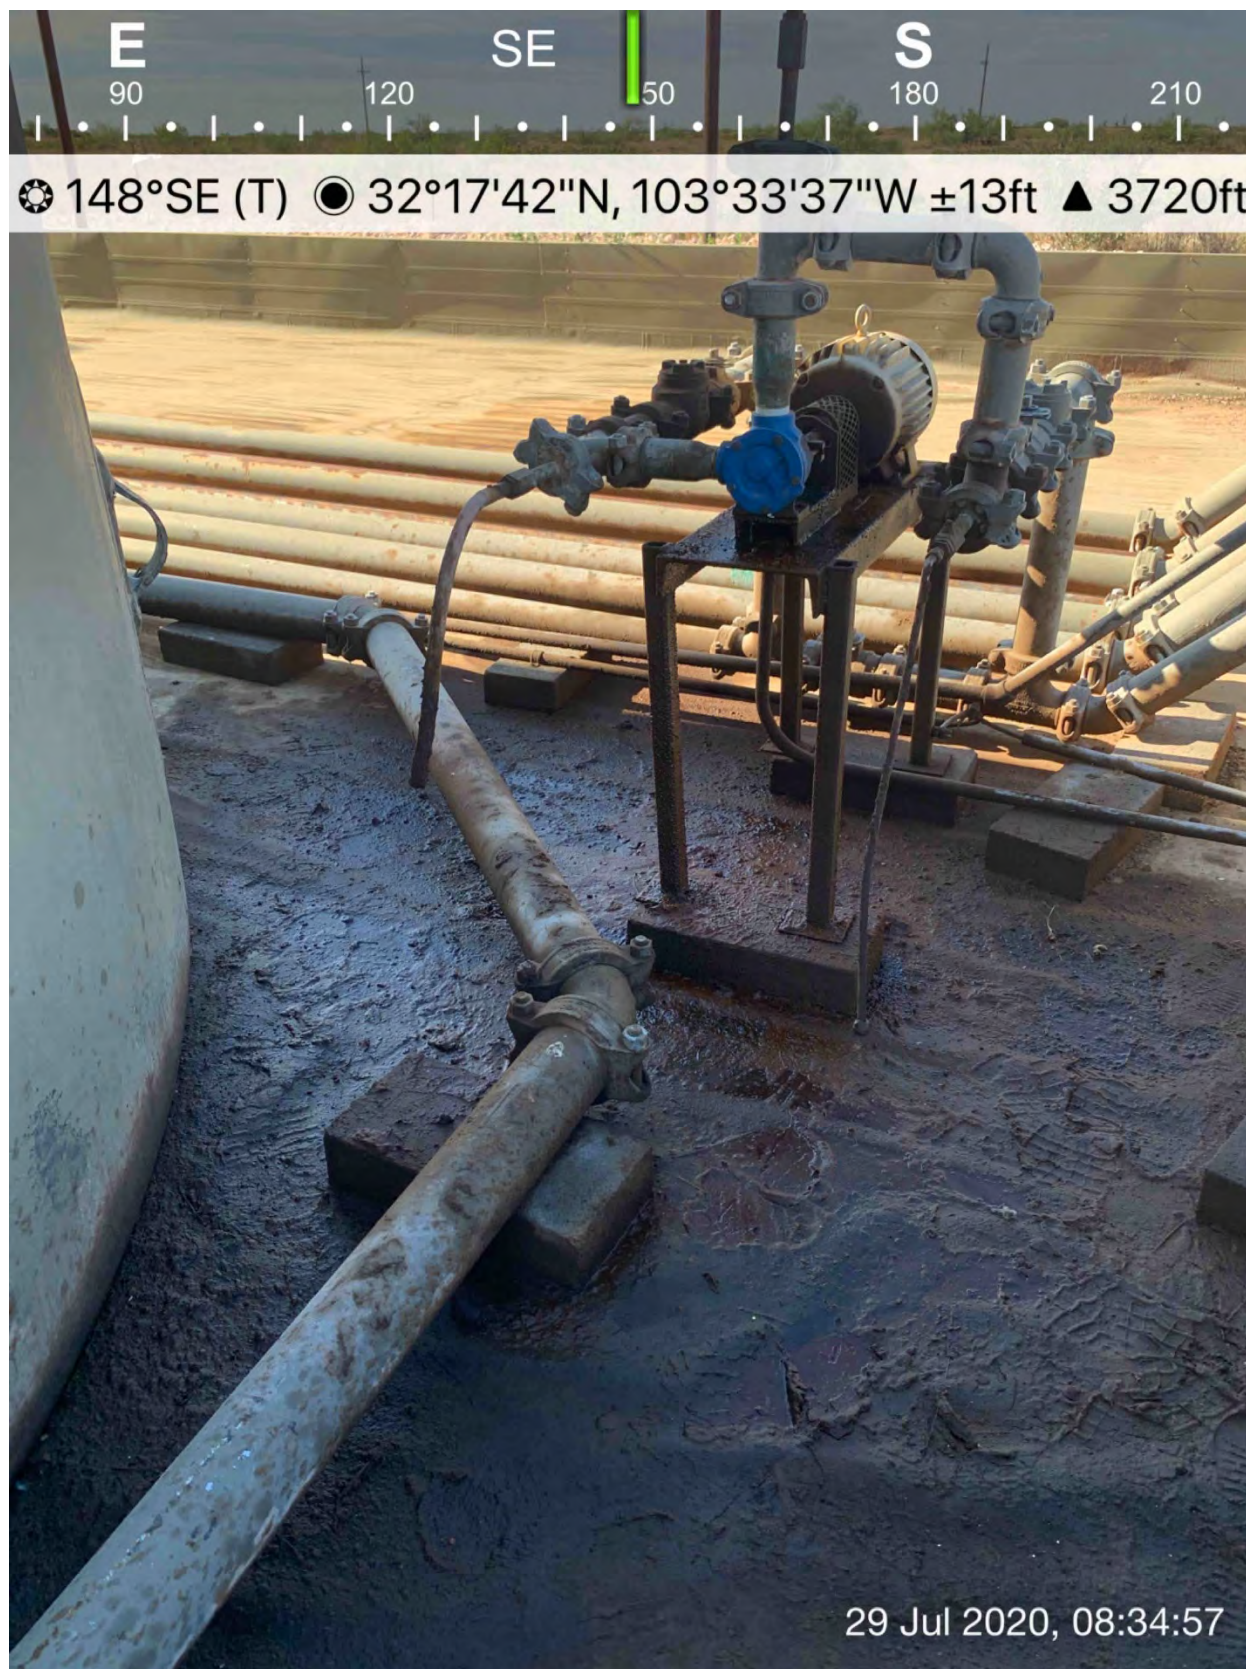
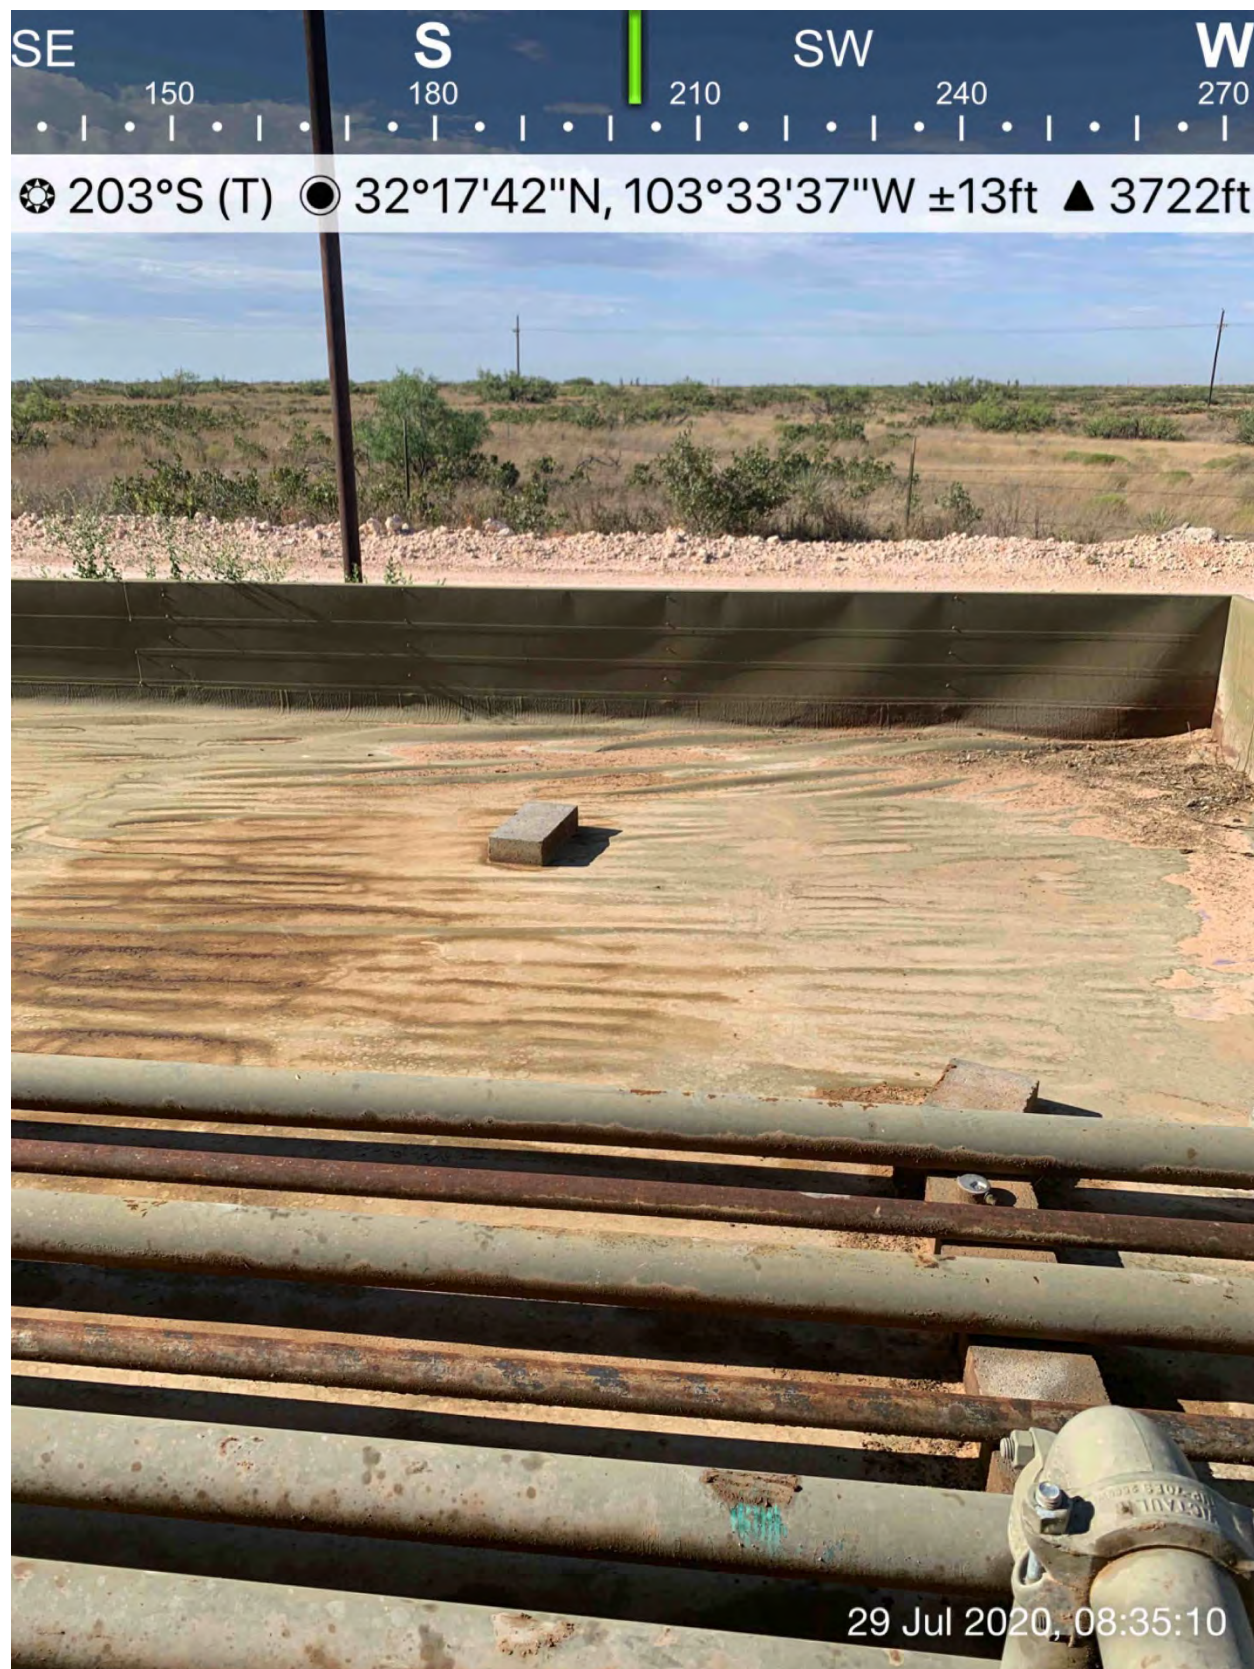
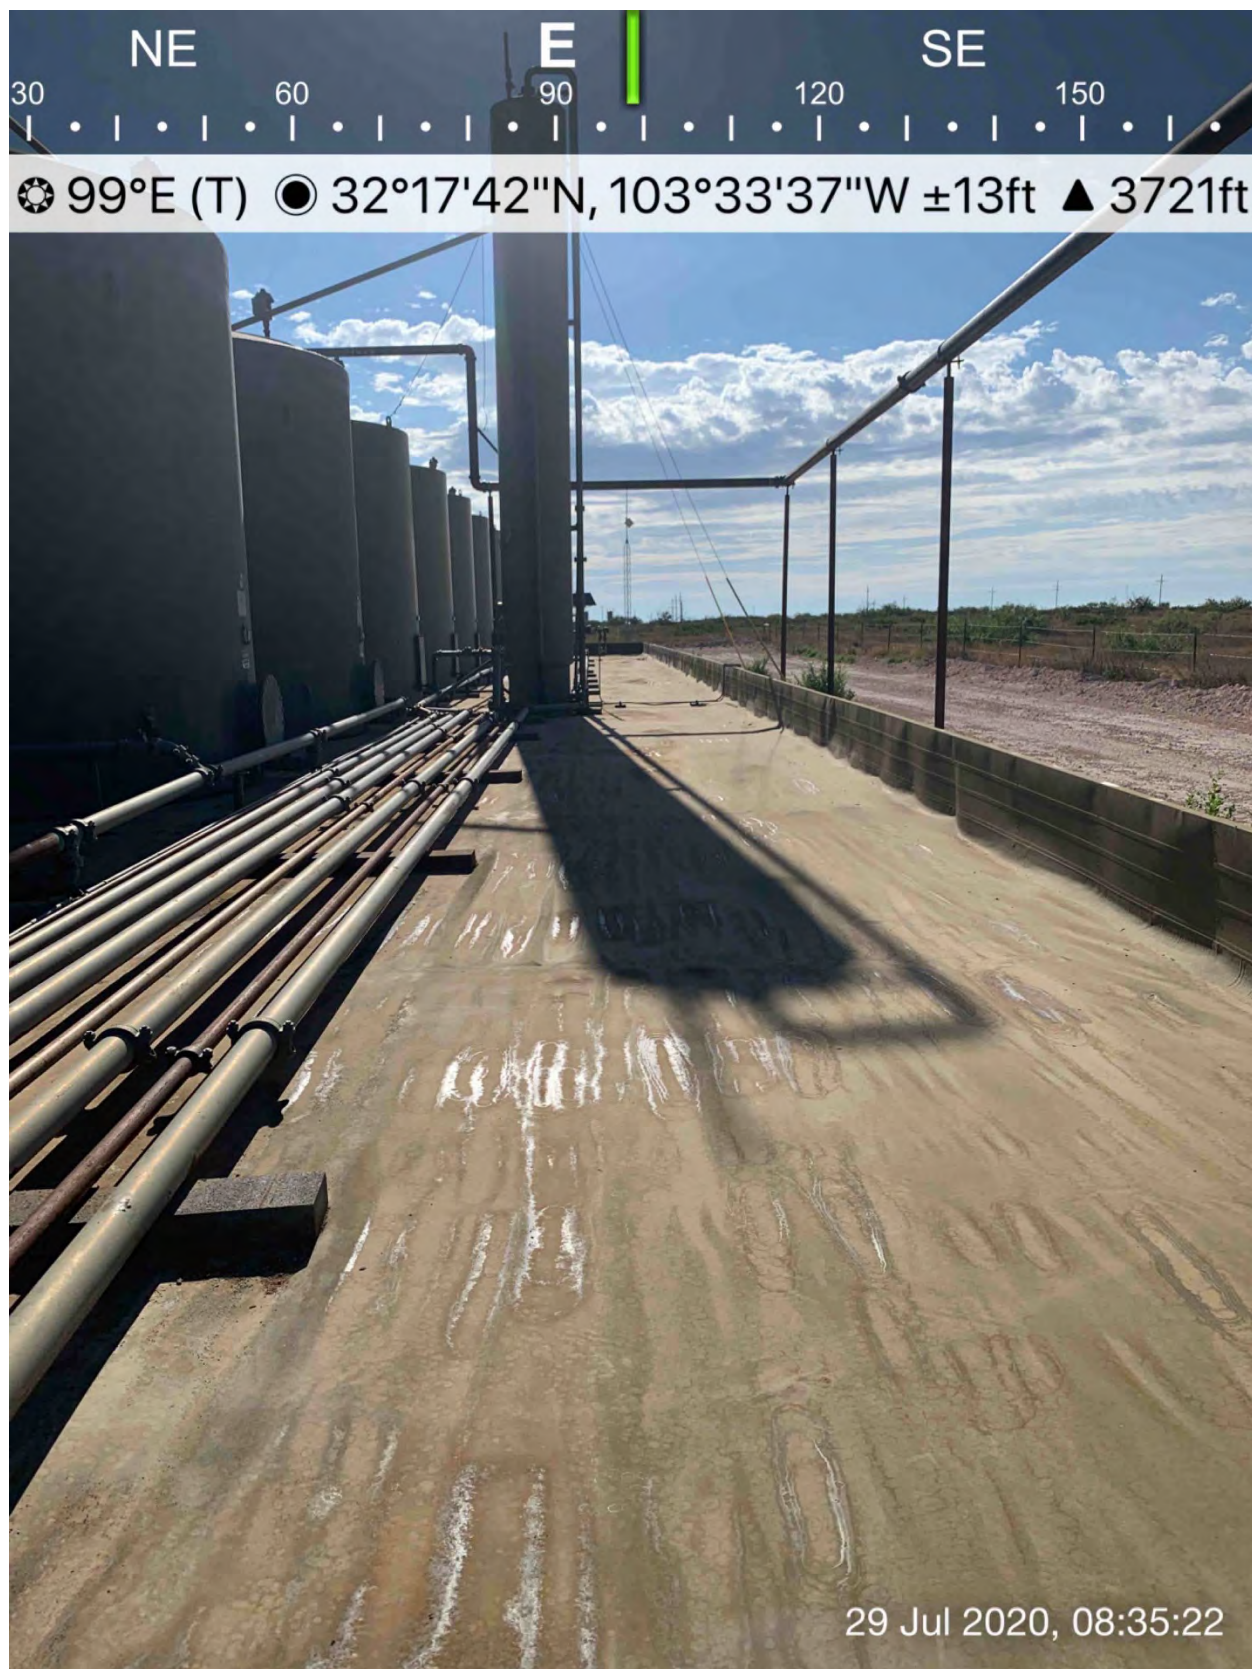
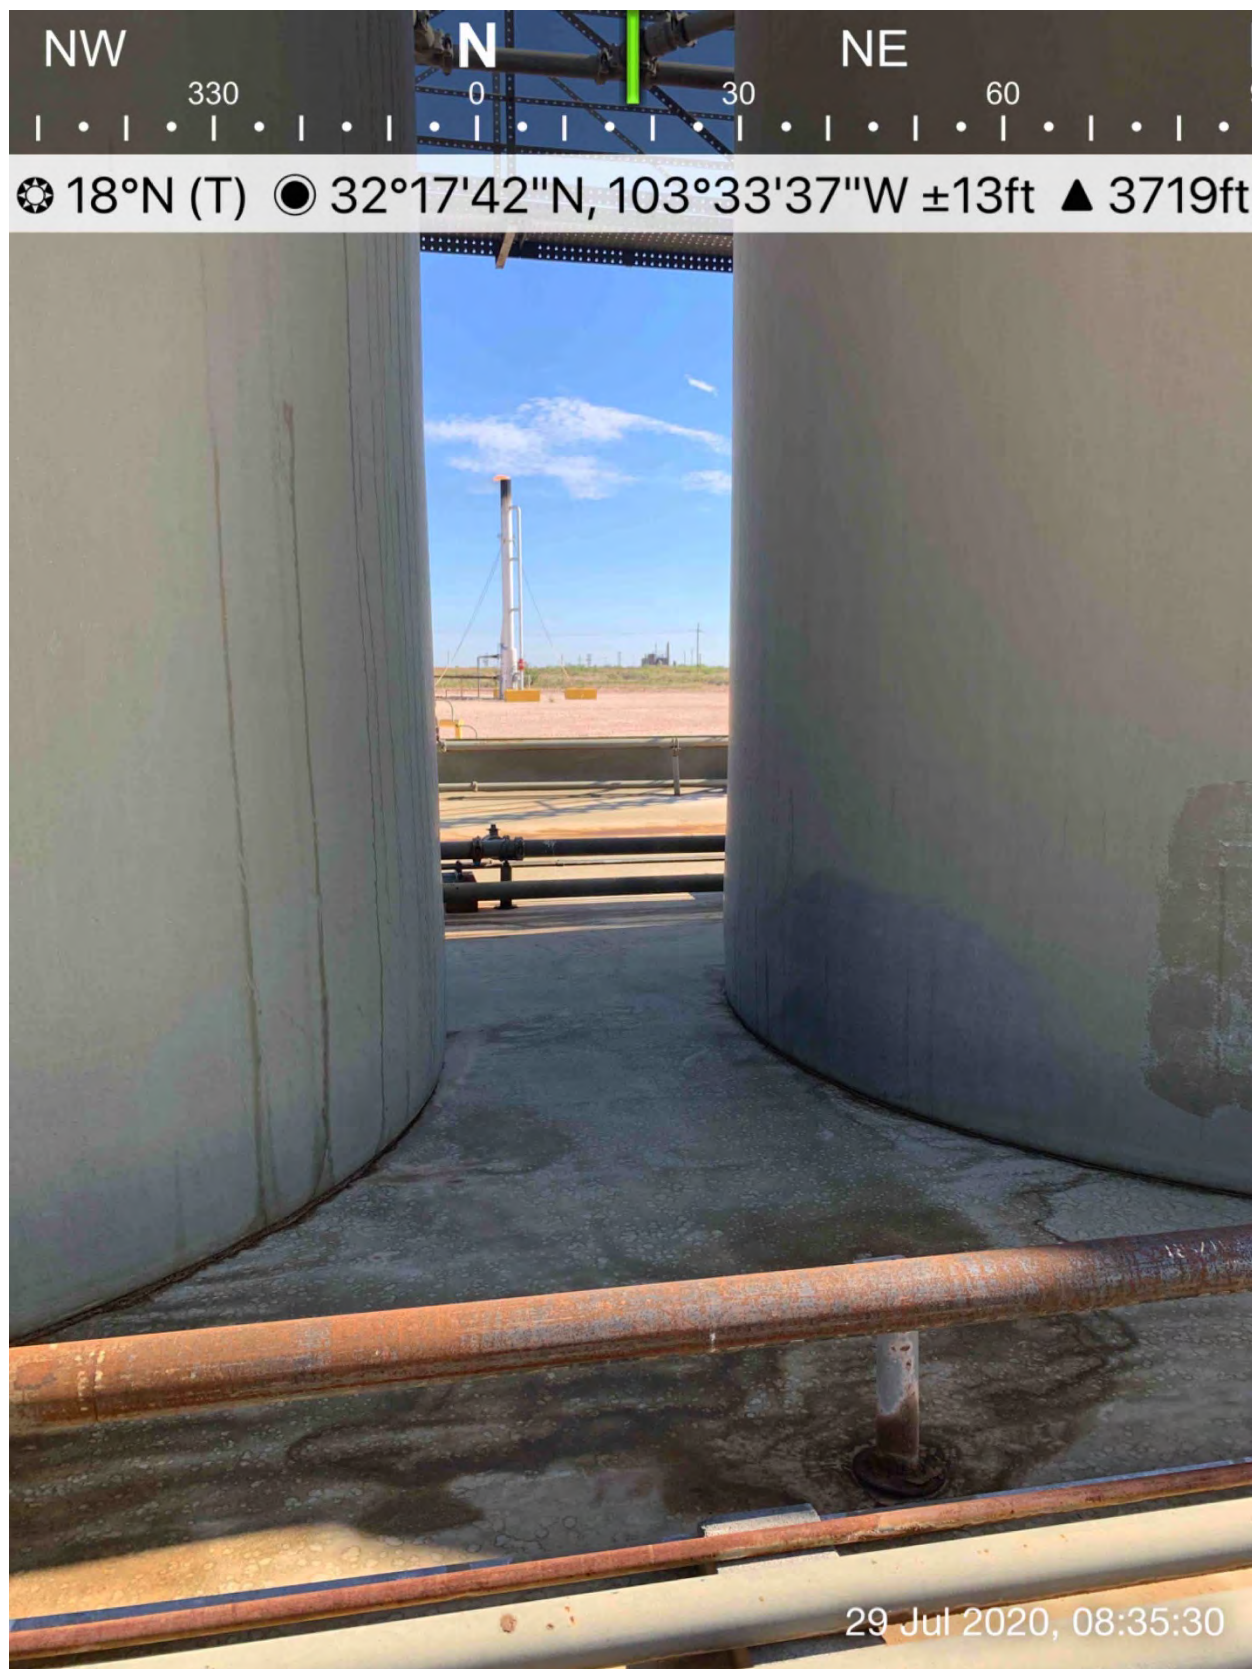
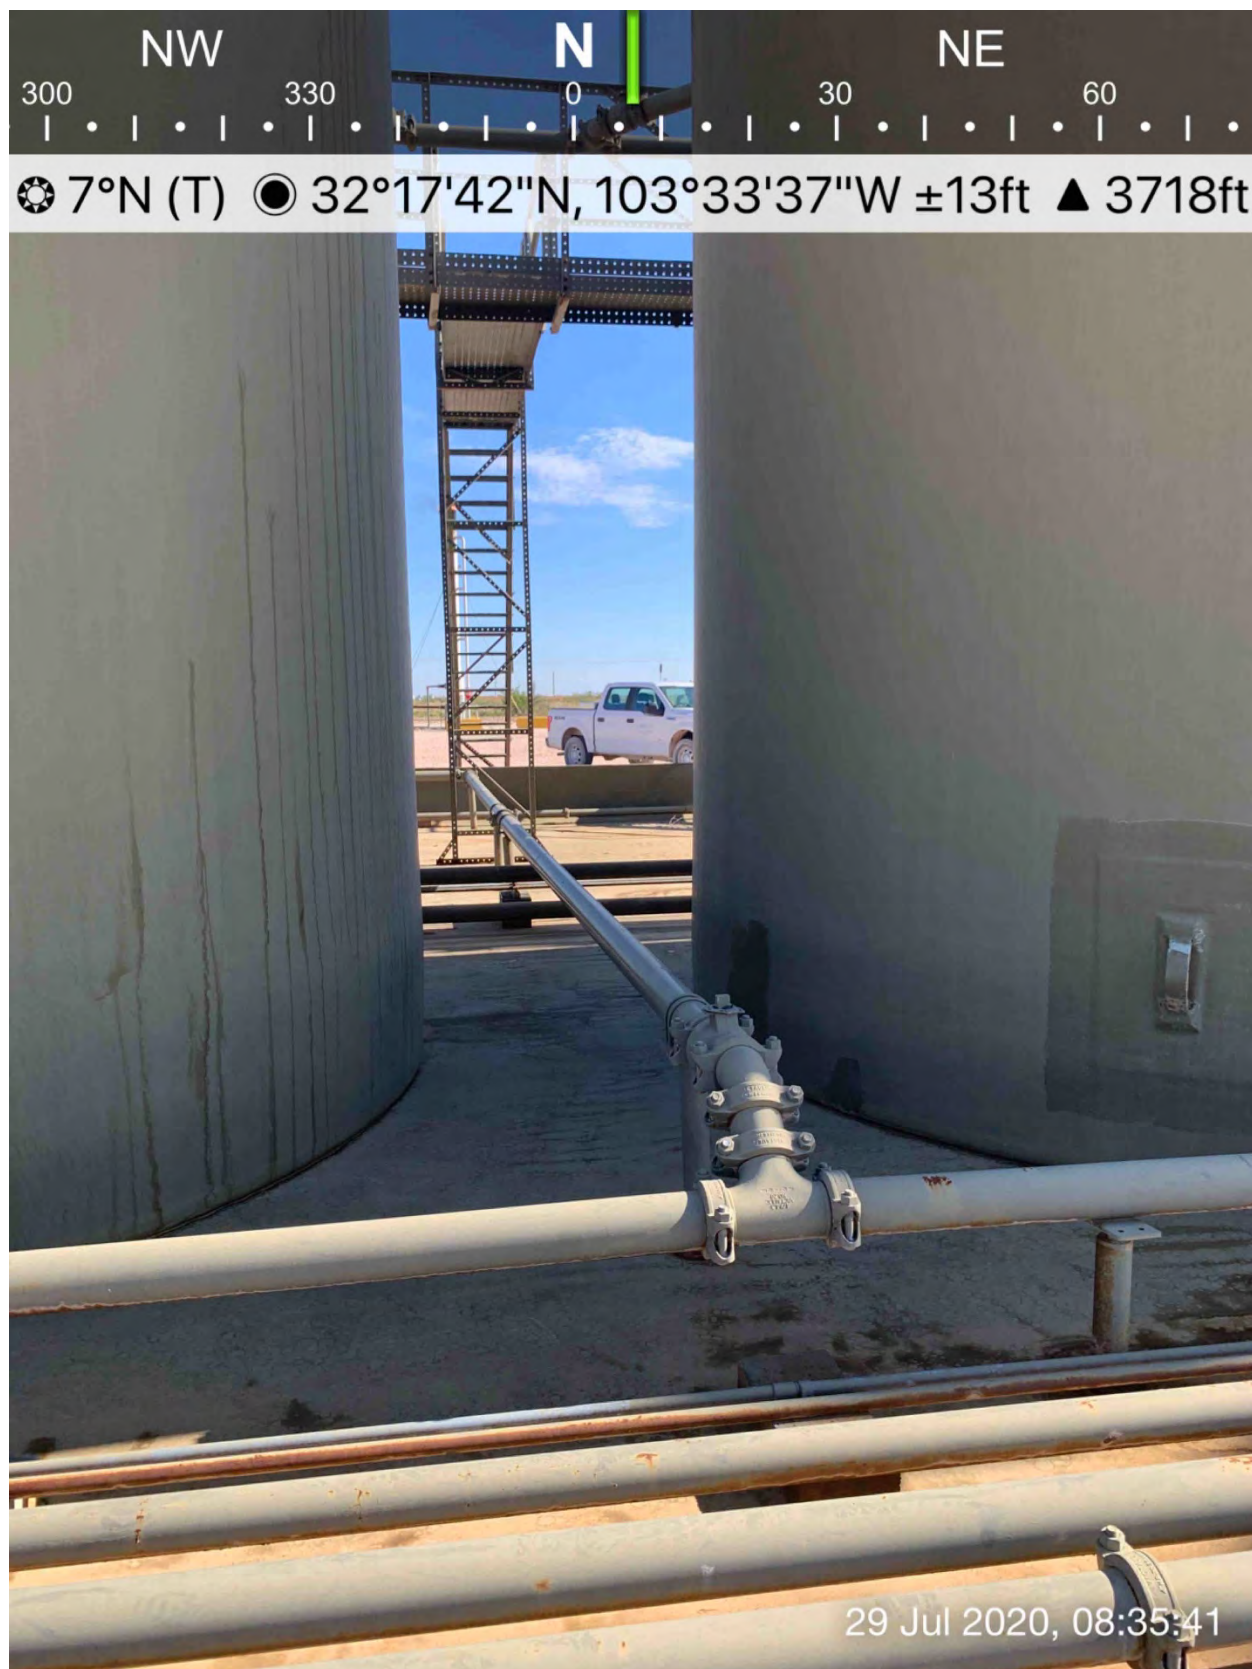
**Appendix A**  
**PHOTO LOG & FIELD NOTES**

At the request of Devon, SMA conducted a liner integrity inspection per the requirements of 19.15.29.11.A(5)(a) NMAC. NMOCD was notified on July 27, 2020 that the liner inspection was to occur. After a thorough visual inspection of the liner within the tank battery containment, the liner appeared to be intact and had the ability to contain the leak in question. The VRT tower from which the release occurred was identified, and SMA verified that the release did not occur outside of the lined containment. A photo log and field notes of the inspection is included in Appendix A.

SMA recommends no further action for this release.
