From:	Bratcher, Mike, EMNRD
Sent:	Tuesday, April 25, 2017 8:00 AM
То:	LeBlanc, Christopher S; Jim Amos (jamos@blm.gov)
Cc:	Weaver, Crystal, EMNRD
Subject:	RE: Henshaw Deep Unit 5 Battery Reclamation

We are currently planning the reclamation of the Henshaw Deep Unit 5 Battery in Eddy County, NM.

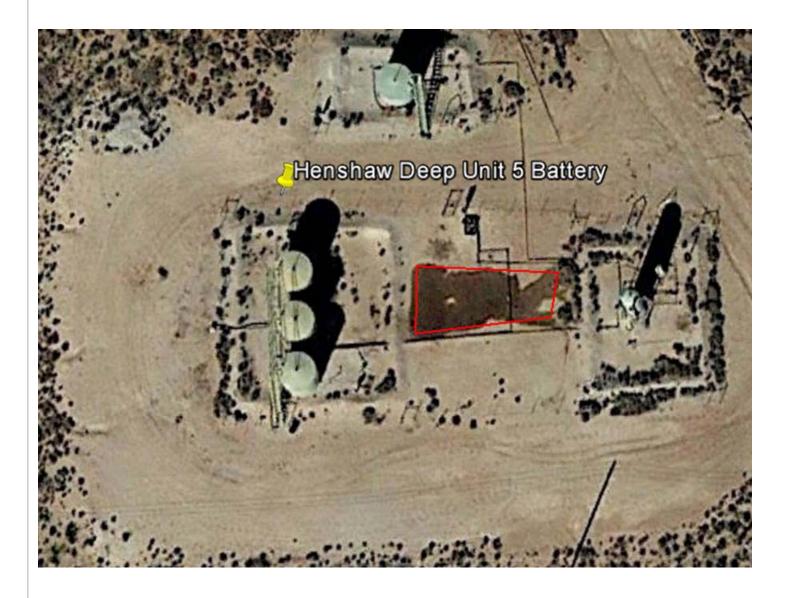
There was a recent small spill (20' x 50' oil) at this location several months ago. From what I understand the spill volume was calculated to be less than 5 bbl. I've had samples collected (2 within the leak area and 4 that surround the leak area to find the horizontal edges).

I have attached the analyticals and lab summary for your review. My current plan is to remove ~ 18 " of the contaminated soil within the spill area (below in red) and fill with native top soil to establish a growing medium.

OCD concurs with BLM. Please proceed on your schedule. A review of records, shows an open RP on this well (Henshaw Deep Ut 5) from Chesapeake ownership (2011). This particular spill was approved for backfill, so it looks like all we need is a Final C-141 to close it out. The event tracking number is 2RP-602.

With these levels the 18" would be adequate. You have the BLM approval to proceed. thanks
