From: Randall Hicks <r@rthicksconsult.com>
Sent: Friday, March 08, 2013 10:09 AM
To: Bratcher, Mike, EMNRD
Cc: mstewart@helmsoil.com; Hollie Lamb; cstoker@helmsoil.com; kristin@rthicksconsult.com
Subject: Alamo - State BK 9
Attachments: BK9WatercourseData.pdf; WaterDiversionDRAFT.pdf

March 8, 2013

RE: Alamo Permian – State BK #9

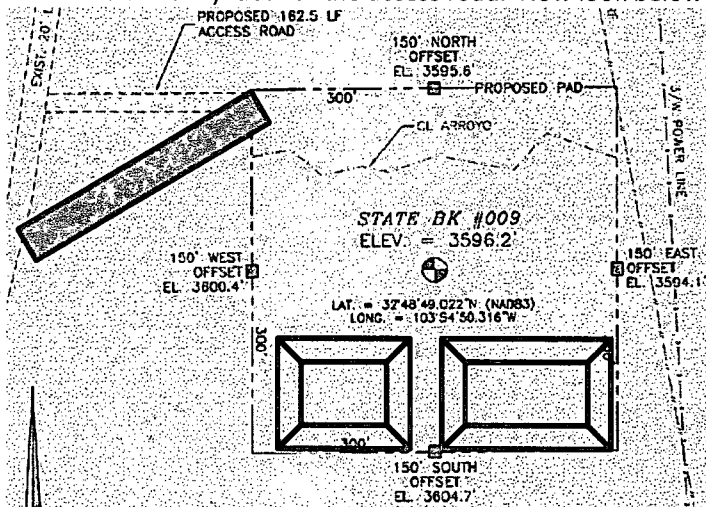
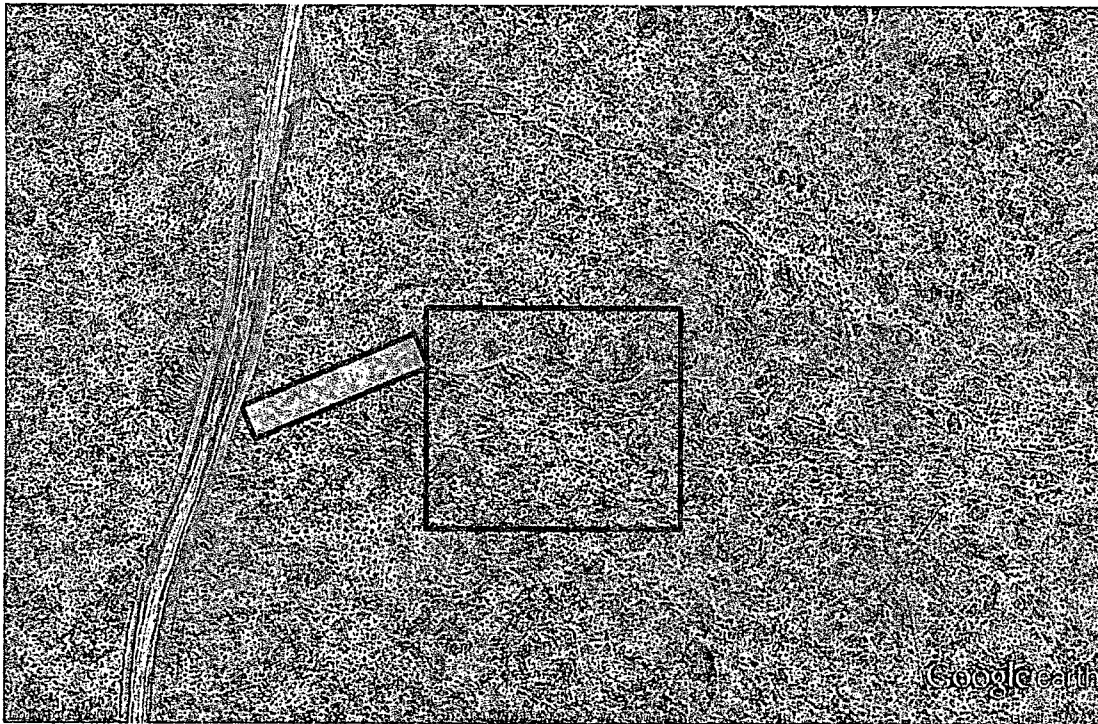
Here is the survey of the site with the pit show. Note the Arroyo shown on the survey – this must be filled to build the location. The Google map below the survey shows the same area. The 150 south survey benchmark is 8 feet higher than the well marker – the pit is built into the side of a dune. Also shown below is my idea for the access road. Now look below at the Google Image.

PRELIMIARY DESIGN - Sweatt creates one or two small bar ditches on each side of the road that direct drainage to the larger arroyo to the north. This water diversion will be necessary with pits or closed loop. In the absence of water diversion, one frog strangler rain will take out the northern portion of the location – probably in July, after construction of the tank battery. In essence, this diversion restores some of the drainage pattern observed in the 1971 Soil Survey map.

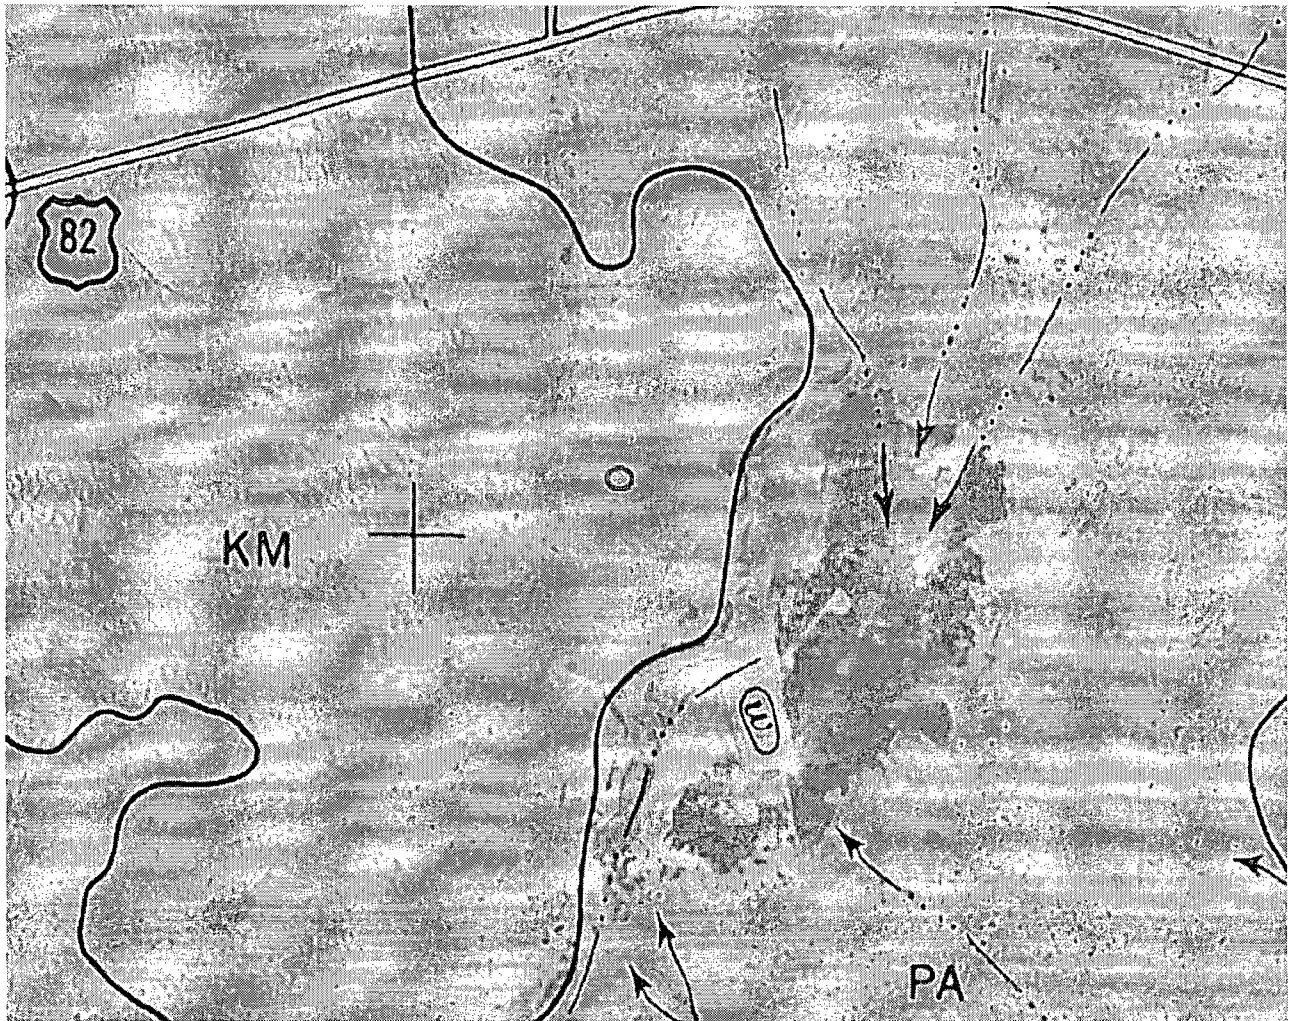
From these data we conclude that the erosional feature/gully that lies about 180 feet north of the proposed pit is not natural and is not a watercourse - it is a by-product of man's activity. However, this feature requires attention with respect to construction of the location and temporary pit. The larger watercourse located about 350 feet north of the well marker may also be a by-product of man's activity, as it is not marked as a drainage on the Soil Survey map (see below).

The aerial photograph below is reproduced from the 1971 Eddy County Soil Survey. The location of the State BK #9 proposed temporary pit lies within the red circle with the larger drainage just north of the circle. No drainage is evident in the area of the State BK 9 location. This map identifies drainages entering the ancient lake bed and a channel draining the ancient lakebed (north and west of the W in the center of the map). The scientists who created this map did not identify a drainage near State BK 9.

When building the access road and location, the operator will divert drainage from the road to the larger watercourse to the north. Please consider this commitment to divert road drainage to the larger watercourse north of the location an amendment to the application.

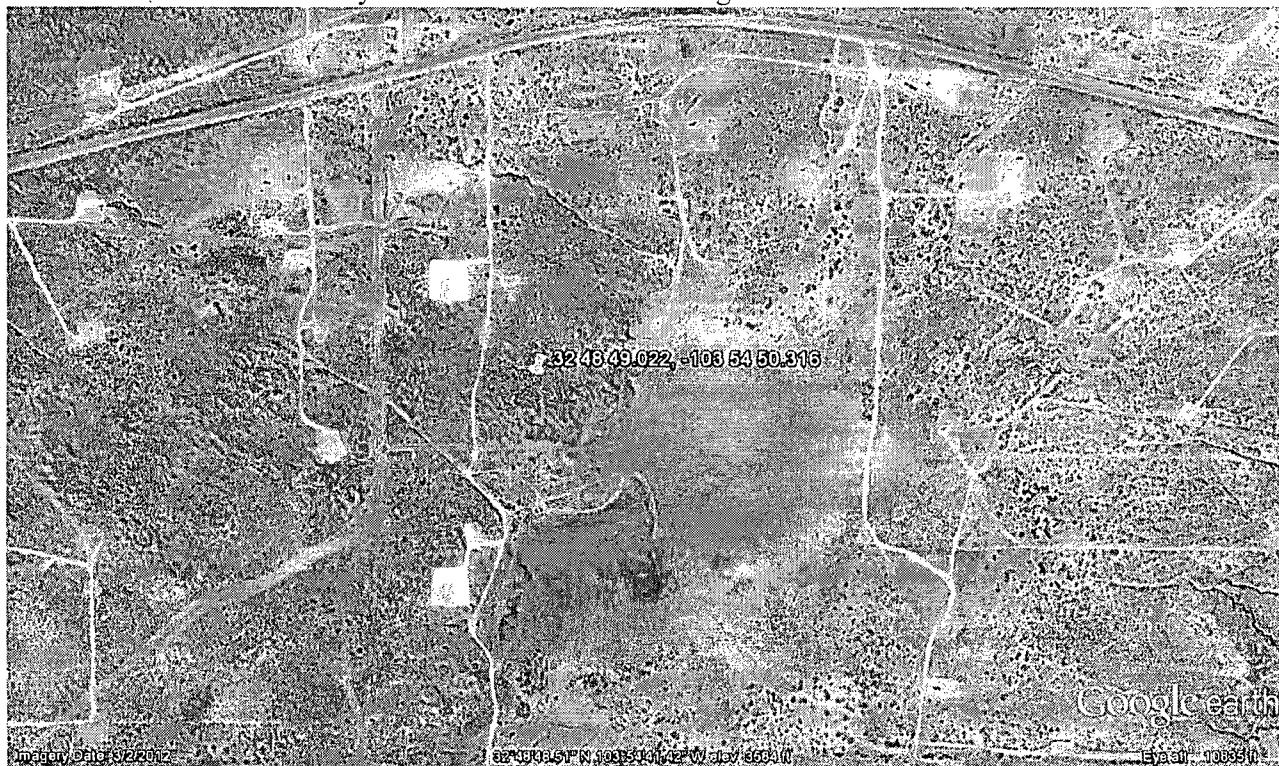
The photograph below was used to "georeference" the location of the temporary pit. One can compare common features to see that the circle on the photograph above is consistent with the location of the State BK 9 temporary pit. Note that numerous roads, pipelines and well locations have materially disturbed the natural drainage in the area.
