**Primero Operating Company
Luke State #3
Pit Closure Report
Section 3, Township 8, Range 27E
Chaves County, New Mexico**

May 21, 2008

**Safety & Environmental Solutions, Inc.
703 E. Clinton
Hobbs, New Mexico 88240
(575) 397-0510**

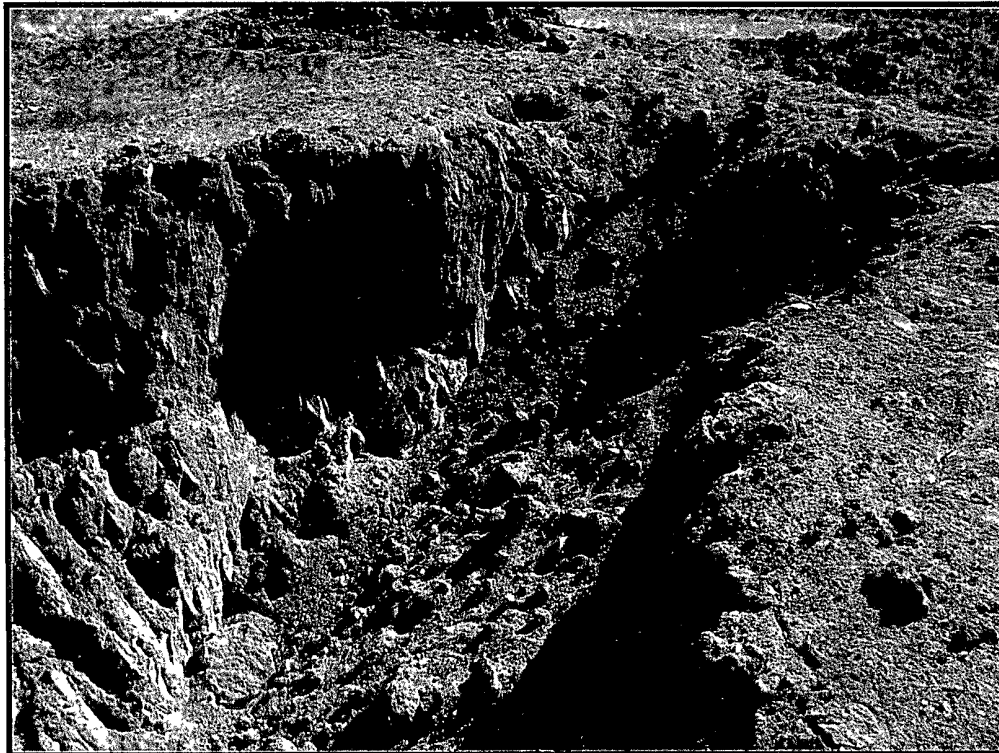
Excavated Pit area facing east

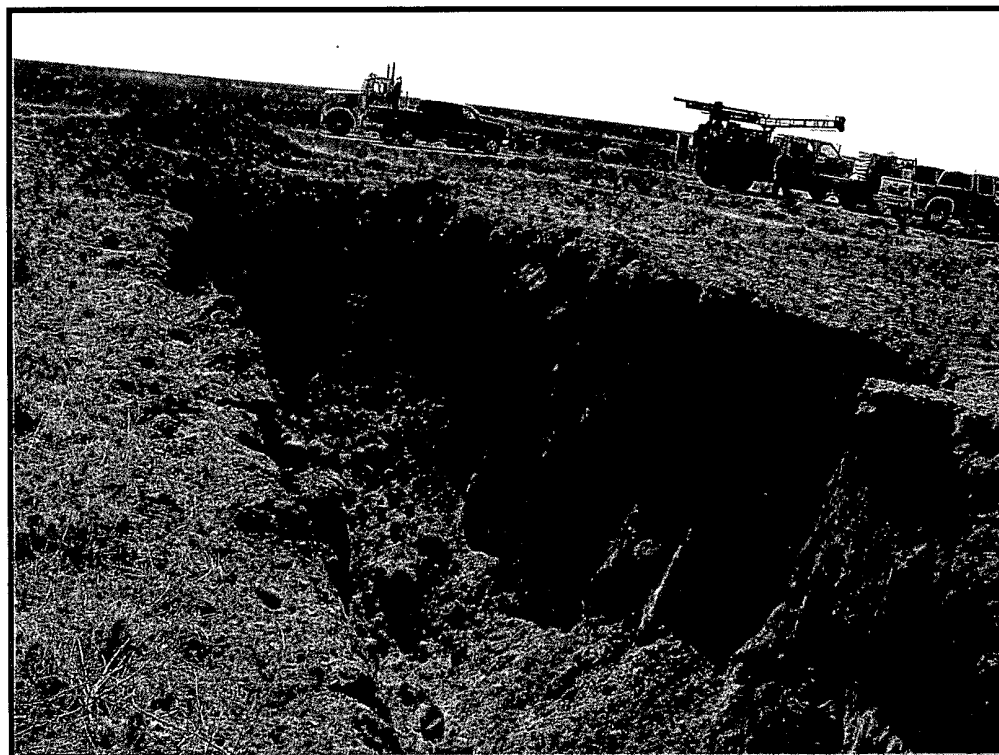
Excavated pit area facing east

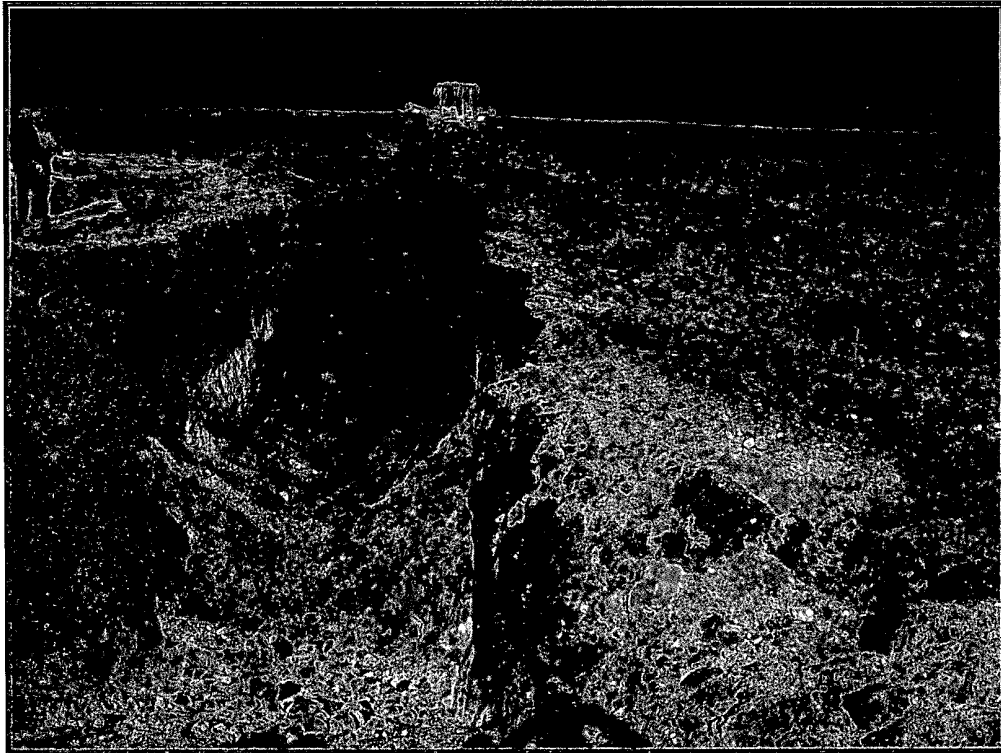
Excavated pit area facing west

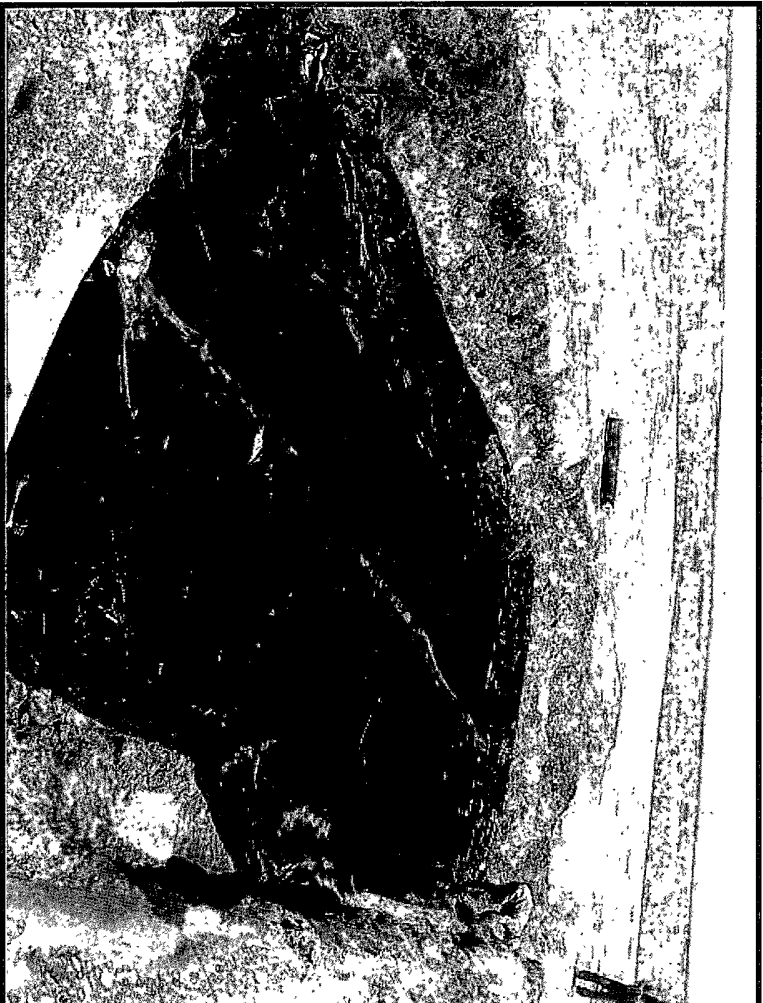
Area lined facing east

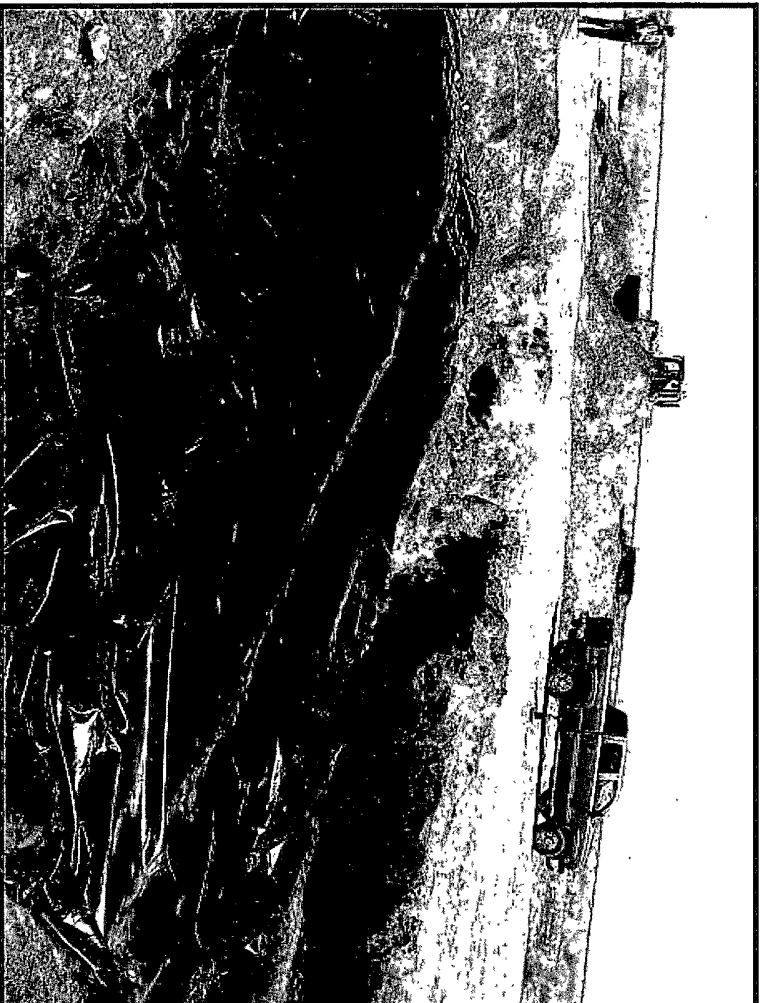
Area lined facing southeast

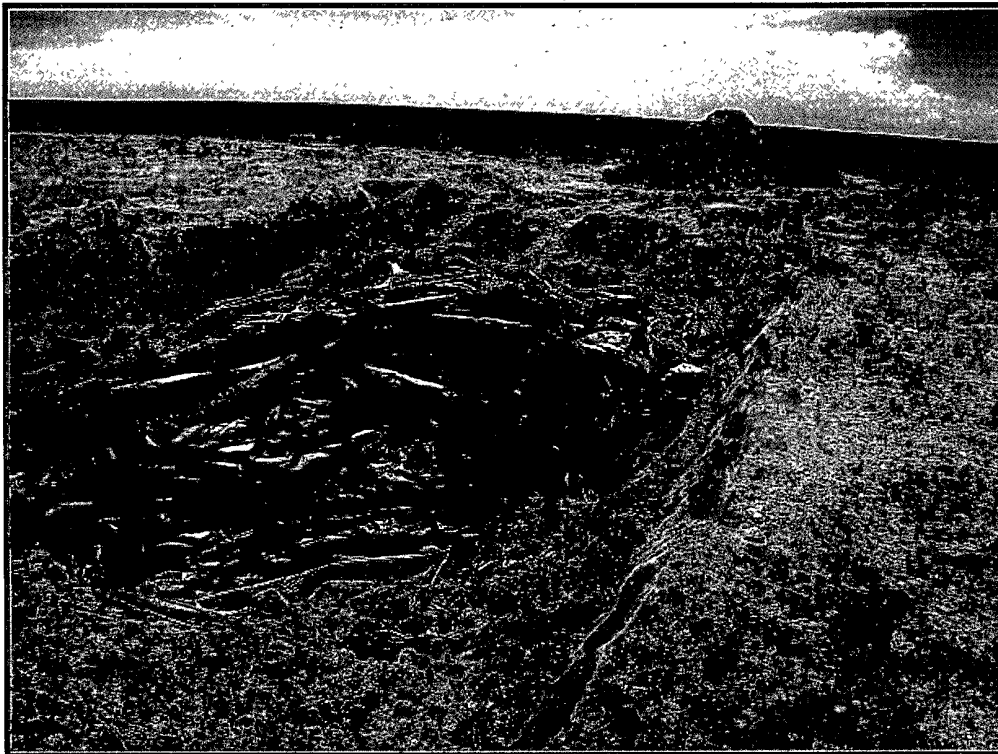
Area lined facing west
