Release Notification

Site Name Buena Vista Compressor Station	Site Type Natural Gas Compressor Station
Date Release Discovered: 7/25/2019	Serial Number (if applicable): NM 093684

Summary of Events
Buena Vista Compressor Station - Emergency Shutdown Vent
UL A Section 13 T30N R9W; 36.81790, -107.72946

Enterprise Field Services, LLC
Buena Vista Compressor Station
UL A Section 13 T30N R9W; 36.81790, -107.72946
Emergency Shut Down Vent

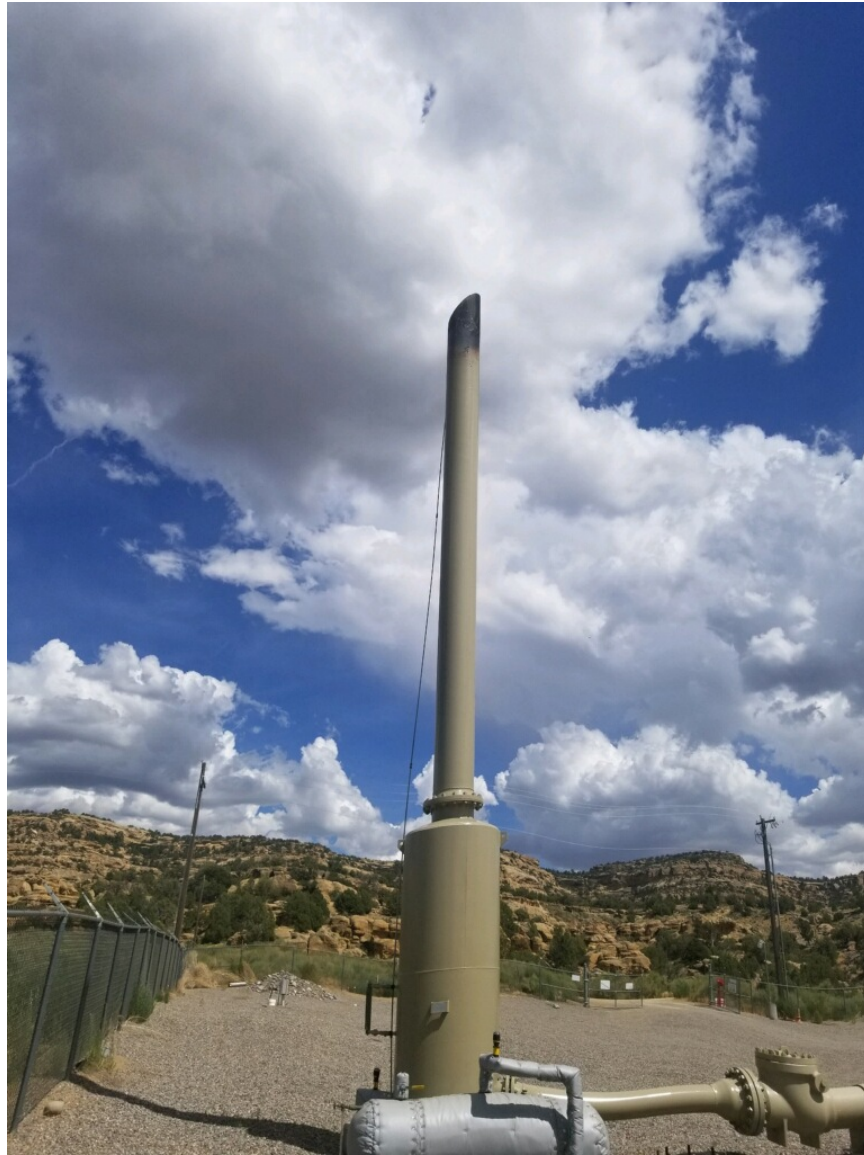
On July 25, 2019, lightning struck the emergency shut down vent causing the vent to catch fire at Buena Vista Compressor Station. The fire was extinguished by facility personnel. No injuries, nor equipment damage occurred. No emergency services responded to the incident. No environmental impacts occurred, no remediation was performed and no soil samples were collected.

Photo 1: View of the ESD Vent.

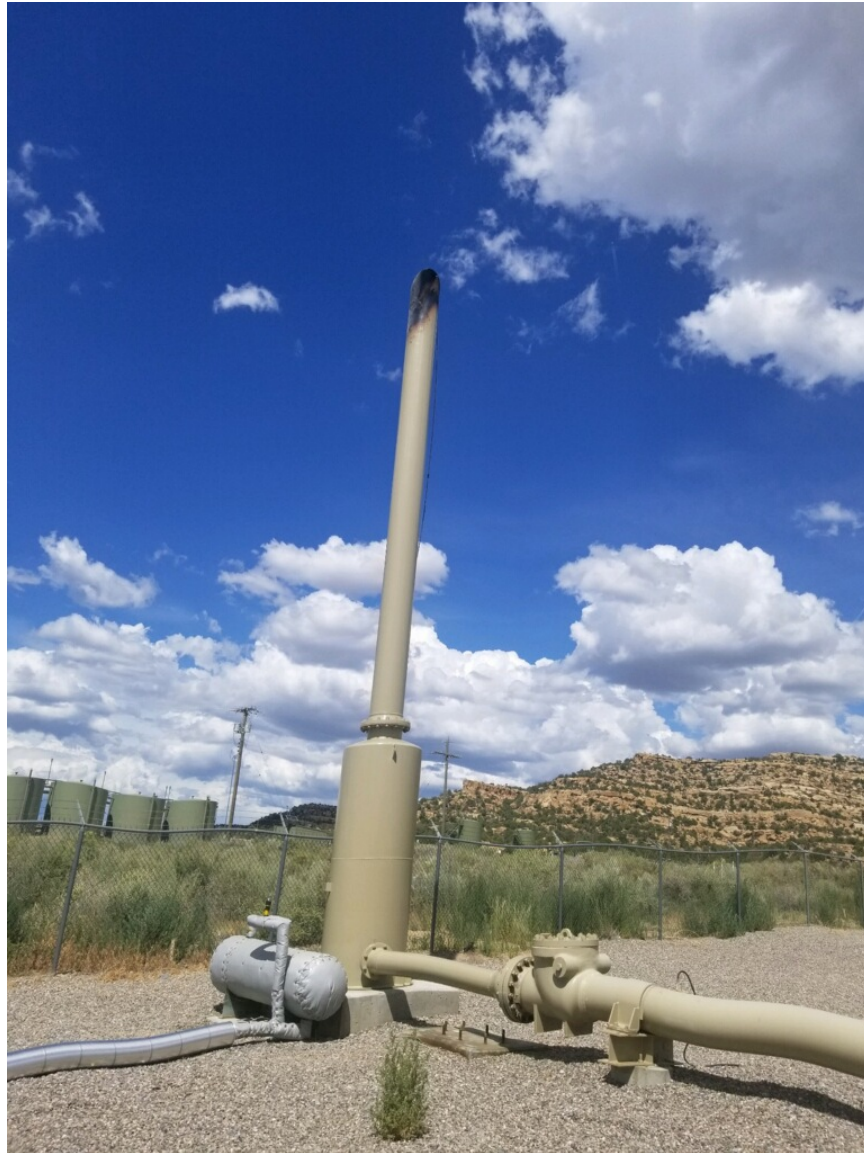
Photo 2: View of the ESD Vent.
