Release Notification

Site Name State Com AE 27R #17 CPD	Site Type Natural Gas Gathering Pipeline Dogleg
Date Release Discovered: 8/30/2019	Serial Number (if applicable):

Summary of Events
State Com AE 27R #17 CPD
UL G Section 36 T30N R9W; 36.767679, -107.730403

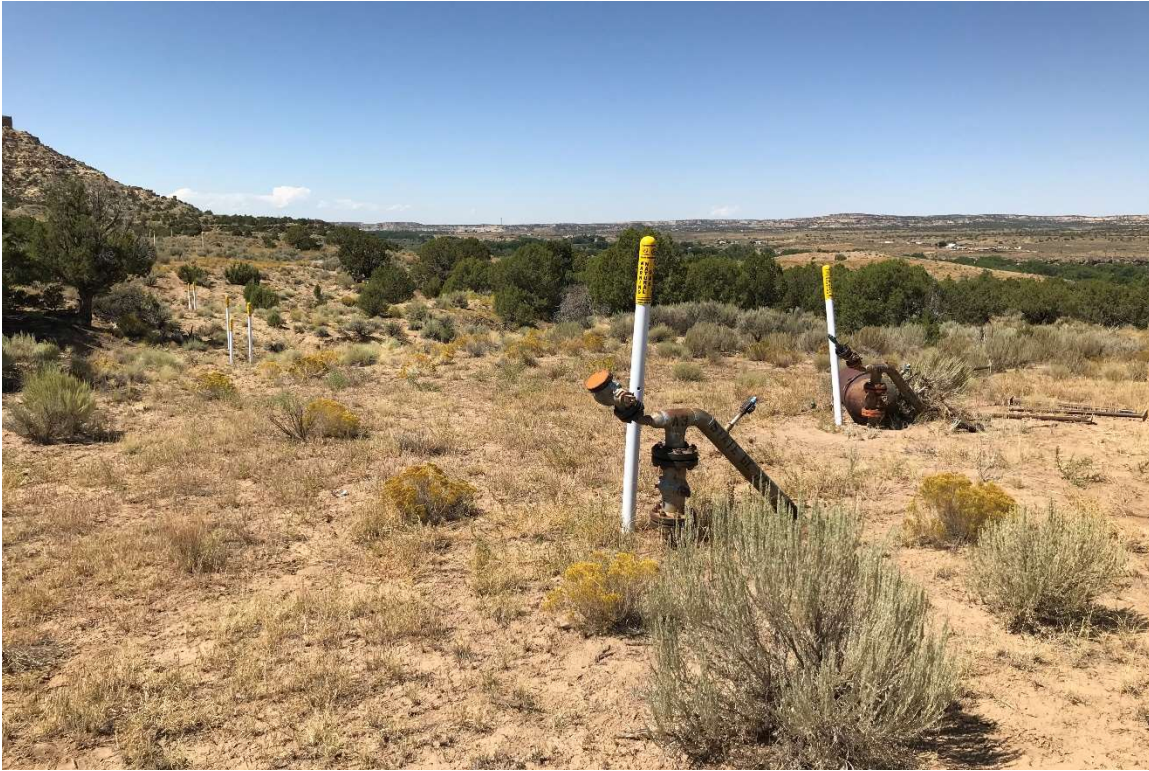
On August 30, 2019, livestock knocked over and methanol injector breaking a one inch valve on the dogleg. No injuries, nor fire occurred. The fire department and state highway patrol responded to this release to isolate the affected area as that the release was adjacent to NM Highway 511. No environmental impacts occurred, no remediation was performed and no soil samples were collected. A NMOCD inspector visited the release site on August 30, 2019 and confirmed no environmental impacts.

Photo 1: View of the release area.

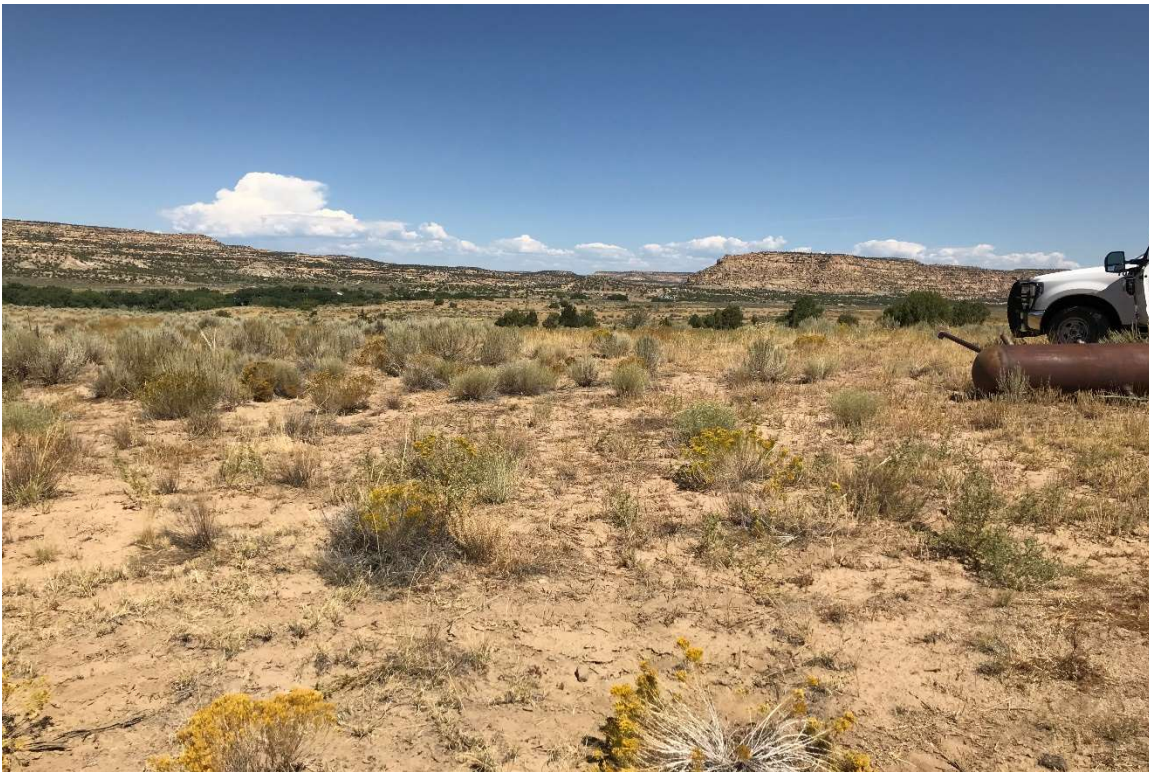
Photo 2: View of the release area.
