Release Notification

Site Name Chaco Plant	Site Type Natural Gas Processing Plant
Date Release Discovered: 9/25/2019	Serial Number (if applicable): N/A

Summary of Events Chaco Plant UL M Section 16 T27N R12W; 36.482664, -108.121322

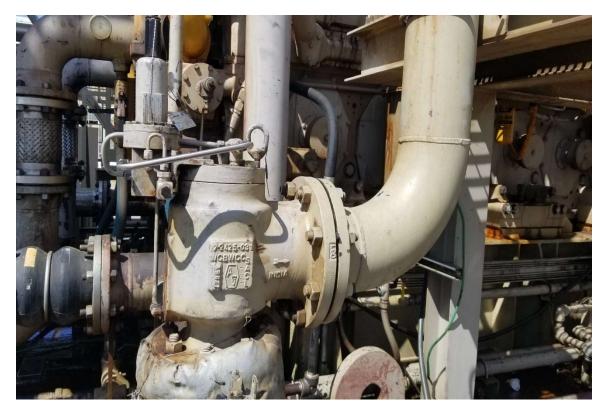
Photo 1: View of the release point.

At approximately 6:30 p.m. the outside operator was making his rounds when he heard a relief valve lift on Bisti 8 interstate pipeline. He notified the board operator to shut the unit down and identified a tubing line had cracked on the pilot of the PSV allowing the valve to open. The pilot was experiencing high vibration due to a broken bolt on the mounting bracket of the pilot. The mounting bracket and tubing line were repaired and the PSV was returned to service. A calculated amount of 61.61 MCF was released to atmosphere. No environmental impacts occurred, no remediation was performed and no soil samples were collected.

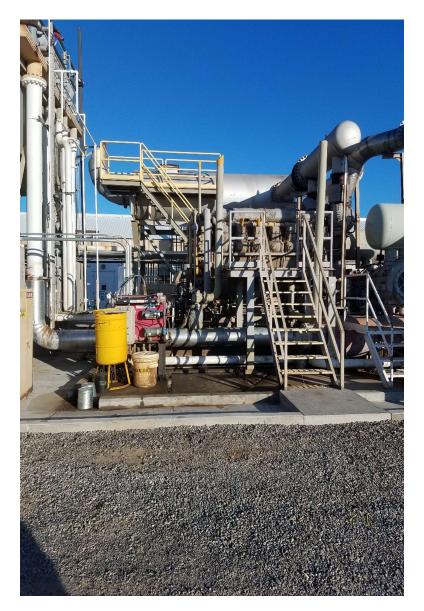
Photo 2: View of the area around the release point.
