From: [Jennifer Deal](#)
To: [Smith, Cory, EMNRD](#)
Subject: [EXT] FW: [EXTERNAL] Hilcorp's Kaufman No. 1 - Weekly Update for week of 4/20/20
Date: Tuesday, April 21, 2020 6:07:13 AM
Attachments: [image001.png](#)
[Kaufman No. 1 \(Fig 5 PSE\).pdf](#)
[Kaufman No. 1 \(Fig 6 groundwaterresults\).pdf](#)
[Kaufman No. 1 \(Fig 7 TPH\).pdf](#)

Status Report - 2nd Quarter Report (AP-0138)

Kaufman No. 1 Release (SE1/4 NE1/4, Sec. 33, T31N, R13W)
Hilcorp Energy Company
San Juan County, New Mexico

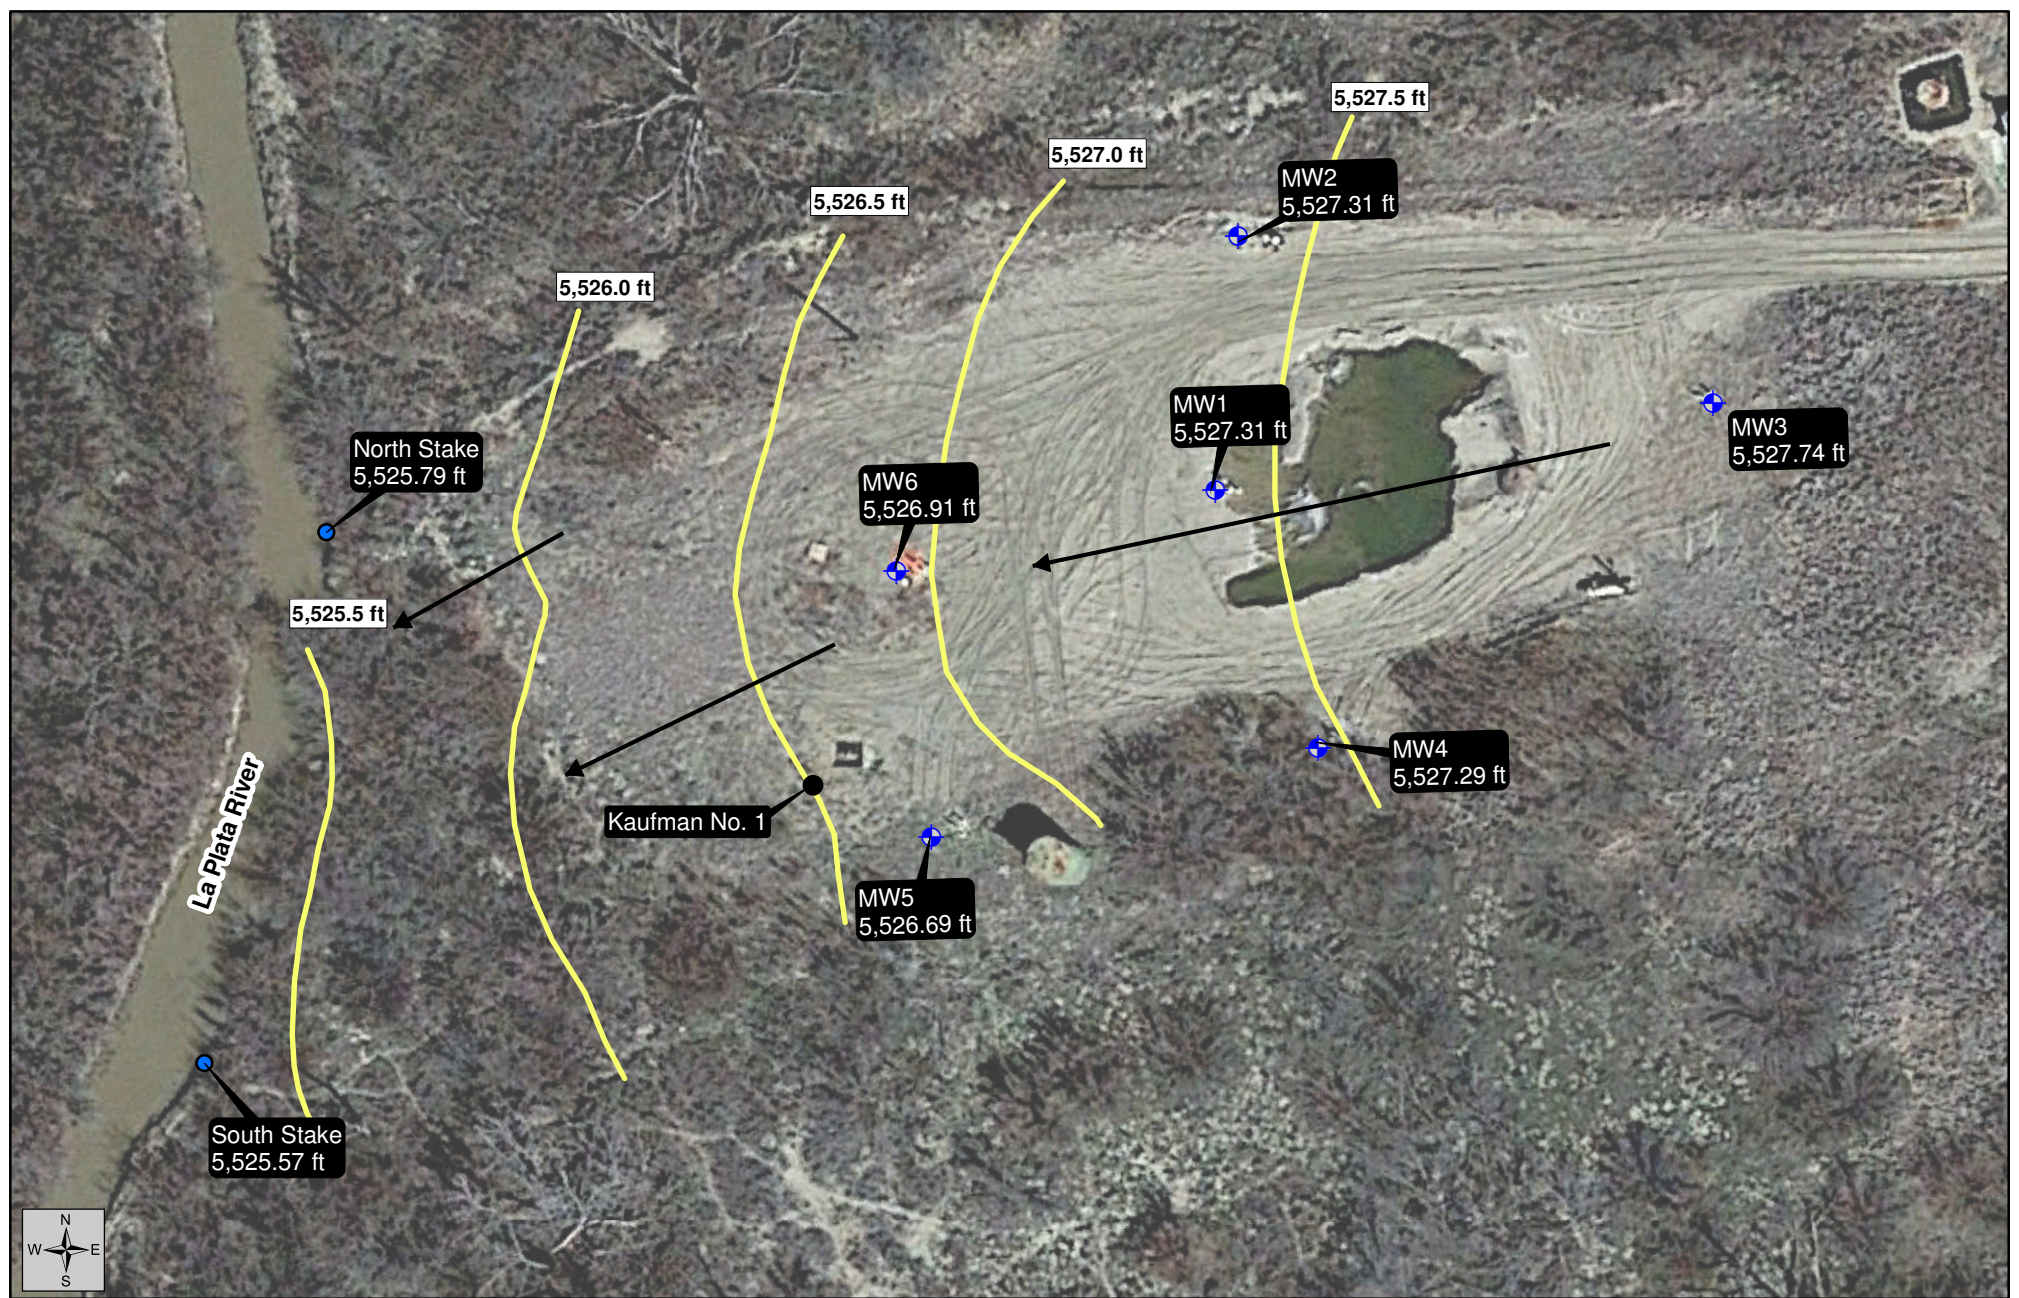
Figure 5
Potentiometric Surface
Elevation Map

During the week of 4/6/20, Timberwolf conducted the second quarter groundwater monitoring at the Kaufman No. 1. Groundwater and surface water gauging data were used to create a potentiometric surface elevation (PSE) map (Figure 5, attached). The PSE map revealed that groundwater across the Site continues to flow west-southwest across the Site and turns southwest as groundwater approaches the La Plata River.

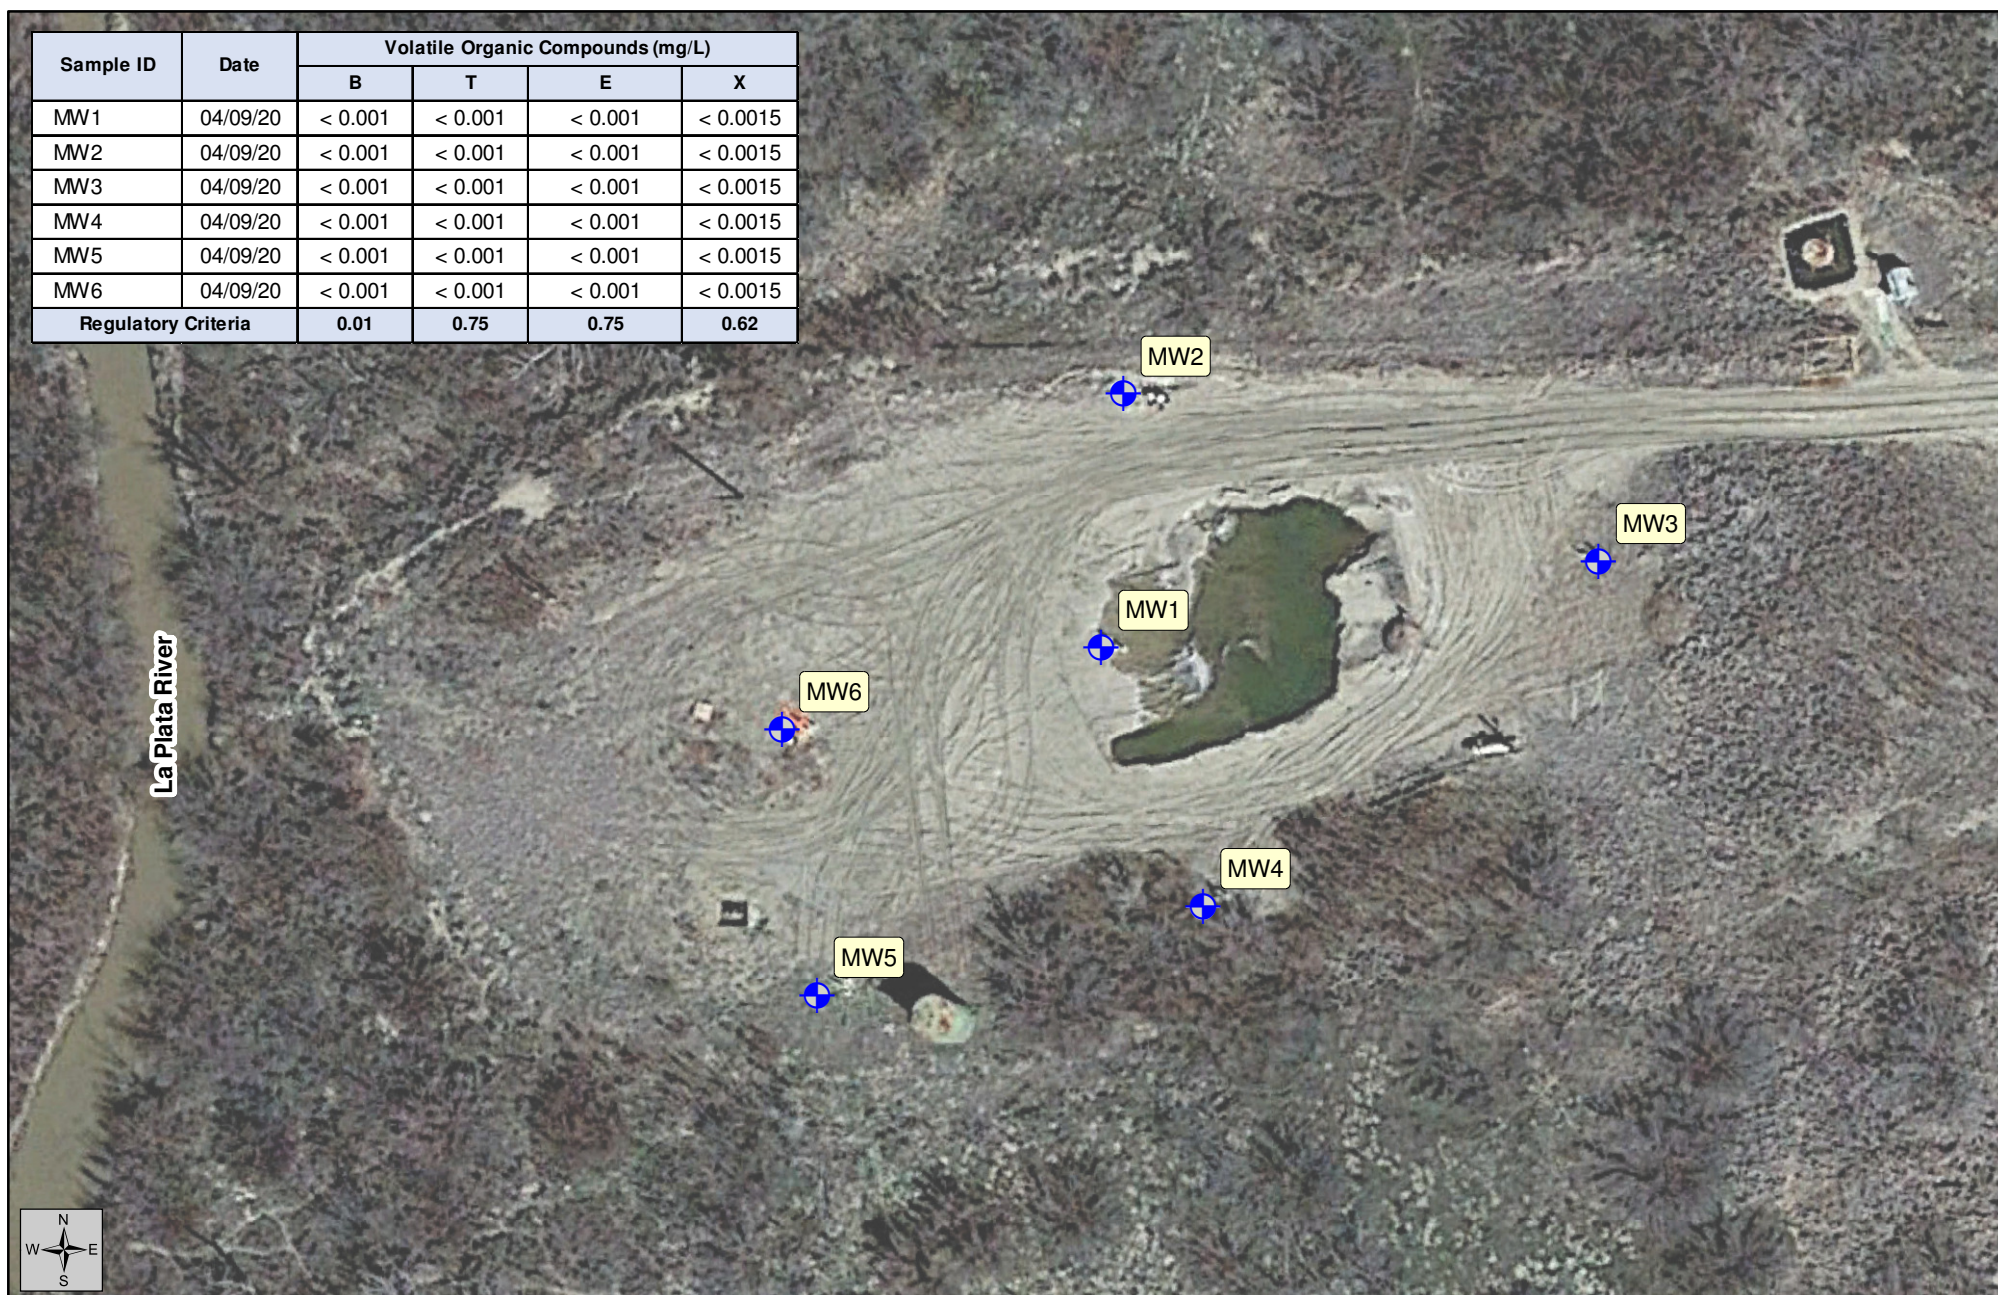
Figure 6
BTEX Results - 2Q20

Groundwater samples were collected from the 6 monitor wells and submitted for laboratory analysis of BTEX and TPH. BTEX results are shown in the attached Figure 6; BTEX concentrations in groundwater samples were below laboratory detection limits and NMOCD regulatory criteria. TPH results are shown in the attached Figure 7; concentrations of TPH in all groundwater samples were below laboratory detection limits and applicable human health standards for groundwater ingestion.

Sample ID	Date	Volatile Organic Compounds (mg/L)			
		B	T	E	X
MW1	04/09/20	< 0.001	< 0.001	< 0.001	< 0.0015
MW2	04/09/20	< 0.001	< 0.001	< 0.001	< 0.0015
MW3	04/09/20	< 0.001	< 0.001	< 0.001	< 0.0015
MW4	04/09/20	< 0.001	< 0.001	< 0.001	< 0.0015
MW5	04/09/20	< 0.001	< 0.001	< 0.001	< 0.0015
MW6	04/09/20	< 0.001	< 0.001	< 0.001	< 0.0015
Regulatory Criteria		0.01	0.75	0.75	0.62

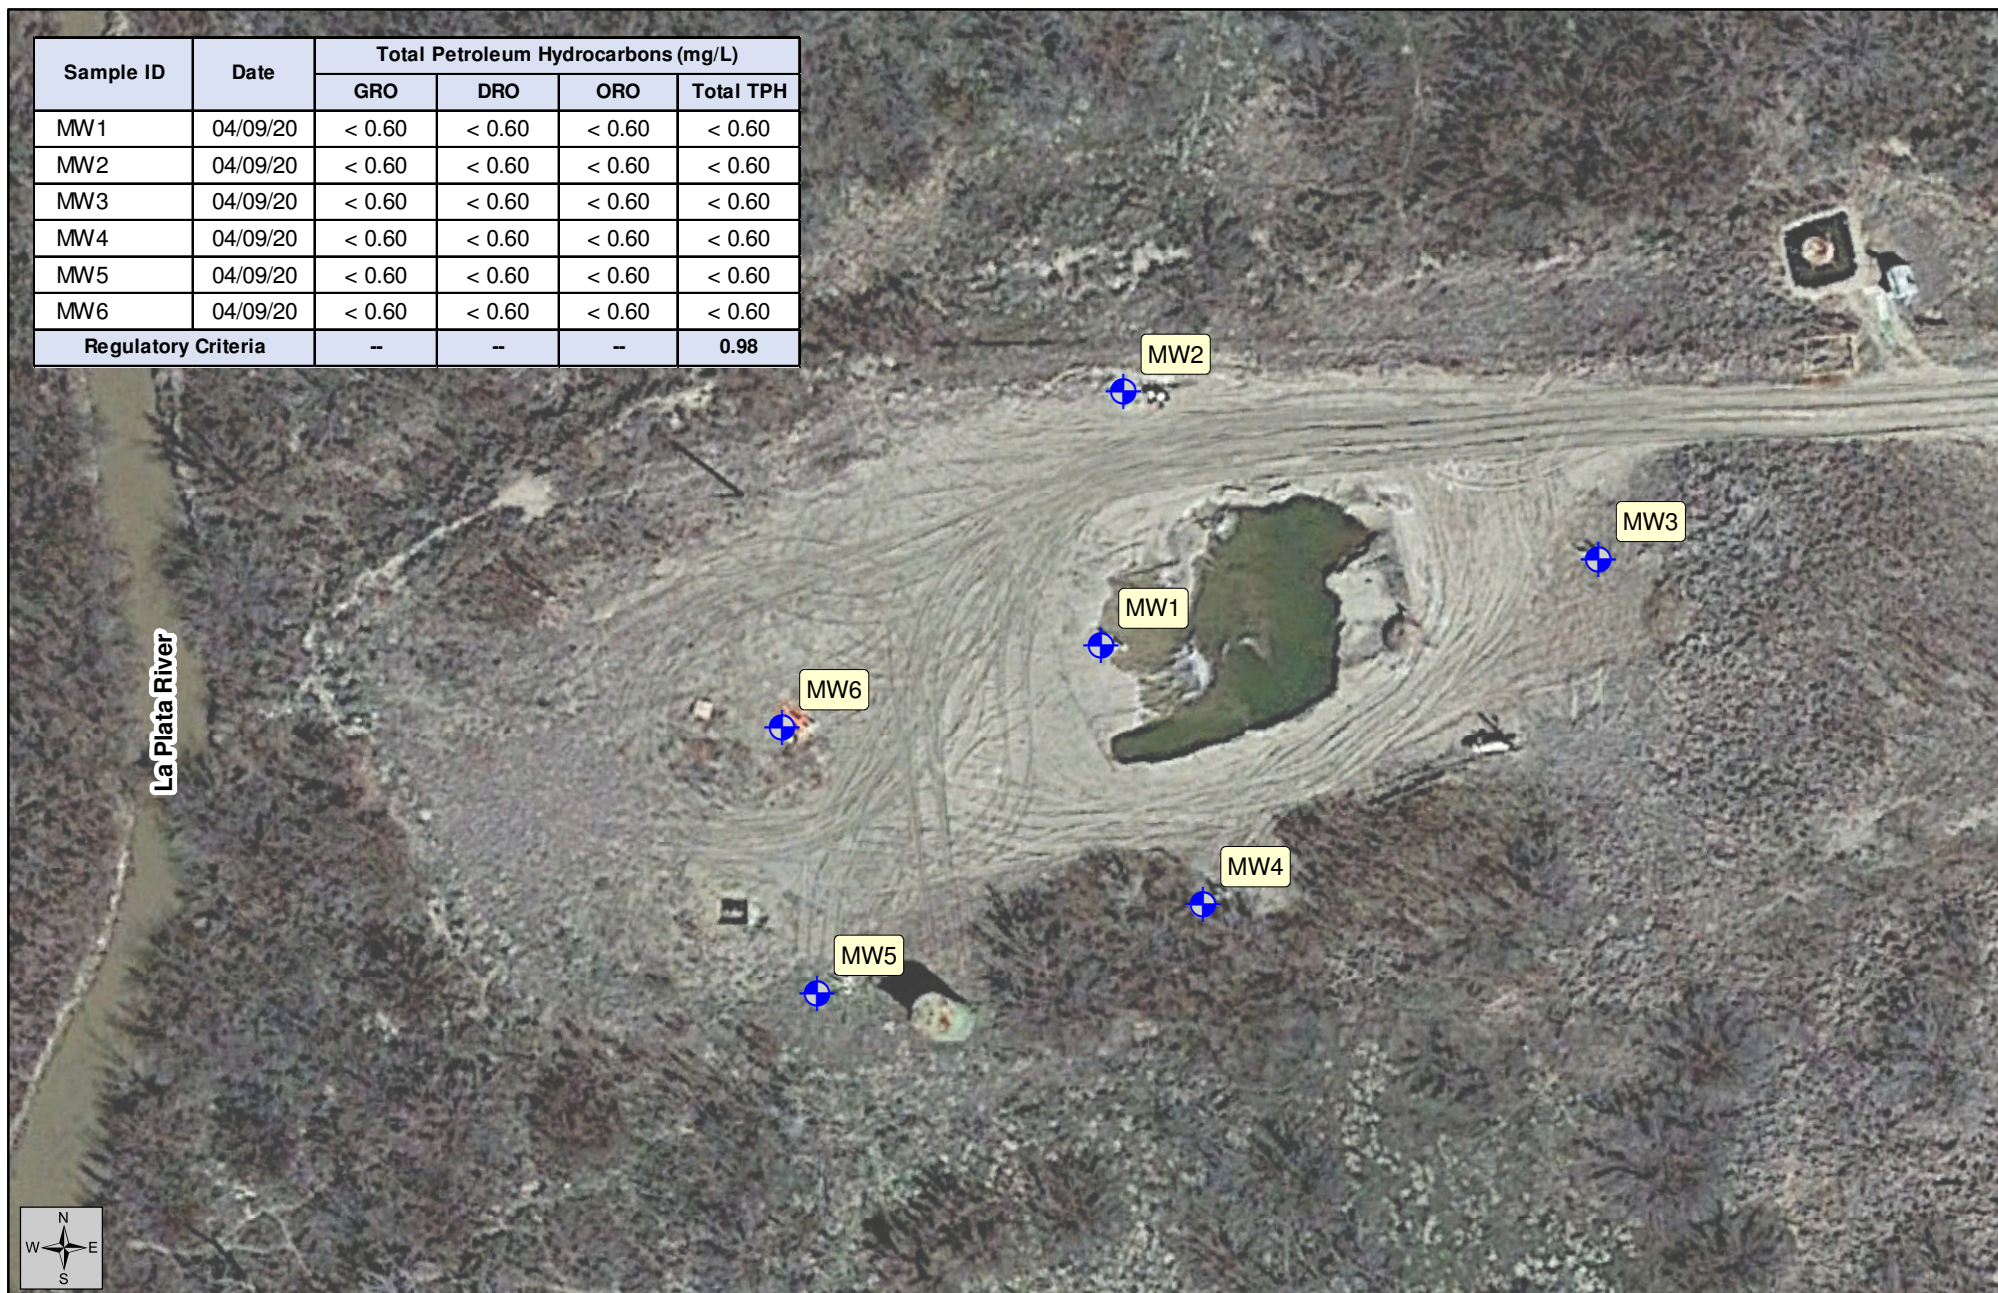
Figure 7
TPH Results - 2Q20

Sample ID	Date	Total Petroleum Hydrocarbons (mg/L)			
		GRO	DRO	ORO	Total TPH
MW1	04/09/20	< 0.60	< 0.60	< 0.60	< 0.60
MW2	04/09/20	< 0.60	< 0.60	< 0.60	< 0.60
MW3	04/09/20	< 0.60	< 0.60	< 0.60	< 0.60
MW4	04/09/20	< 0.60	< 0.60	< 0.60	< 0.60
MW5	04/09/20	< 0.60	< 0.60	< 0.60	< 0.60
MW6	04/09/20	< 0.60	< 0.60	< 0.60	< 0.60
Regulatory Criteria		--	--	--	0.98
