SVE REPORT

Re: Status Report – 2nd Quarter 2020
San Juan 28-7 Unit 183M
Rio Arriba County, New Mexico
OCD Incident No. NCS1901627746

On behalf of Hilcorp Energy Company (Hilcorp), Timberwolf Environmental, LLC (Timberwolf) presents this report to document remedial activities conducted during the second quarter of 2020 (2Q20) at the San Juan 28-7 Unit 183M (Site). Activities conducted during the 2Q20 consisted of the following:

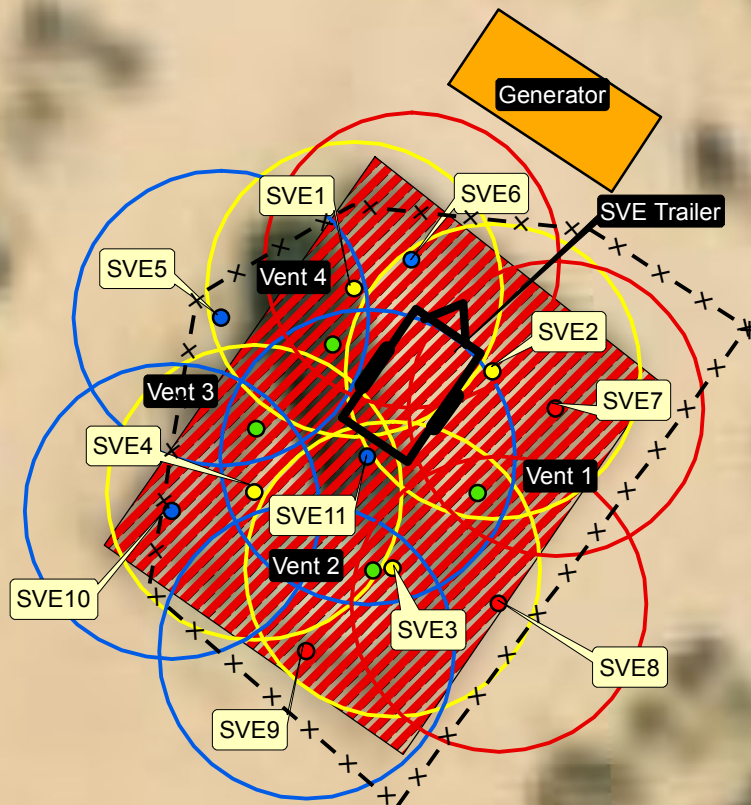
Figure 4
SVE System Overview

The SVE system creates a treatment field of approximately 0.15 acres and treats soil to a depth of approximately 30 ft bgs for a total volume of approximately 7,021 cubic yards of soil. The SVE wells, measured radius of influence of 25 ft, and leg configurations are shown in Figure 4.

Treatment Area= 6,320 ft²
Assuming a 25 ft radius of influence
