Status Report

Re: Status Report – 3<sup>rd</sup> Quarter 2020  
Kaufman No. 1  
San Juan County, New Mexico  
OCD No.: AP-0138

On behalf of Hilcorp Energy Company (Hilcorp), Timberwolf Environmental, LLC (Timberwolf) prepared this letter to document the 3<sup>rd</sup> Quarter 2020 (3Q20) activities at the Kaufman No. 1 (Site). Activities conducted during 3Q20 included:

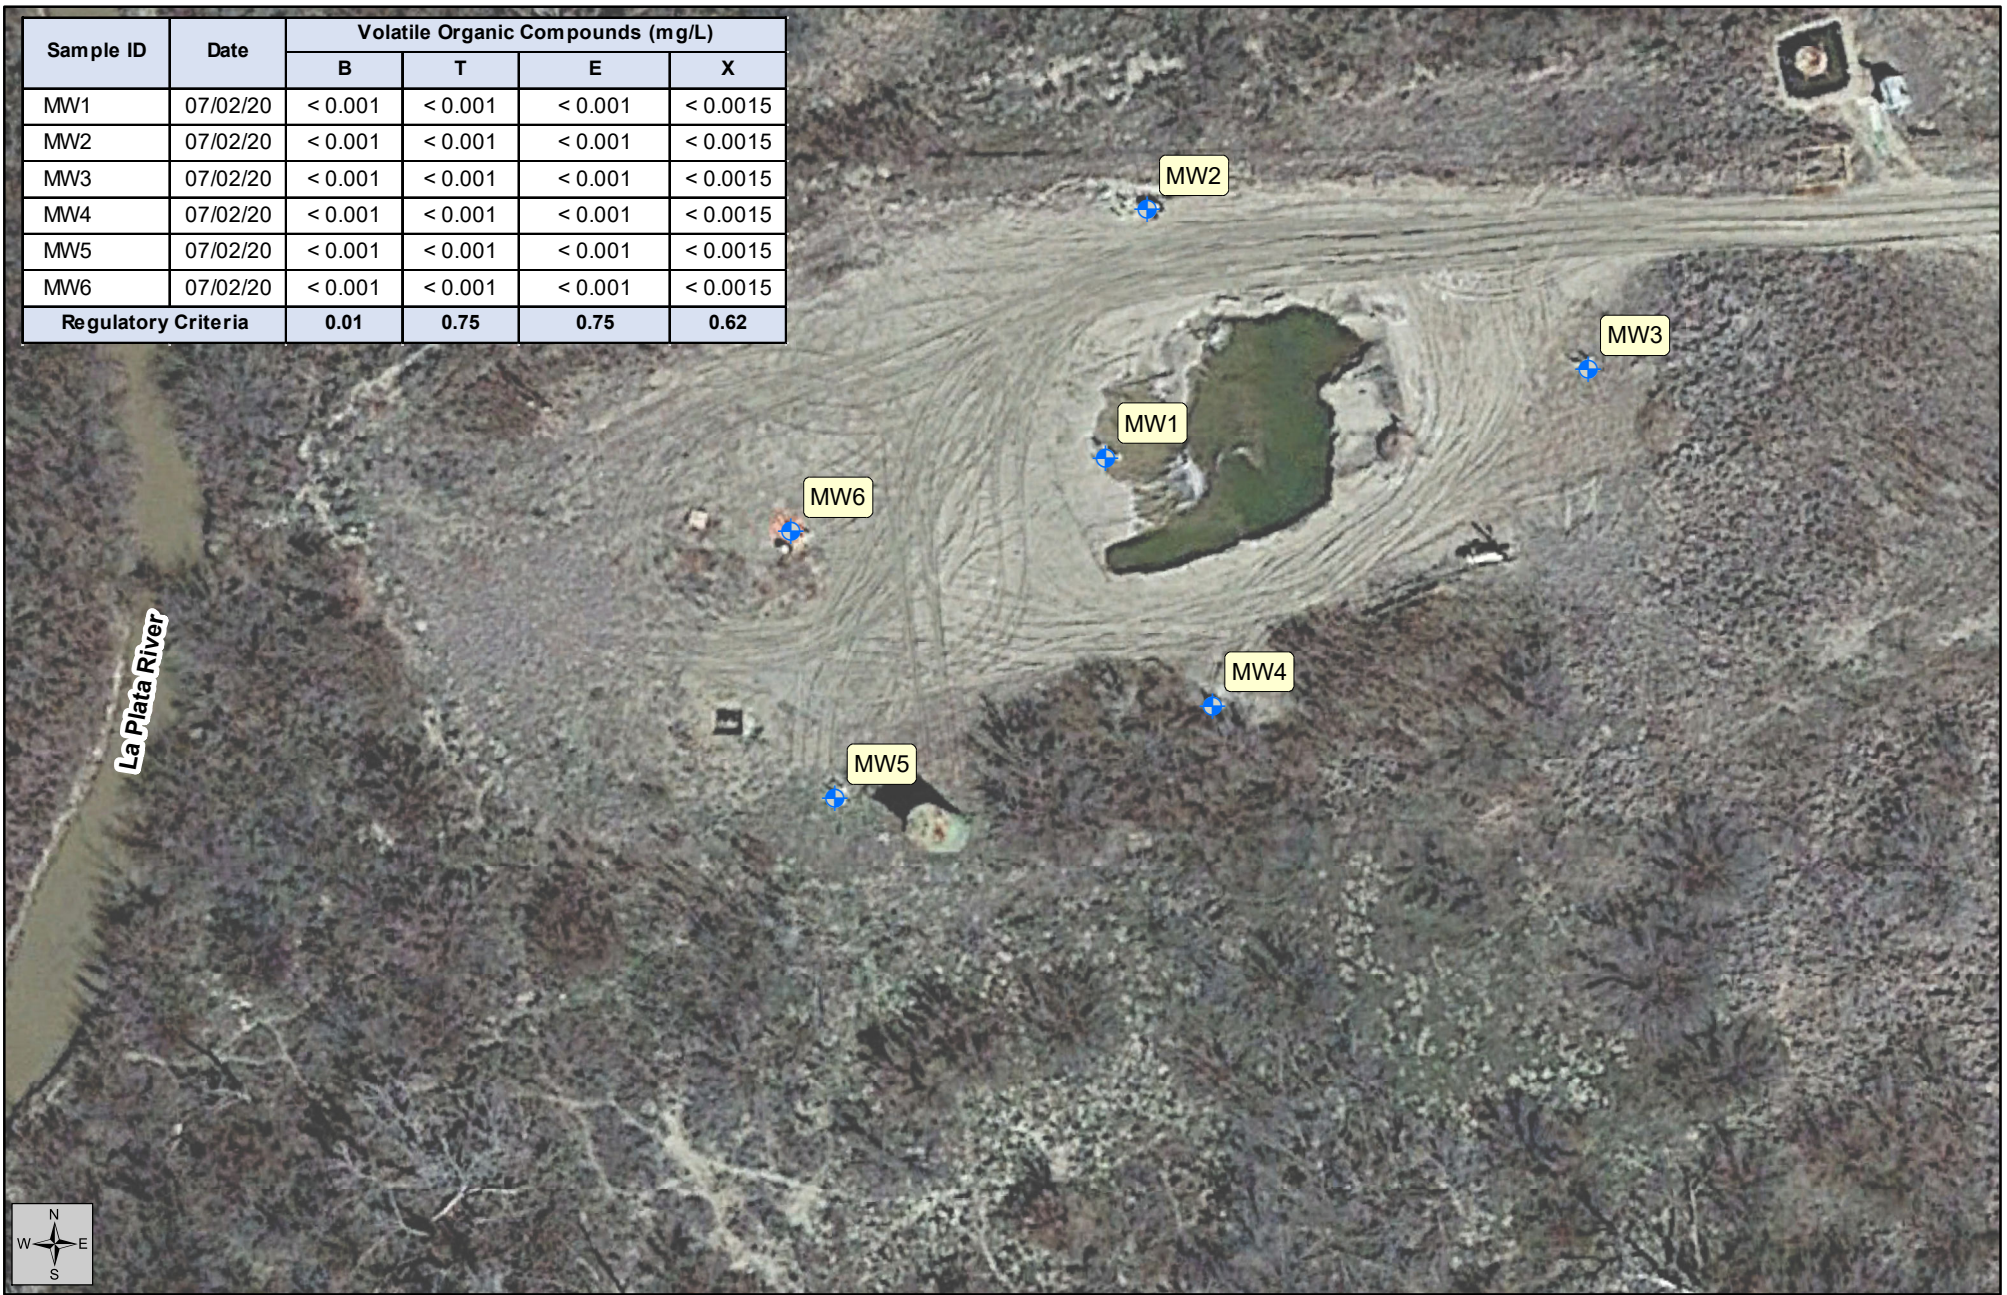
**Figure 6**  
BTEX Results - 3Q20

Groundwater samples were analyzed for the following constituents: BTEX by EPA Method 8260. Cumulative analytical results from each groundwater sampling station is documented in Table A-3 (attached). Analytical results for the 3Q20 groundwater monitoring event are summarized in Table 2 below and shown in Figure 6.

- Quarterly groundwater monitoring revealed that:
  - Concentrations of BTEX were below human health criteria and laboratory detection limits in all samples (i.e., MW1 – MW6)

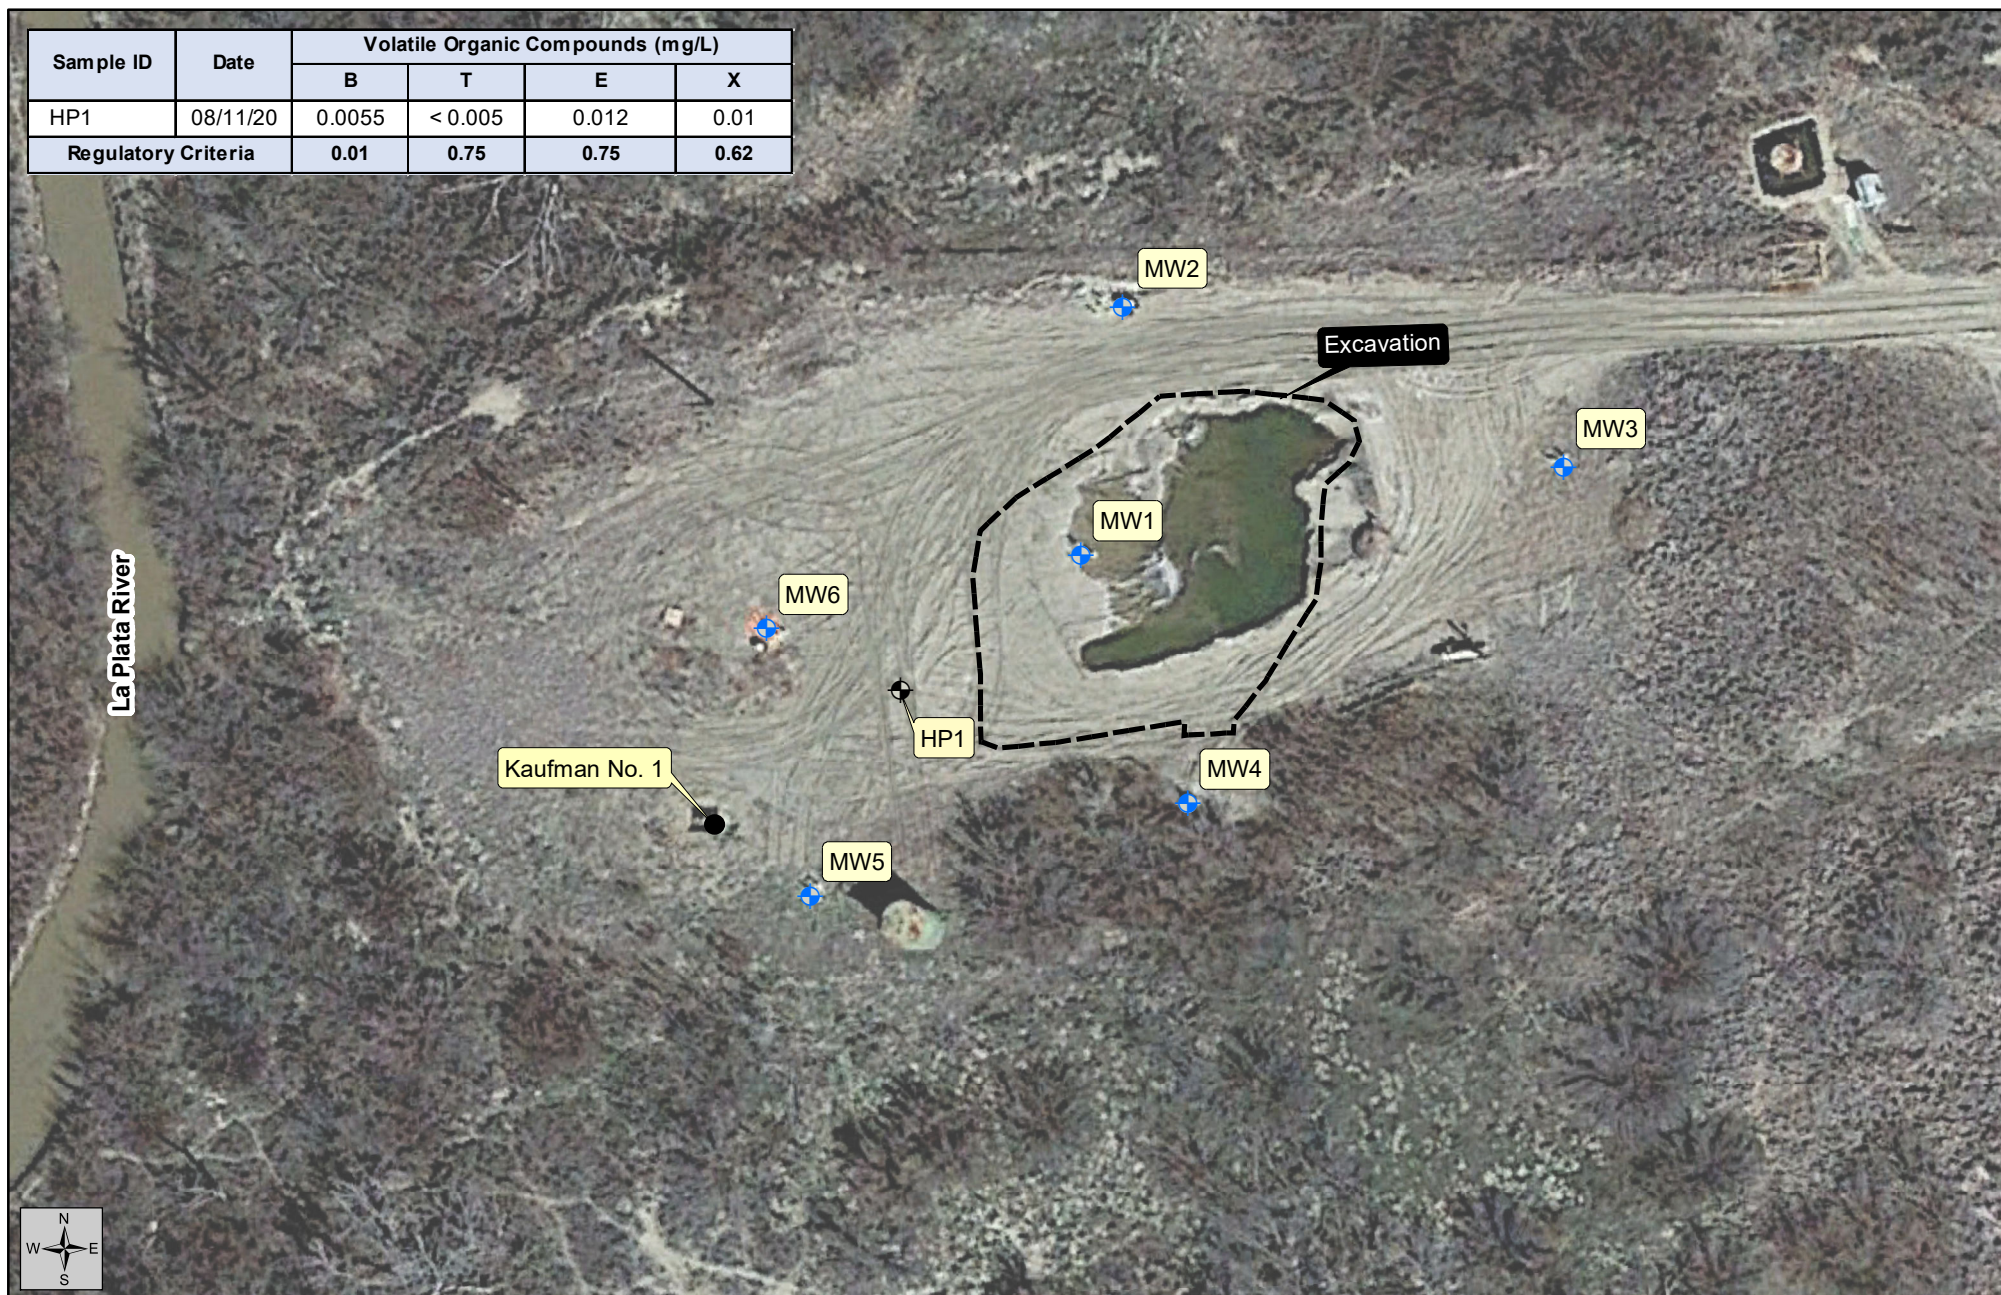
**Figure 7**  
Additional Groundwater  
Investigation

On 08/11/20, Timberwolf conducted an additional groundwater investigation at the Site. The purpose of the investigation was to determine if a residual groundwater plume was present between MW1 and MW5. To evaluate the area of concern, a groundwater sample was collected by installing a temporary sampling point in lieu of MW7 as proposed in “Further Actions” section of the *Status Report – 2<sup>nd</sup> Quarter 2020*. Location of temporary sampling point is shown in Figure 7.

A groundwater sample (i.e., HP1) was collected from the temporary sampling point using a 3/8-inch bailer. Sample HP1 was submitted to Hall Environmental for BTEX analysis. Analytical results of HP1 revealed all constituents of BTEX were below the Site’s regulatory criteria. Laboratory results are documented in the attached laboratory report and summarized in the Table 4 below.

- Groundwater flow across the Site is west-southwest towards the La Plata River
- Additional groundwater investigation revealed:
  - Concentrations of benzene, ethylbenzene, and xylene in sample HP1 were above laboratory detection limits but below established human health criteria limits

- This demonstrates that groundwater in the area of concern (i.e., between MW1 and MW5) does not present a risk to human health
  - Toluene concentrations in HP1 were below laboratory detection limits and established human health criteria

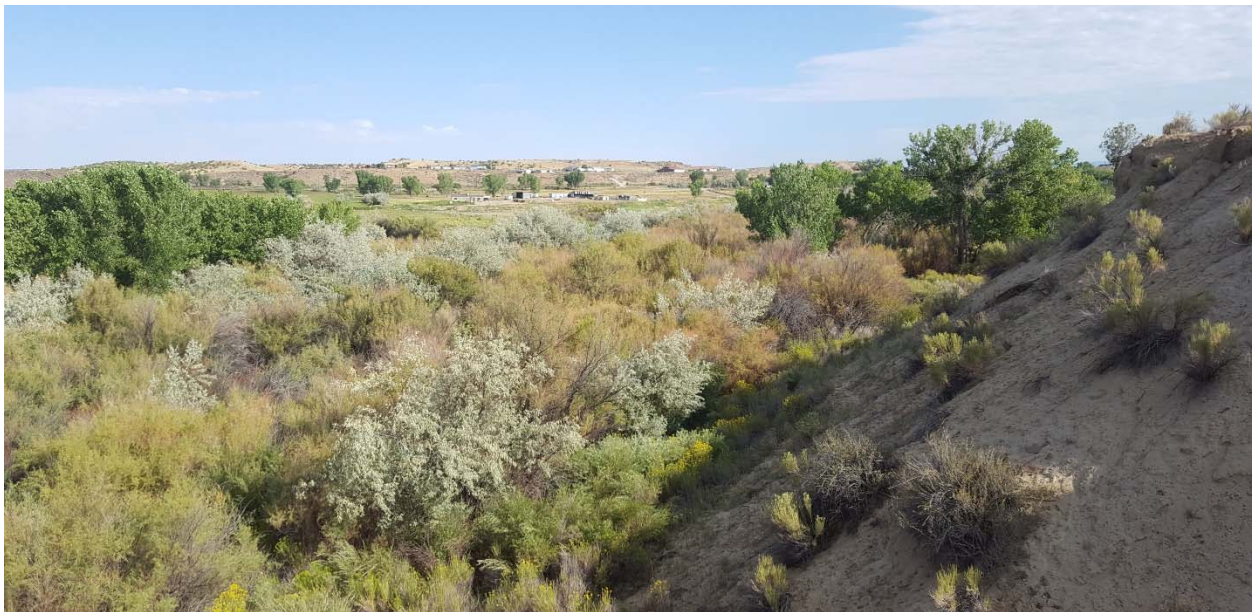
8/03/2020: Photo from midway along the survey area facing north towards the northern survey area. Note areas of tamarisk impacted by tamarisk beetles (*Diorhabda* sp.) as denoted by brown foliage.

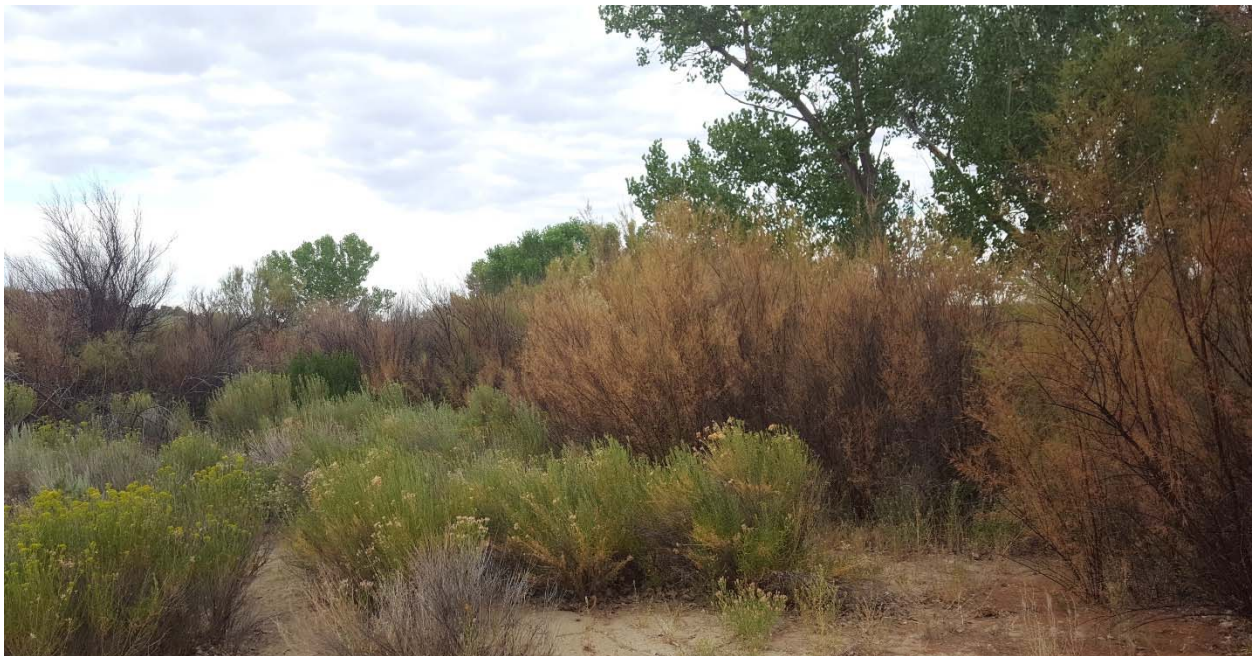
7/10/2020: Photo from the northeastern survey area facing north. Note impacts to tamarisk foliage.

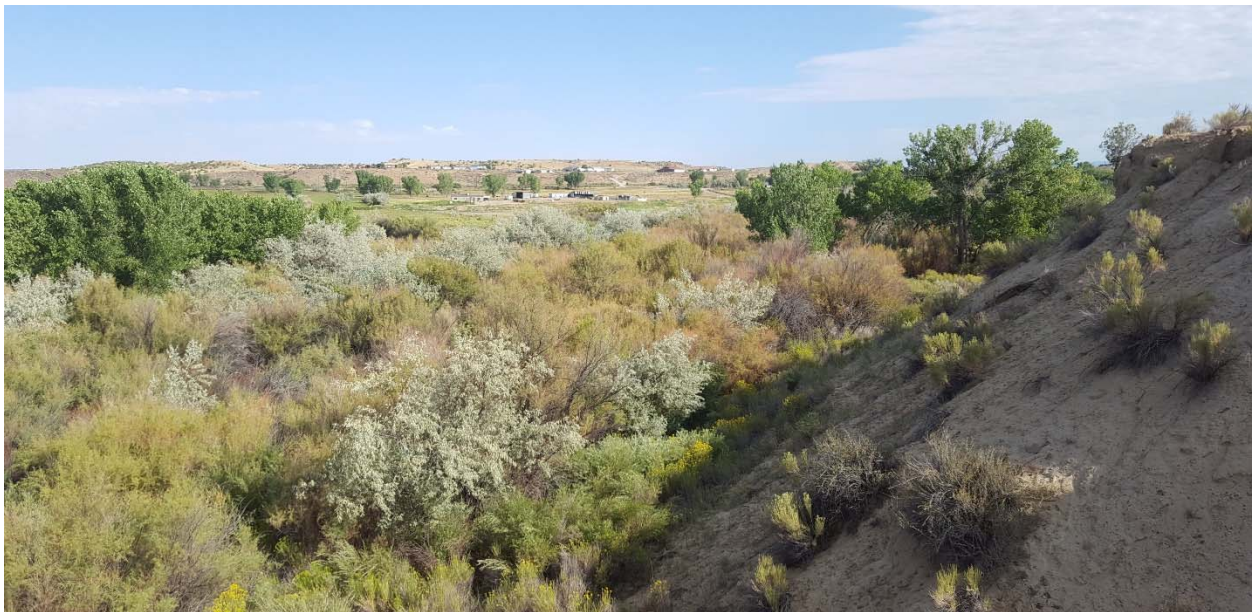
8/03/2020: Photo from the southern survey area facing north towards the northern survey area. Note areas of tamarisk impacted by tamarisk beetles (*Diorhabda* sp.) as denoted by brown foliage.

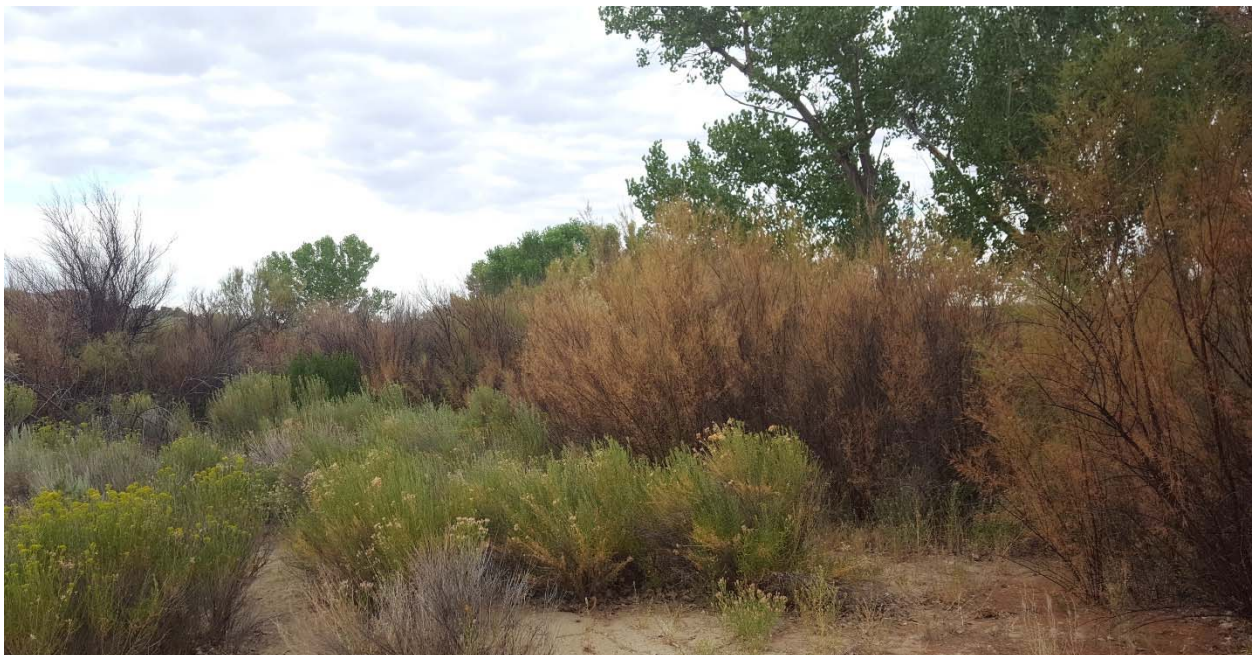
7/10/2020: Photo from the northeastern survey area facing north. Note impacts to tamarisk foliage. Also note sparse cottonwood cover along periphery of floodplain.
