SAN JUAN 30-4 UNIT 12

30-039-07878

Southland Royalty Company LLC/MorningStar Operating LLC submits the attached Final Abandonment report for the San Juan 30-4 Unit #12.

Reclamation Report for the San Juan 30-4 Unit #12 Well Pad and Access Road

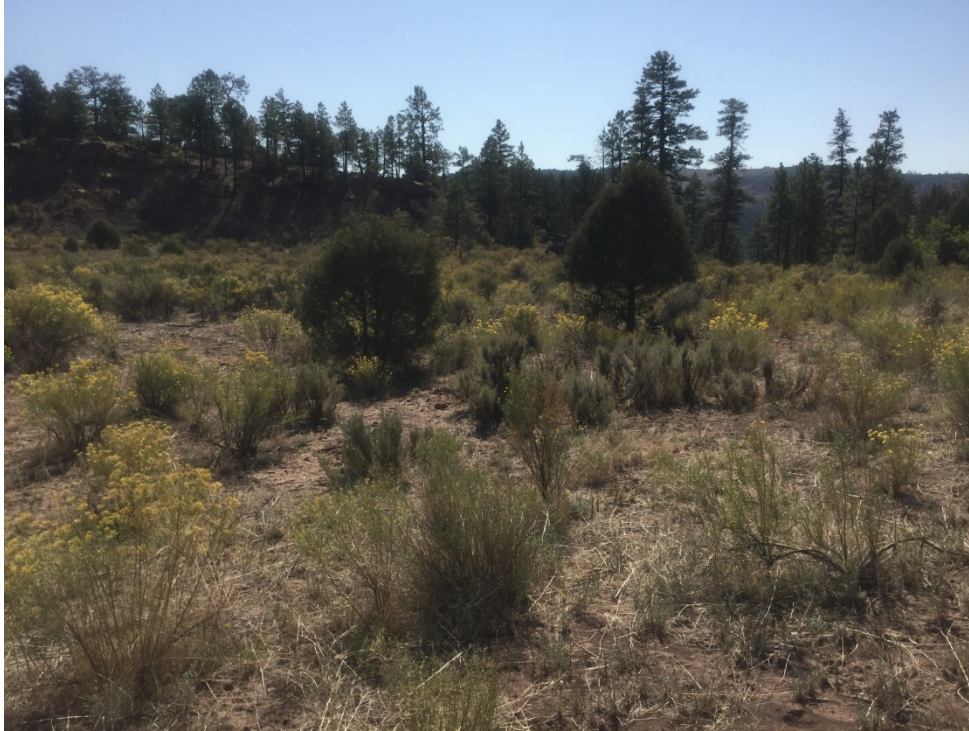
Vegetation on the reclaimed well pad is dominated by rubber rabbitbrush (*Ericameria nauseosa*). Understory vegetation consists of crested wheatgrass (*Agropyron cristatum*), western wheatgrass (*Pascopyrum smithii*), yarrow (*Achillea spp.*), and prairie sagewort (*Artemisia frigida*). The wheatgrasses on the well pad were heavily grazed, with evidence of both horses and cattle using the area. No NMDA A, B or C noxious species were observed. No cheatgrass (*Bromus tectorum*) was observed on the well pad. Minor erosion is evident on the well pad cut slopes. This erosion is limited to the slopes themselves. Dead trees, most likely from the well pad, have been piled in the drainage leading off the pad, assisting in erosion control. There is little erosion on the well pad or leading off the pad. Due to the rabbitbrush overstory, vegetation cover across the well pad is estimated at 60%. Adjacent vegetation cover is estimated at 40%. There is no trash or well debris on the well pad.

Reclaimed San Juan 30-4 #12 Well Pad

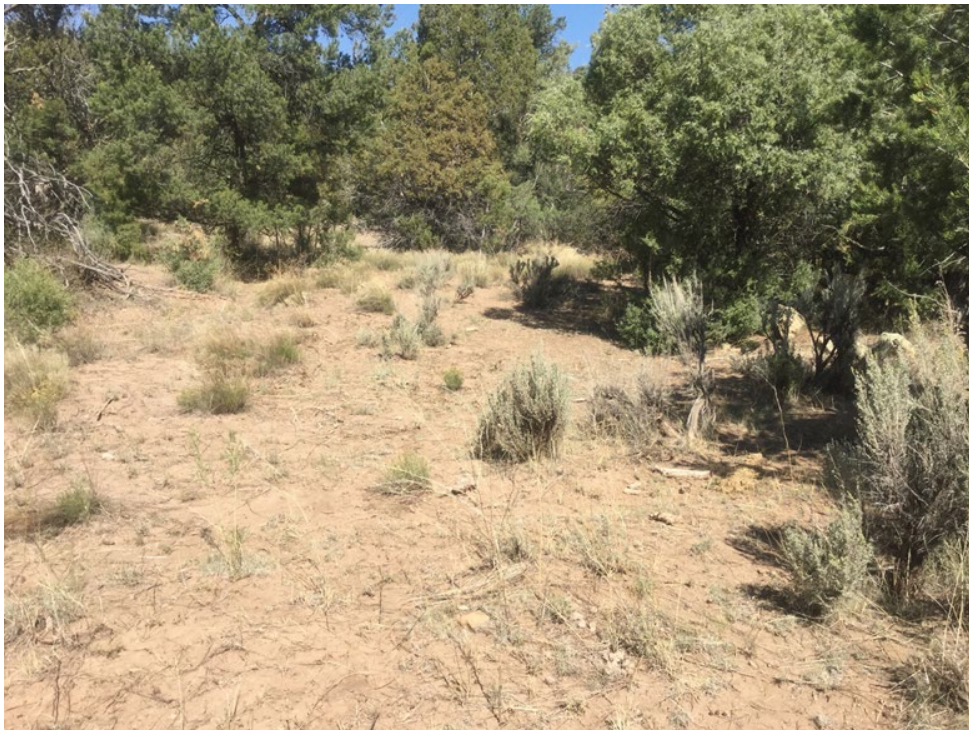
Undisturbed Area near the San Juan 30-4 #12 Well Pad

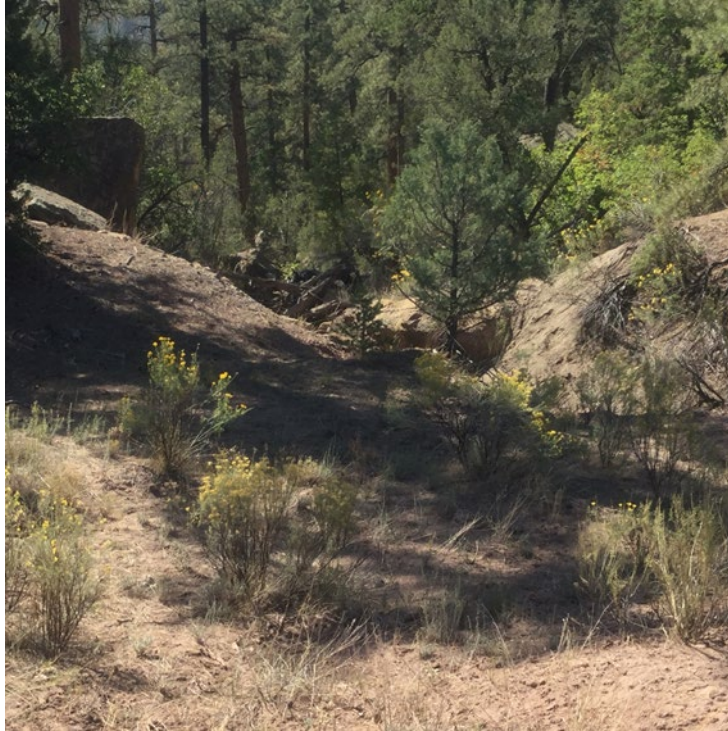
Dead Trees Placed in Drainage along Well Pad Fill Slope

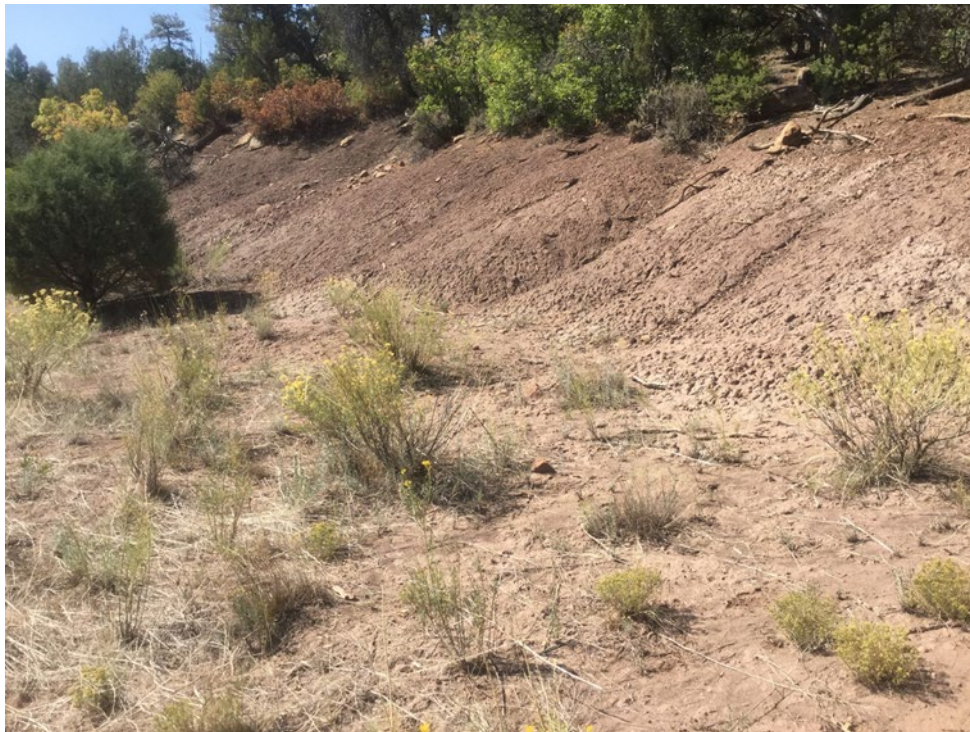
Well Pad Cut Slope, Showing some Erosion

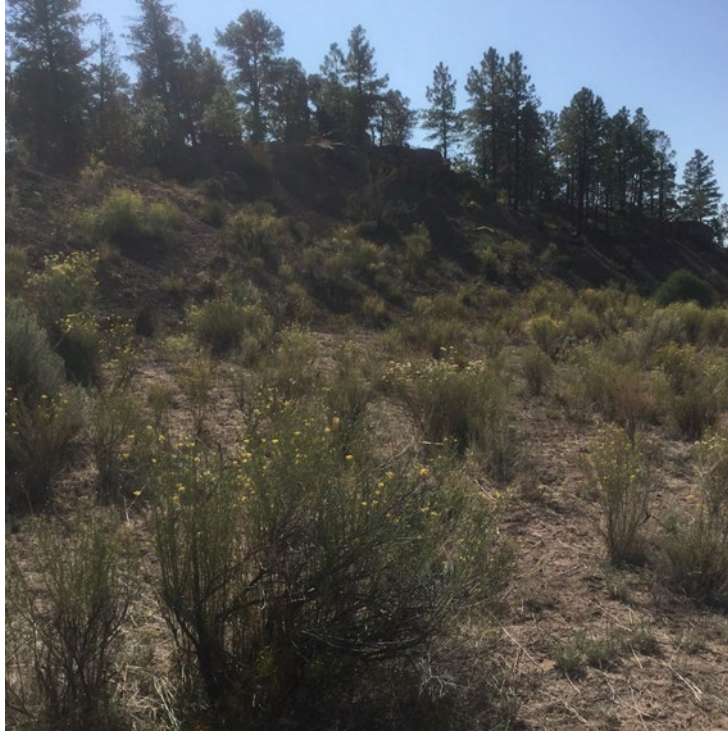
Well Pad Cut Slope with Little Erosion

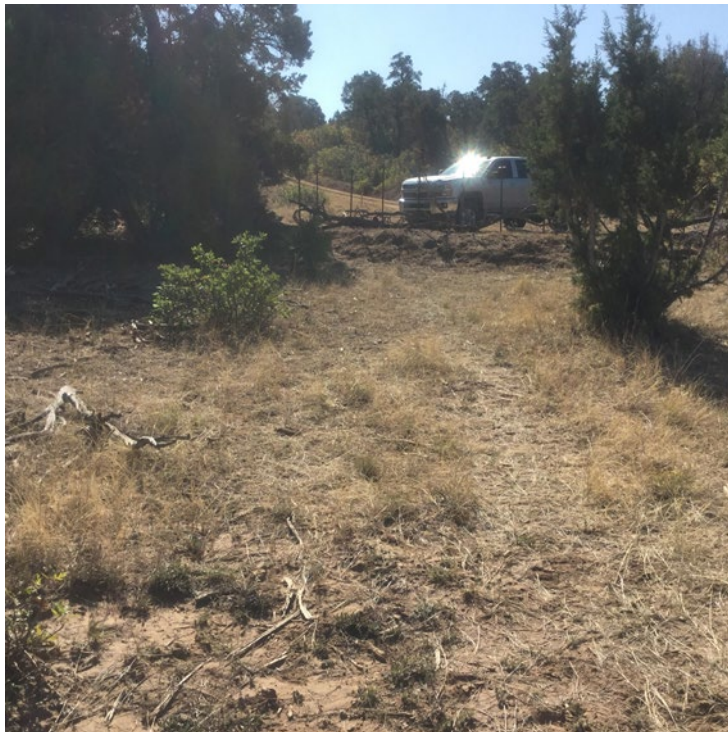
water bars. The water bars appear to be functioning correctly, as little to no erosion is occurring off the access road. The access road is blocked to vehicle access by a number of t-posts in place at the junction with Forest Service Road 310E1. Vegetation cover across the access road is estimated at 35%. Adjacent vegetation cover is estimated at 45%. There is no trash or well debris on the access road.

Access Road Blocked to Motorized Vehicles at the Junction of Forest Service Road 310E1

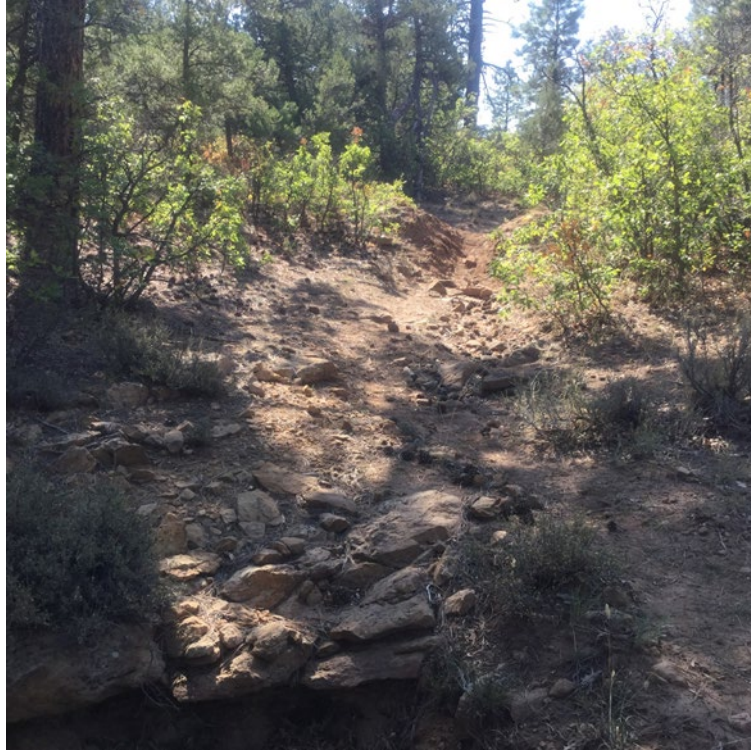
Vegetation on the access road is dominated by a variety of shrubs, including antelope bitterbrush (*Purshia tridentata*), big sagebrush (*Artemisia tridentata*), prairie sagewort, beetle silver sagebrush (*Artemisia cana*), and four-wing saltbush (*Atriplex canescens*). A number of young pinyon (*Pinus edulis* Engelm) and Utah juniper (*Juniperus osteosperma*) trees were noted. Grass species include crested wheatgrass and intermediate wheatgrass (*Thinopyrum intermedium*). No NMDA A, B or C noxious species were observed. No cheatgrass was observed on the access road. Some erosion is evident within the access road in a few places. However, this erosion has been contained to the road and properly drained off the road via

Erosion along Access Road

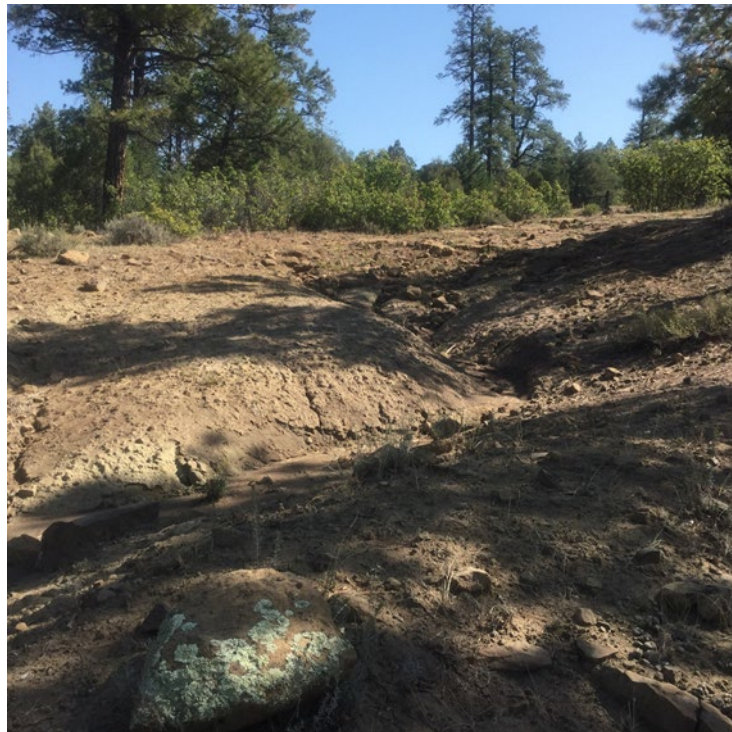
Erosion along Access Road

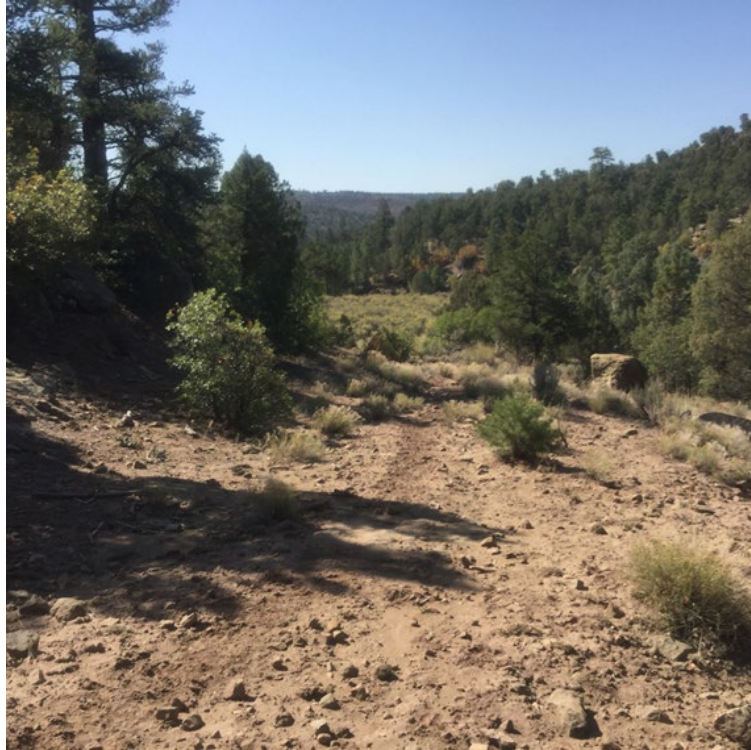
Access Road Looking South, Southwest to the Well Pad

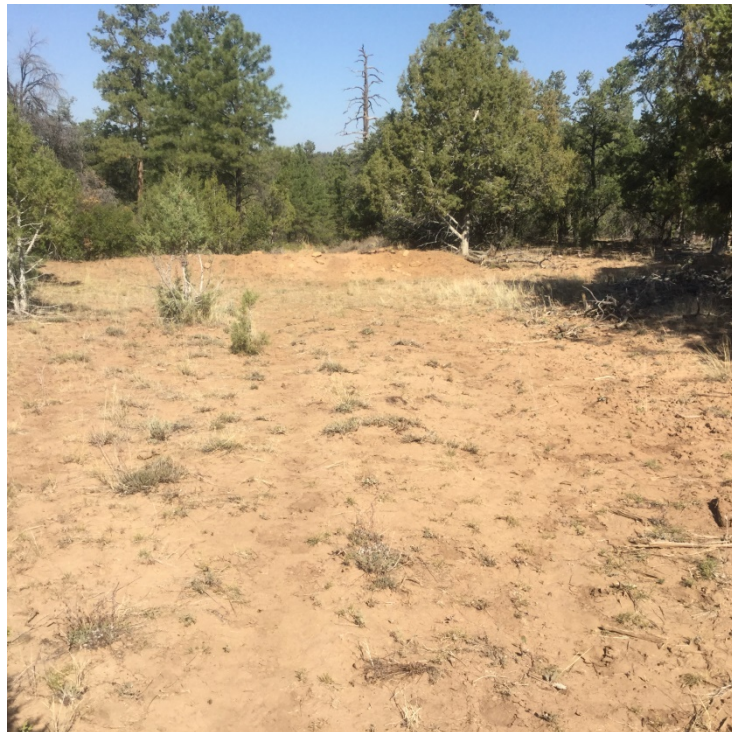
Water Bar within Access Road

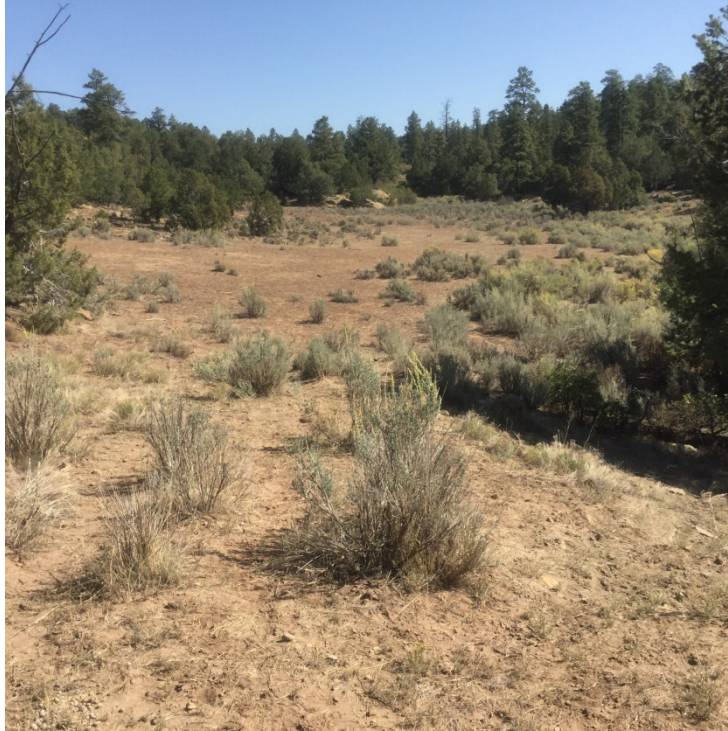
Area Adjacent to Access Road that Appears to have been Disturbed. Reason for Disturbance Unknown

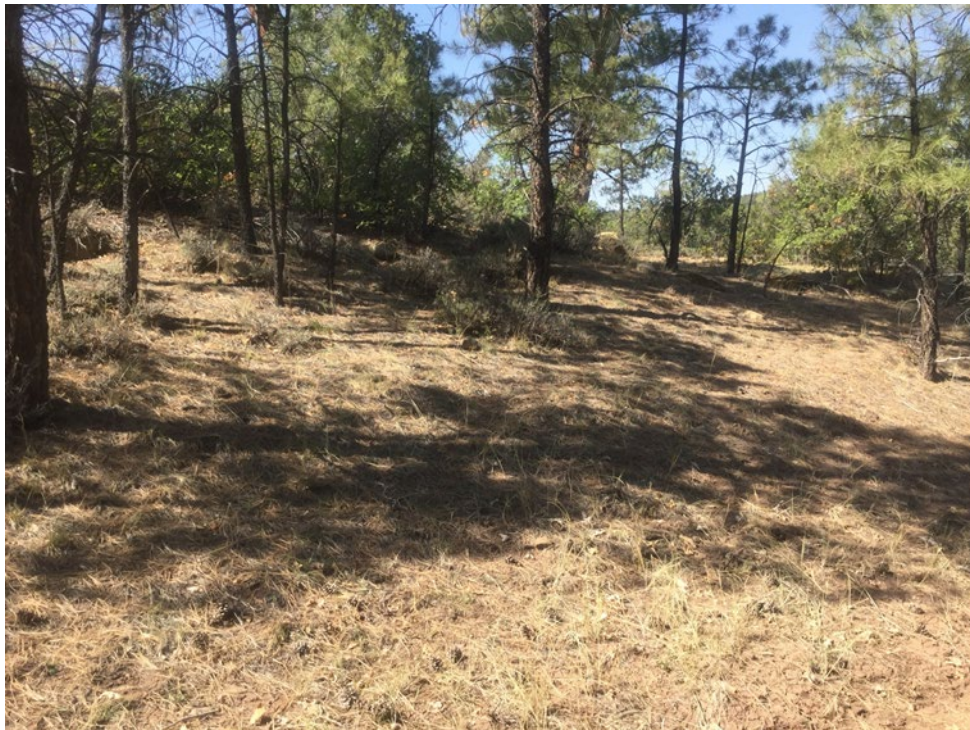
Undisturbed Area Adjacent to the Access Road

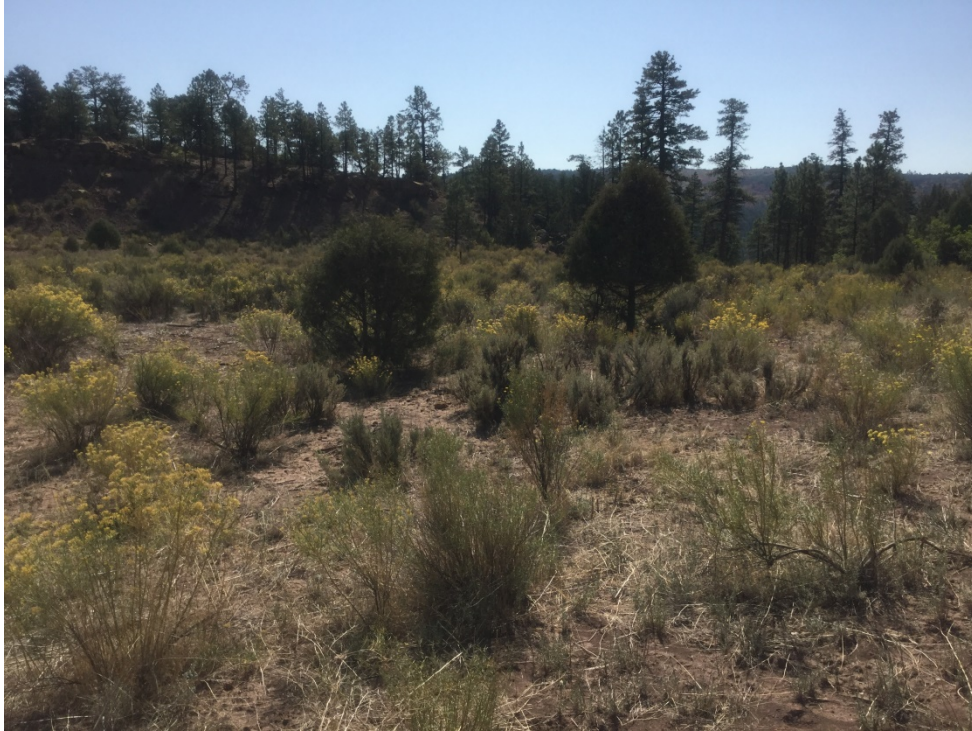
Vegetation on the reclaimed well pad is dominated by rubber rabbitbrush (*Ericameria nauseosa*). Understory vegetation consists of crested wheatgrass (*Agropyron cristatum*), western wheatgrass (*Pascopyrum smithii*), yarrow (*Achillea spp.*), and prairie sagewort (*Artemisia frigida*). The wheatgrasses on the well pad were heavily grazed, with evidence of both horses and cattle using the area. No NMDA A, B or C noxious species were observed. No cheatgrass (*Bromus tectorum*) was observed on the well pad. Minor erosion is evident on the well pad cut slopes. This erosion is limited to the slopes themselves. Dead trees, most likely from the well pad, have been piled in the drainage leading off the pad, assisting in erosion control. There is little erosion on the well pad or leading off the pad. Due to the rabbitbrush overstory, vegetation cover across the well pad is estimated at 60%. Adjacent vegetation cover is estimated at 40%. There is no trash or well debris on the well pad.

Reclaimed San Juan 30-4 #12 Well Pad

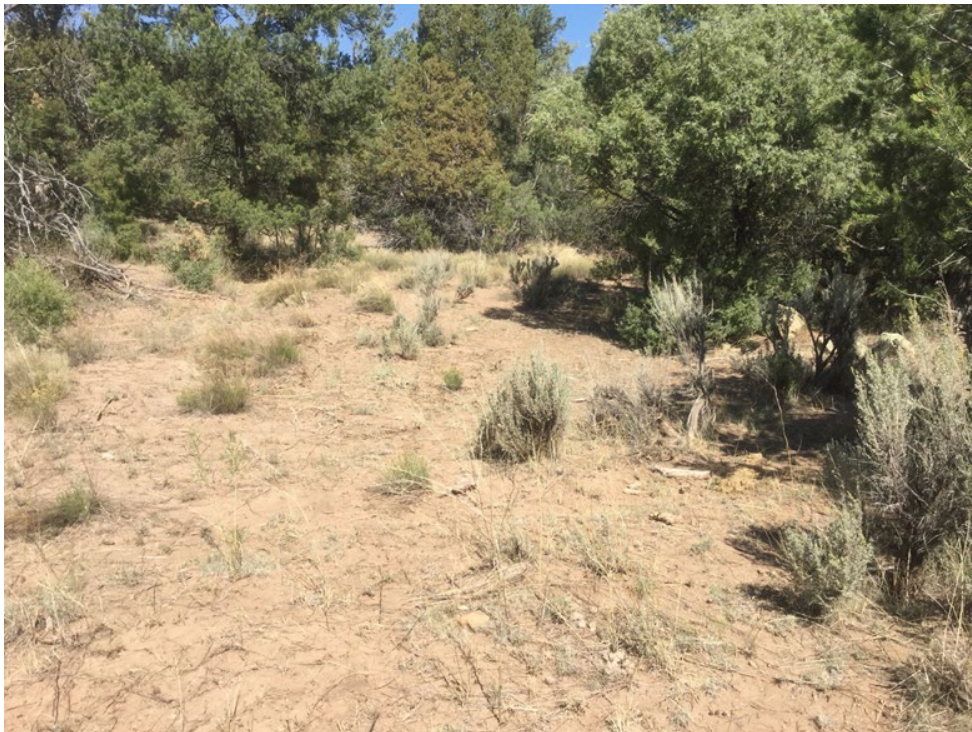
Undisturbed Area near the San Juan 30-4 #12 Well Pad

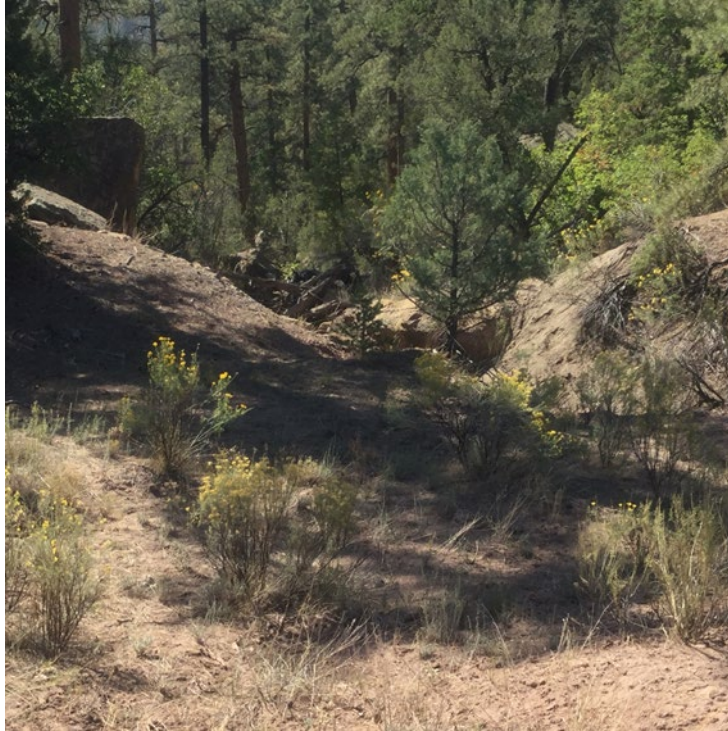
Dead Trees Placed in Drainage along Well Pad Fill Slope

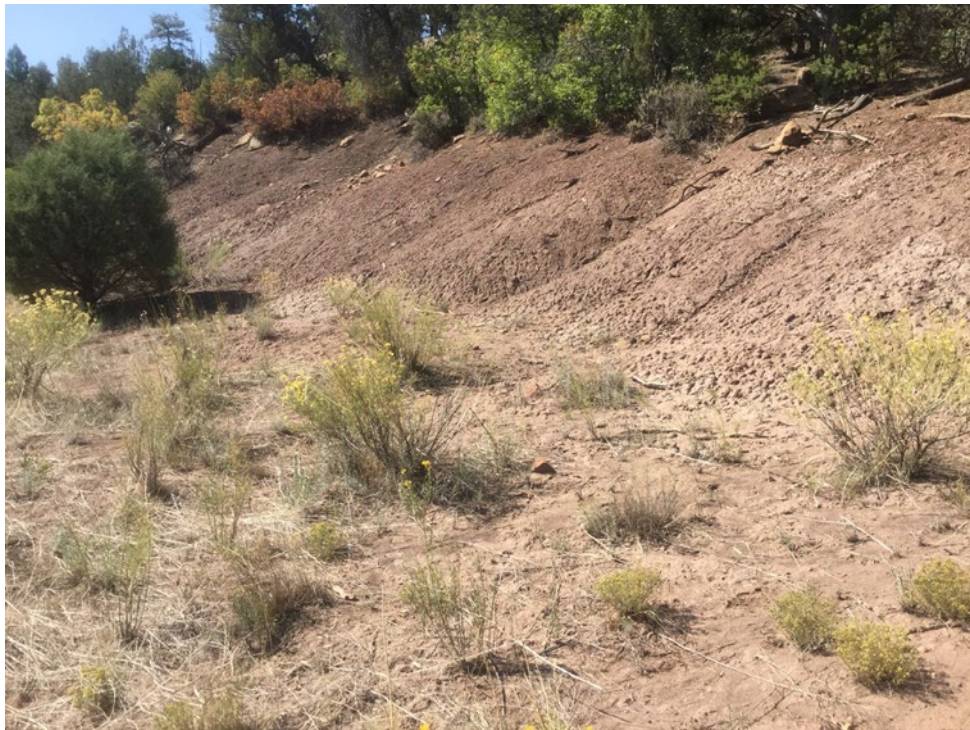
Well Pad Cut Slope, Showing some Erosion

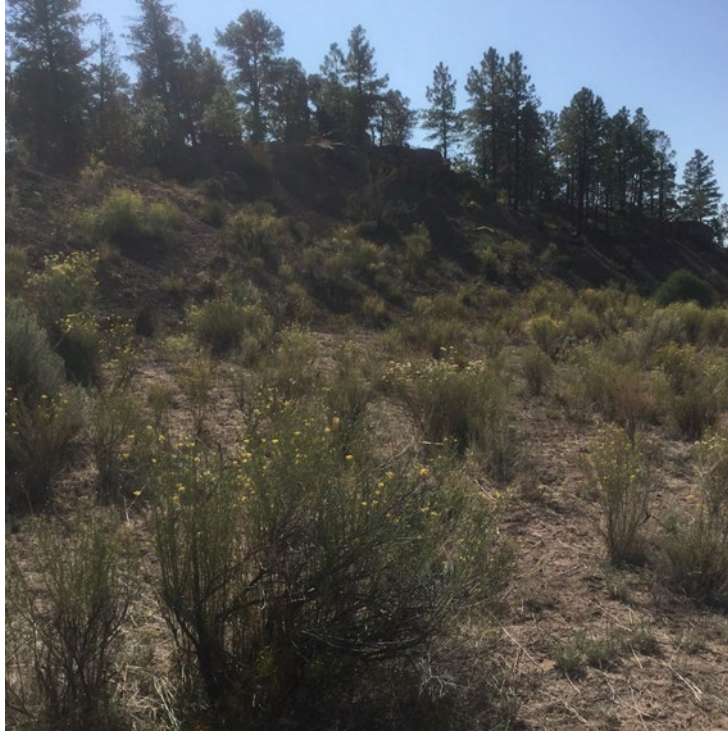
Well Pad Cut Slope with Little Erosion

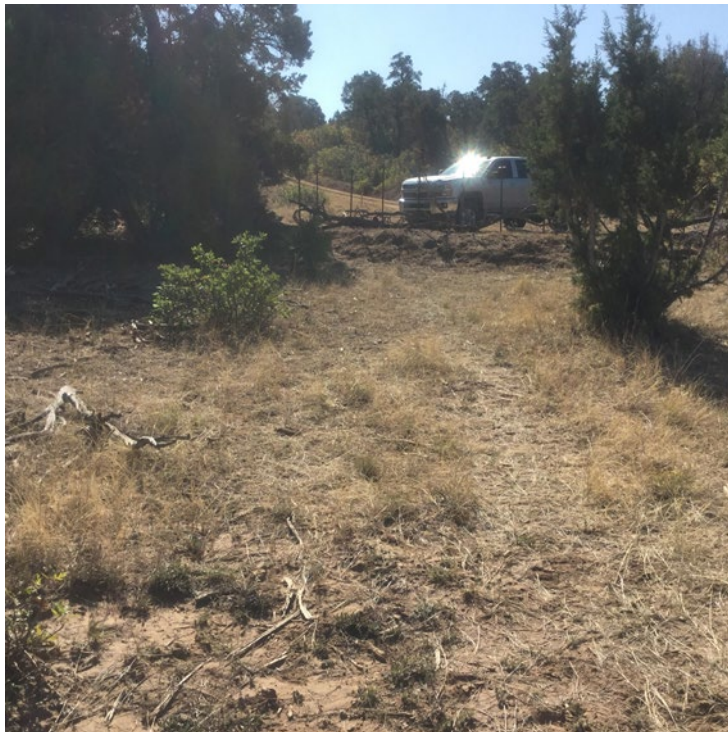
water bars. The water bars appear to be functioning correctly, as little to no erosion is occurring off the access road. The access road is blocked to vehicle access by a number of t-posts in place at the junction with Forest Service Road 310E1. Vegetation cover across the access road is estimated at 35%. Adjacent vegetation cover is estimated at 45%. There is no trash or well debris on the access road.

Access Road Blocked to Motorized Vehicles at the Junction of Forest Service Road 310E1

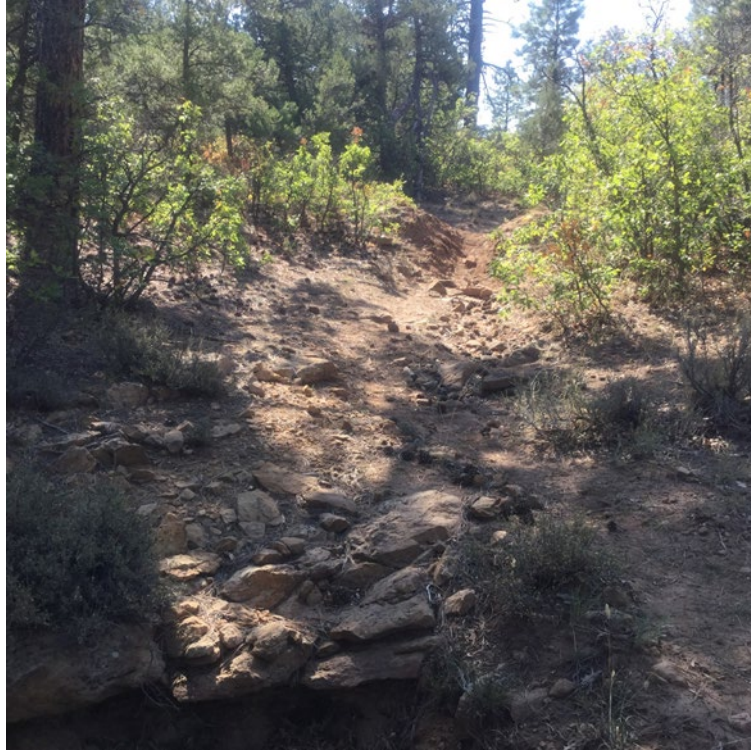
Vegetation on the access road is dominated by a variety of shrubs, including antelope bitterbrush (*Purshia tridentata*), big sagebrush (*Artemisia tridentata*), prairie sagewort, beetle silver sagebrush (*Artemisia cana*), and four-wing saltbush (*Atriplex canescens*). A number of young pinyon (*Pinus edulis* Engelm) and Utah juniper (*Juniperus osteosperma*) trees were noted. Grass species include crested wheatgrass and intermediate wheatgrass (*Thinopyrum intermedium*). No NMDA A, B or C noxious species were observed. No cheatgrass was observed on the access road. Some erosion is evident within the access road in a few places. However, this erosion has been contained to the road and properly drained off the road via

Erosion along Access Road

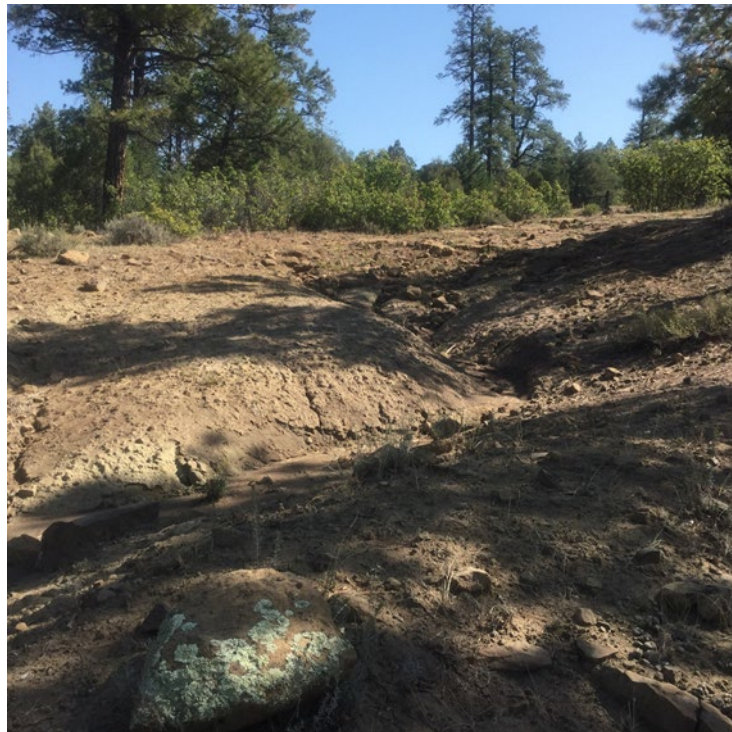
Erosion along Access Road

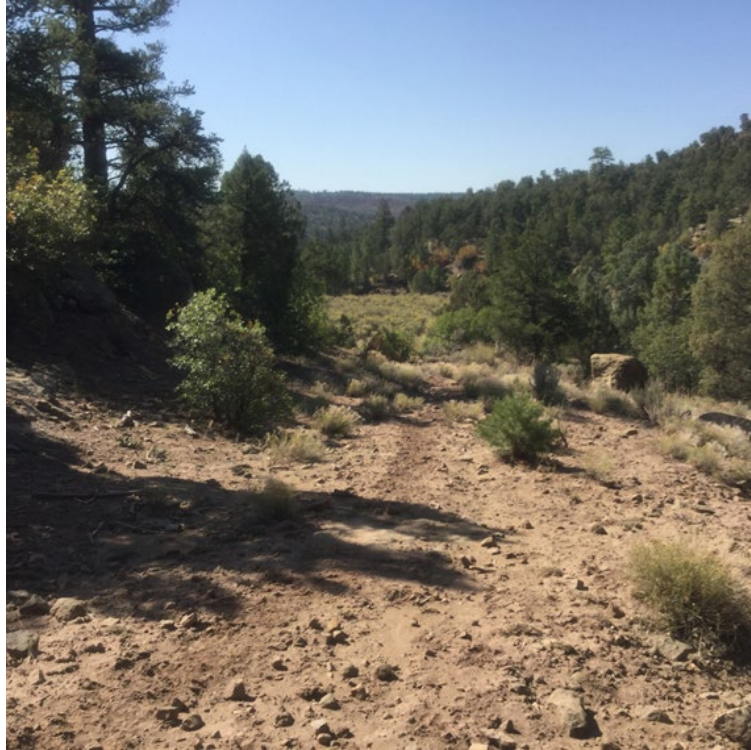
Access Road Looking South, Southwest to the Well Pad

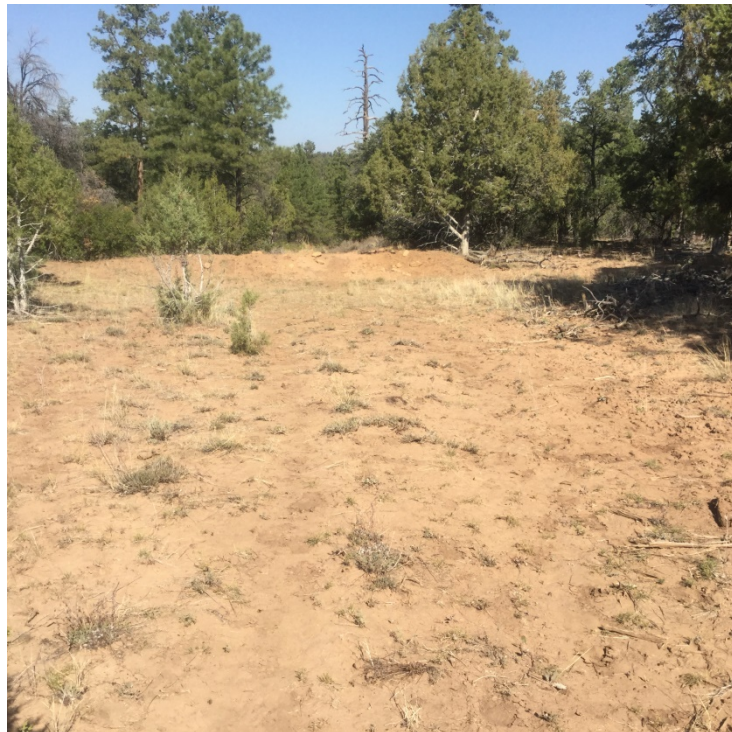
Water Bar within Access Road

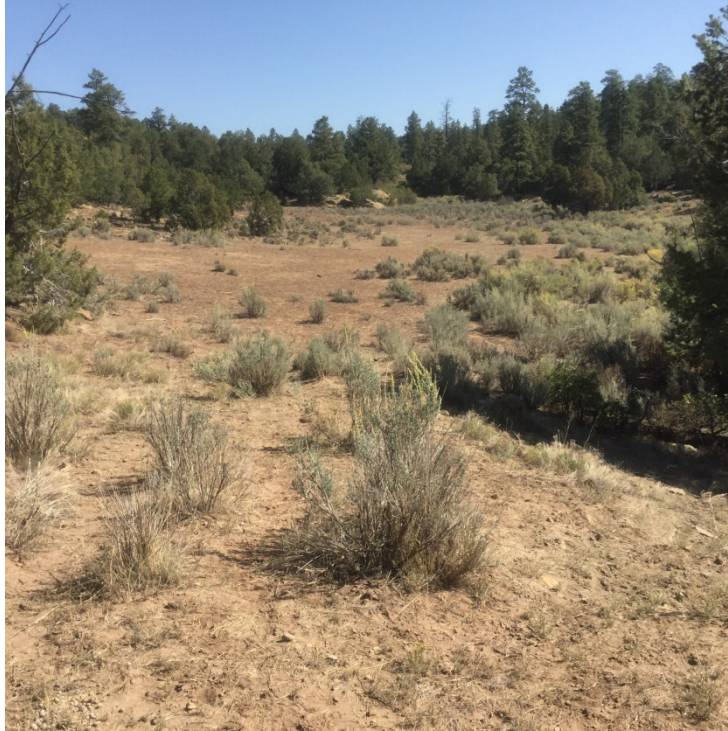
Area Adjacent to Access Road that Appears to have been Disturbed. Reason for Disturbance Unknown

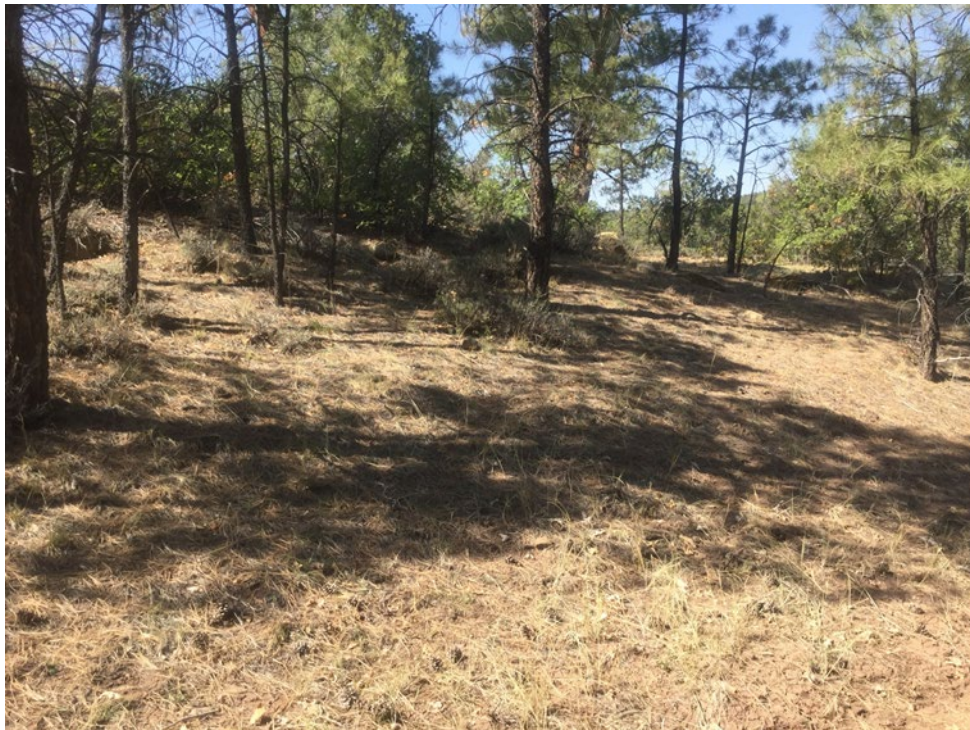
Undisturbed Area Adjacent to the Access Road
