Release Notification and Corrective Action

Name of Company: XTO Energy, Inc.	Contact: James McDaniel
Address: 382 Road 3100, Aztec, New Mexico 87410	Telephone No.: (505) 333-3701
Facility Name: Pipeline Near NV Kyle 23 #3 (30-045-33433)	Facility Type: Pipeline

XTO Energy, Inc.
NV Kyle 23 #3 (30-045-33433)
Section 23, Township 29N, Range 14W
9/17/2013

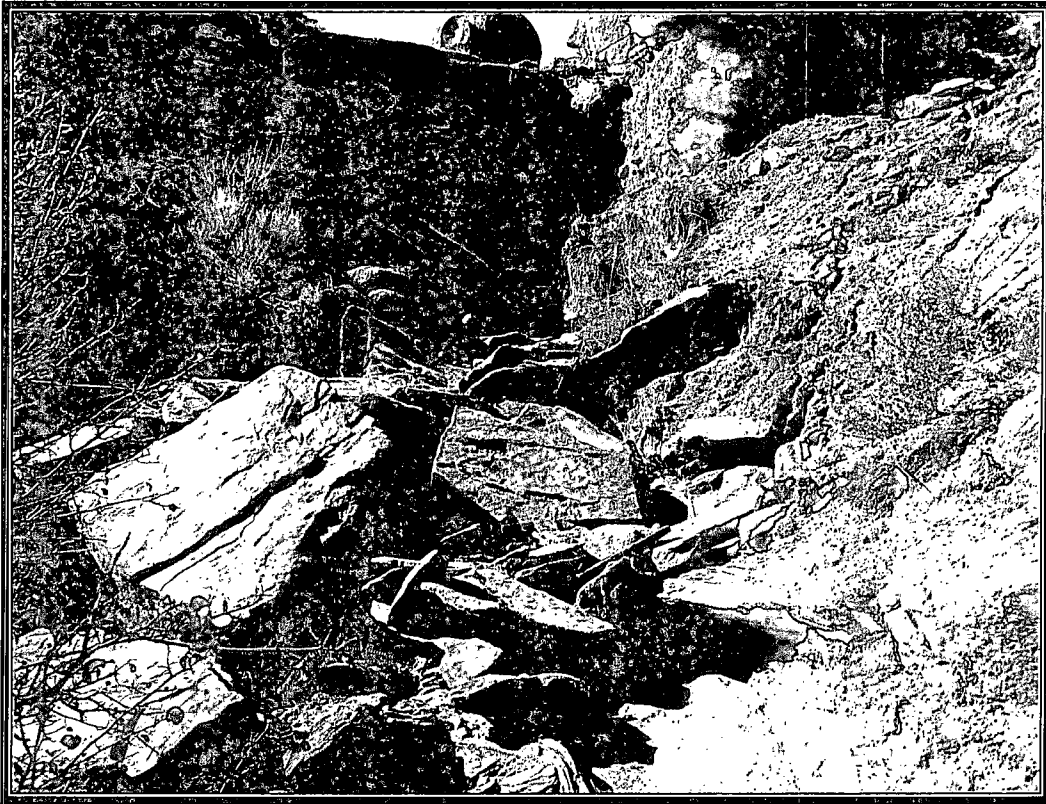
We received our approval from the Historic Preservation Department earlier this week, and due to the large amount of rain we have received in the past weeks, we wanted to go take a look at the spill area and see what we were looking at. Upon visual inspection, it appears that visual signs of the spill are mostly gone. With this in mind, we collected a composite sample from the wash area in a three point composite along the spill area, approximately 0-6" deep. The sample was analyzed for chlorides, and sample returned results of only 120 mg/kg. With the visual signs of the spill mostly gone, and the chloride levels below even groundwater standards, I cannot see a benefit to a flush of this location any longer, and feel that any remediation activities would add no benefit to human health or the environment. XTO proposes that we close this incident as is, and submit the final closure paperwork accordingly. Thank you for your time in regards to this matter. Photos of the spill area and sampling results are attached for your reference.

Photo 1: Ravine after Rain (View 1)

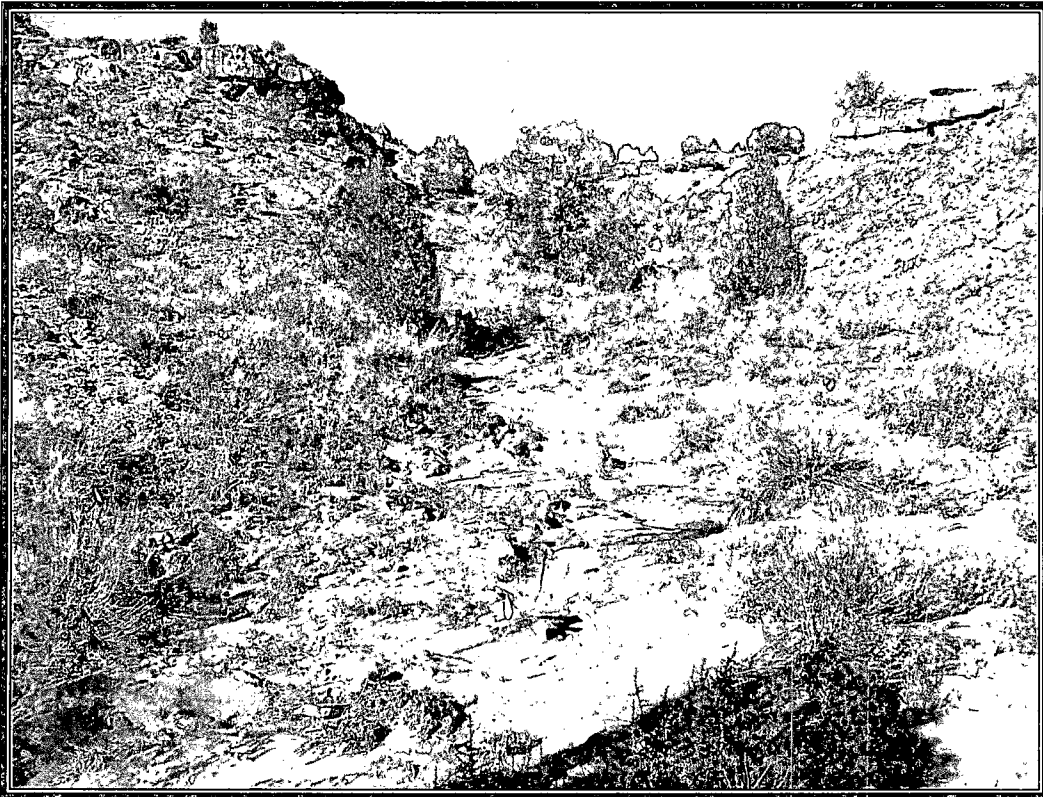
Photo 2: Ravine after Rain (View 2)

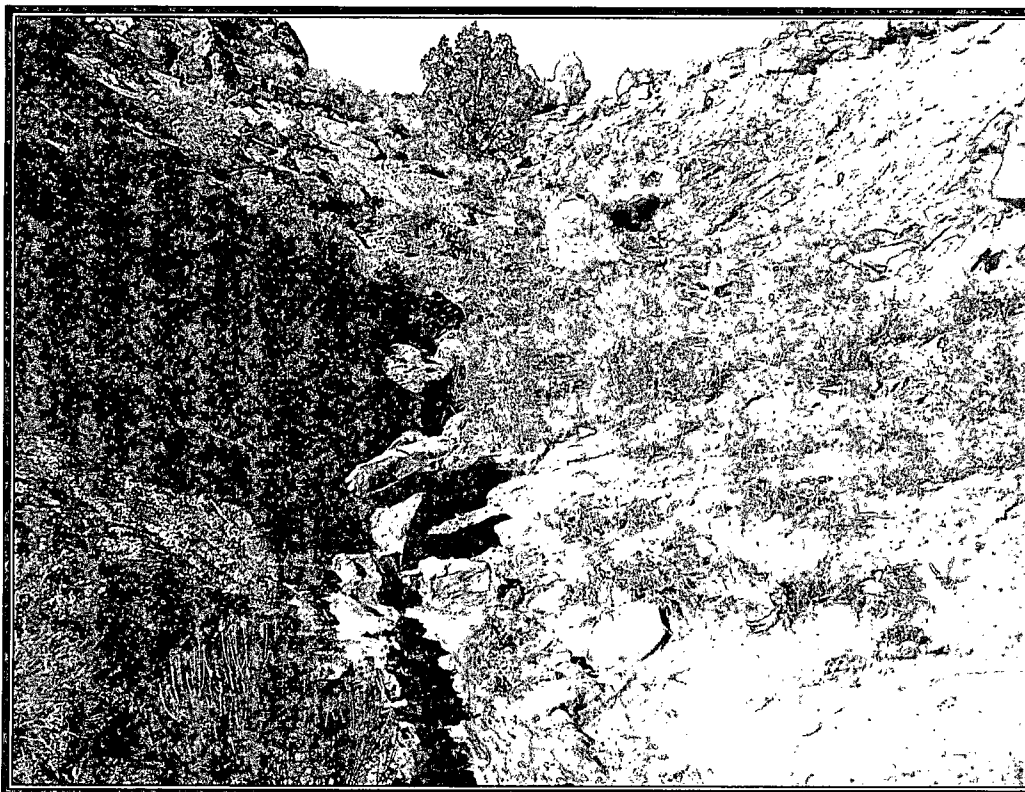
Photo 3: Ravine after Rain (View 3)

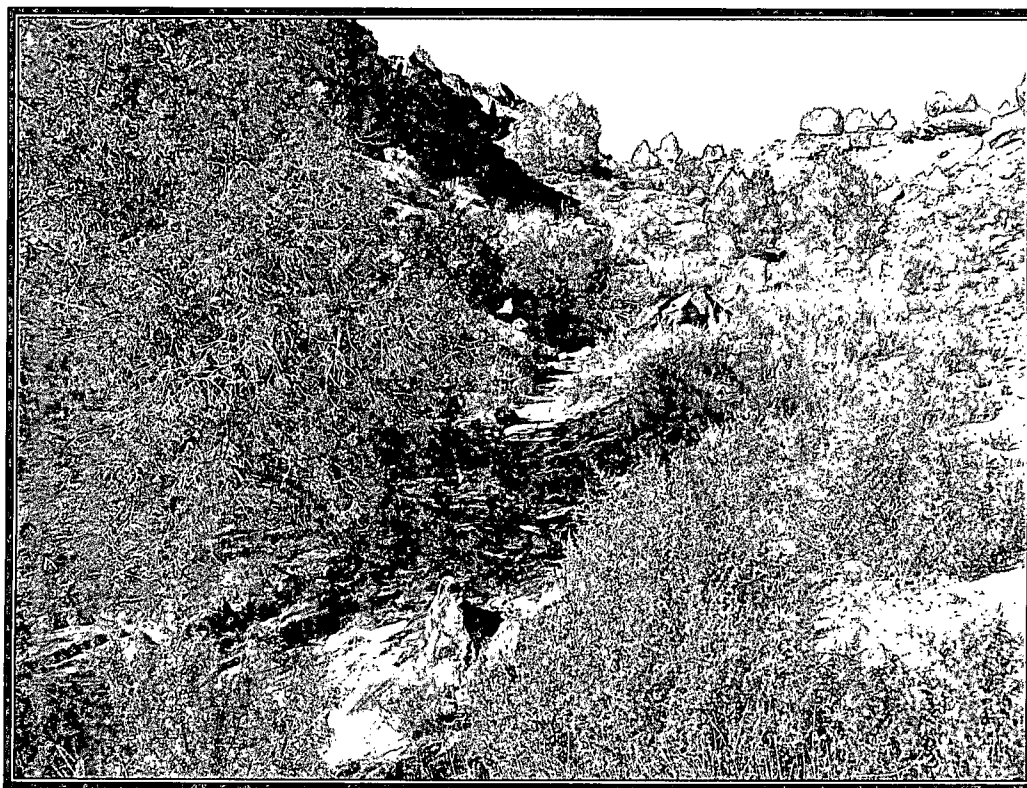
Photo 4: Ravine after Rain (View 4)
