Release Notification and Corrective Action

Name of Company: HPOC, LLC	Contact: Butch Butler
Address: PO Box 5046, Buena Vista, CO 81211	Telephone No.: Office-719-395-8059; Butch's cell-719-207-0164
Facility Name: Eagle Springs Injection Facility	Facility Type: Injection building
Surface Owner: BLM	Mineral Owner: BLM
API No: 30-043-20950 (Closest well)

Eagle Springs Spill Analysis

Charge pump failure Jan. 5, 2015

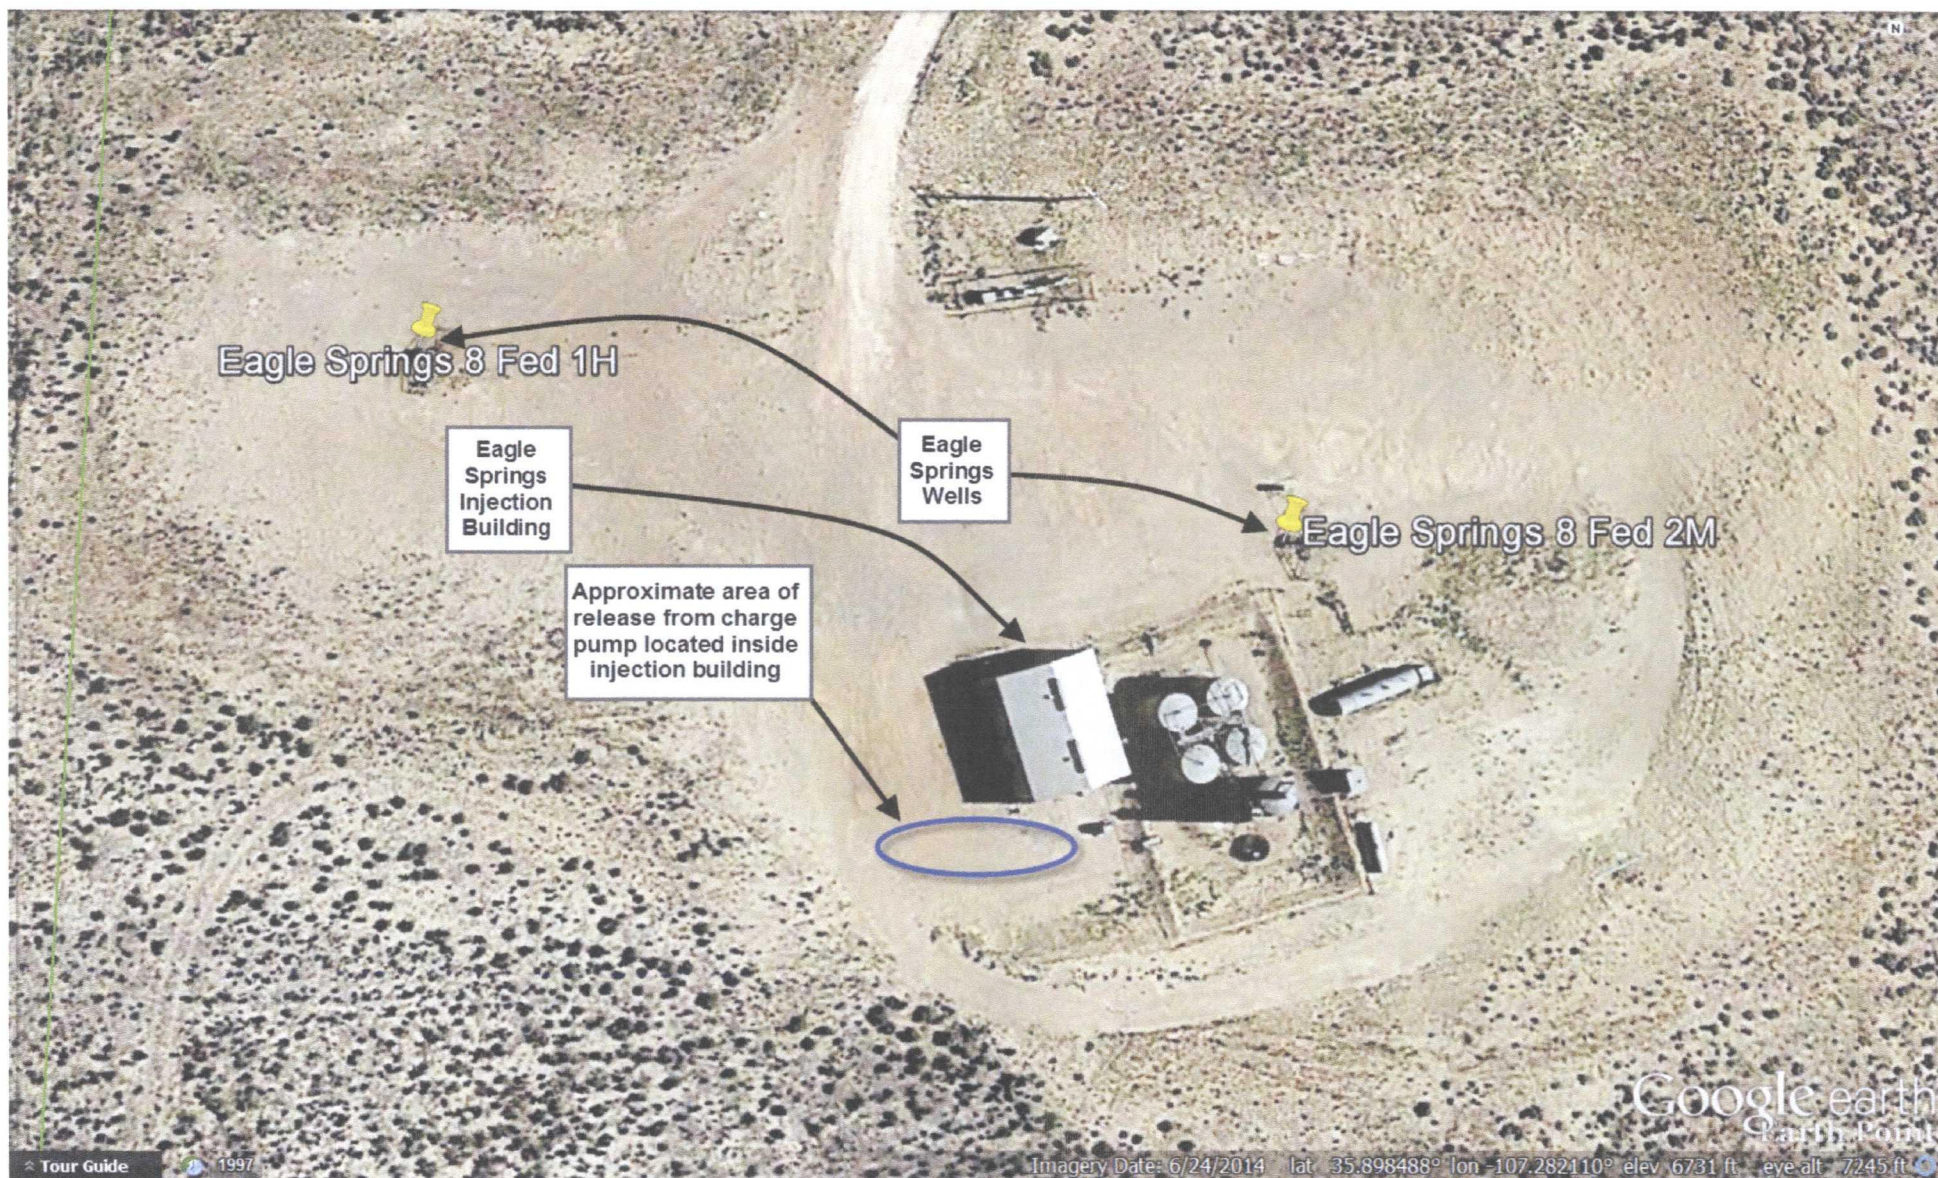
Describe Cause of Problem and Remedial Action Taken.* The charge pump, which is part of our injection system, failed. This small pump is located inside--on the south end of our injection building--at Eagle Springs. Water ran out the south end of the building and ponded up south & west of the building. See Goggle Earth image that accompanies this release notification. We have discussed the pump failure with our pump vendor and implemented new maintenance procedures for the charge pump, which should prevent this from happening again.

Describe Area Affected and Cleanup Action Taken.* When the charge pump failed, it leaked water onto the concrete floor of HPOC's injection building at Eagle Springs. The water ran under the metal siding on the south end of the building and onto the ground to the south and southwest of the building. HPOC field personnel estimated the area covered by water to be 20 ft X 60 ft in size and 1/2" in depth. See the Google Earth annotated image of the facilities and the approximate area of the spill that follows. To estimate the spill volume, HPOC office staff erred on the high side and estimated the water depth at 0.1', or 1.2". This gives a spills volume of 21 bbls. See the calculation sheet that follows. HPOC will be collecting soil samples from the spill area as directed by Shari Ketcham of the BLM and Cory Smith of NM OCD. A 5-point composite sample will be collected in the spill area and tested for TPH, BTEX/Benzine and Chlorides. A background soil sample will also be collected approximately 20-30 feet from the spill area and tested for chlorides to determine the background chloride level in the local soils. Once the results of these analyses are returned from the lab, a detailed remediation plan will be developed with the BLM and NM OCD. Once remediation is completed, a final C-141 will be submitted.
