Release Notification and Corrective Action

Name of Company : Synergy Operating, LLC	Contact: Thomas E. Mullins
Address: PO Box 5513, Farmington, NM 87499	Telephone No.: (505) 325-5449
Facility Name: Tayler 29-13	Facility Type: Well Location
Surface Owner: BLM	Mineral Owner
API No.: 30-043-20569

From: Tom Mullins <tom.mullins@synergyoperating.com>
Sent: Tuesday, July 14, 2015 9:41 PM
To: Lucas Vargo (lvargo@blm.gov); Jonathan EMNRD Kelly (Jonathan.Kelly@state.nm.us)
Cc: Justin Ingram (nevertoslow1247@gmail.com)
Subject: Tayler 29-13 - Site Visit Today
Attachments: 2015.07.14 - Scan of location plat - Tayler 29-13 from APD.pdf

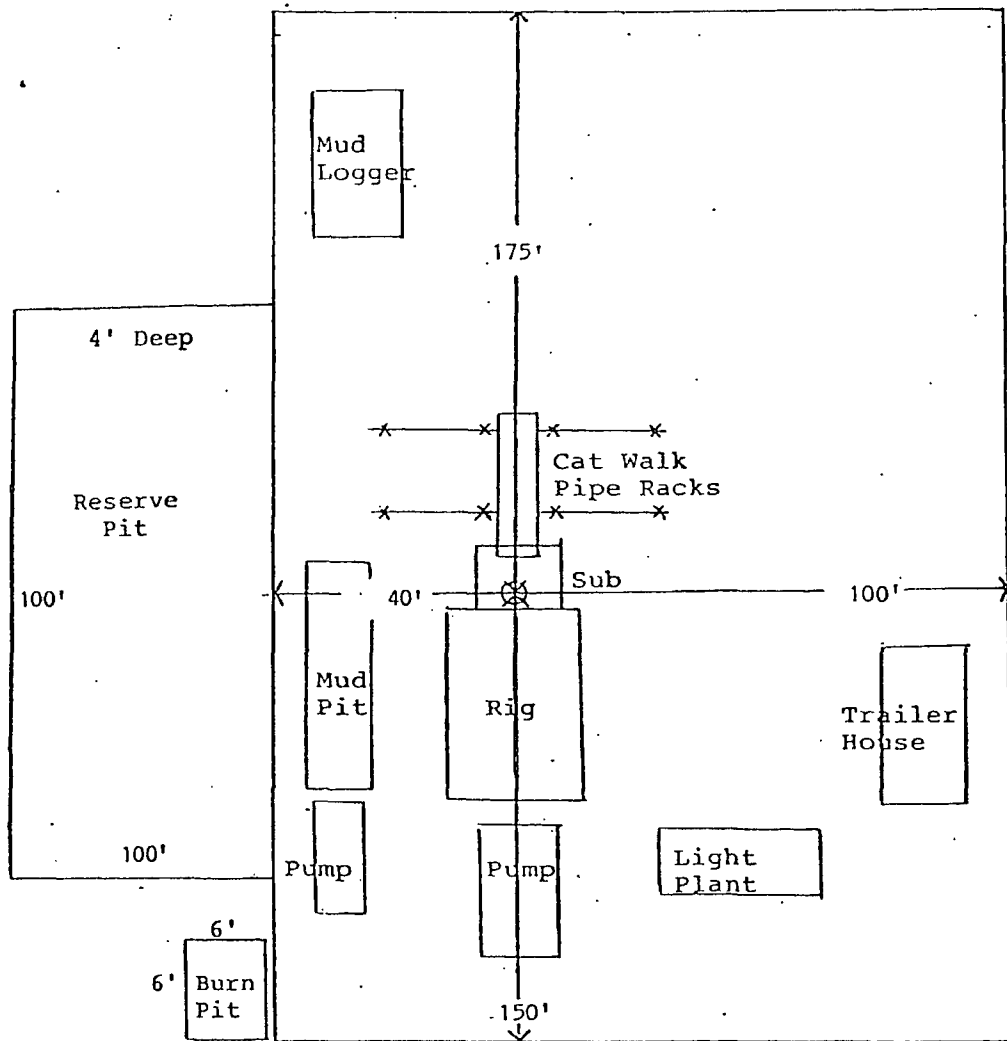
SCHEMATIC
LOCATION LAYOUT PLAN

- a) Attached is the well location plat that detailed the initial well location disturbance for the Tayler 29-13. As we recognized on the well location, the lower tier to the Southeast was part of the original permitted location disturbance.

- b) Plan to mark off the distance (measure bee line) to the end of the spill, on the lower tier, and represent on a modified version of the attached plat. This will confirm the impacted area is on the original permitted disturbance/pad.
