SUNDRY NOTICES AND REPORTS ON WELLS

BARNES LS 7M

API # 30-045-32491

Location: Unit E - Sec 23 - T32N - R11W

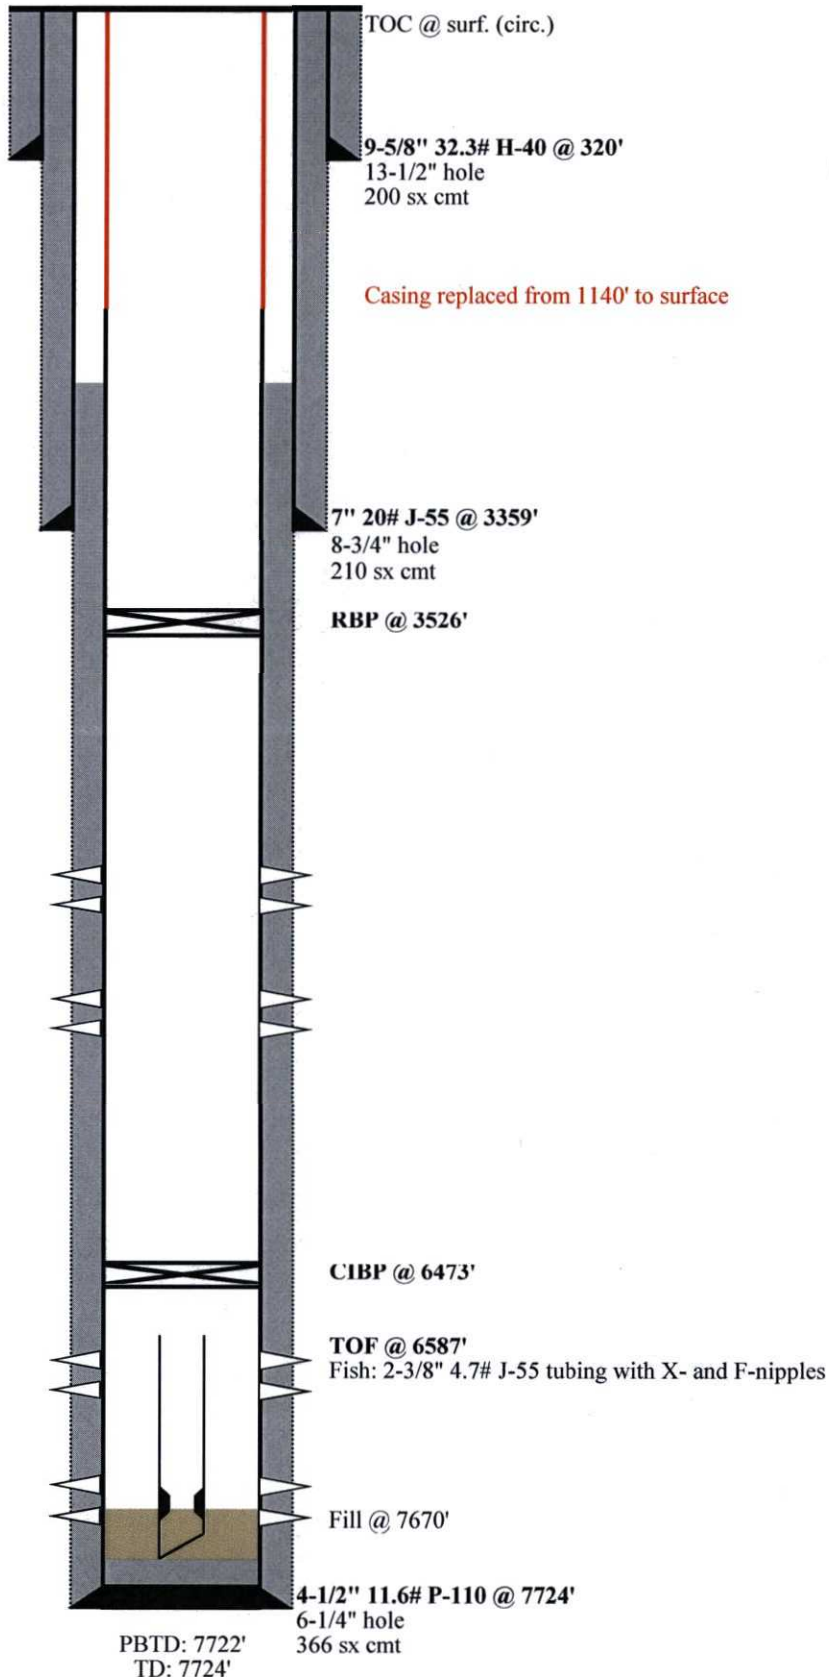
Barnes LS 007M
MV/DK
API #: 300453249100
Unit E - Sec. 23 - T32N - R11W
San Juan, NM

After encountering some difficulty in removing the packer from the wellbore, we discovered that the 4-1/2" production casing was parted (or at least separated from the slips) at surface while running a CIBP to set at 6473' KB (above the tubing fish). We then set a retrievable bridge plug at 3526' KB and found a secondary part in the 4-1/2" casing at 1140'. We pulled the 4-1/2" casing to this depth—at that point, we considered installing a liner packer and using the upper portion of the 7" intermediate casing as production casing. Instead, however, we opted to run 4-1/2" casing from the part all the way back to surface, leaving the wellbore above the RBP unchanged from its original configuration.

- **RUN 4-1/2" CASING TO THE PART AT ~1140'**
- **TEST THE 4-1/2" CASING AGAINST THE RBP TO 1000 PSI – NOTE RESULTS OF TEST TO NMOCD**
- **PULL THE RBP**
- **RIH WITH PACKER AND TEST FROM BELOW MESA VERDE PERFORATIONS (~5500') TO THE CIBP AT 6473' – NOTE RESULTS OF TEST TO NMOCD**
- **PULL THE PACKER**
- **RUN PRODUCTION TUBING**
- **RIG DOWN AND RESUME PRODUCTION AS A MESA VERDE WELL**
