Release Notification and Corrective Action

Name of Company: BP America Production Co.	Contact: Steve Moskal	
Address: 200 Energy Court, Farmington, NM 87401	Telephone No.: 505-330-9179	
Facility Name: JACQUEZ COM No. 005	Facility Type: Salt Water Disposal Well	
Surface Owner: Fee	Mineral Owner: Fee	API No. 3004526833

BP Remediation Plan

To: Cory Smith & Vanessa Fields – NMOCD Dist. III, Aztec, NM
From: Steve Moskal - BP
CC: Roland Mora; Vance Hixon - BP
Date: 8/28/2017
Re: Jacquez Com 005 Remediation Plan

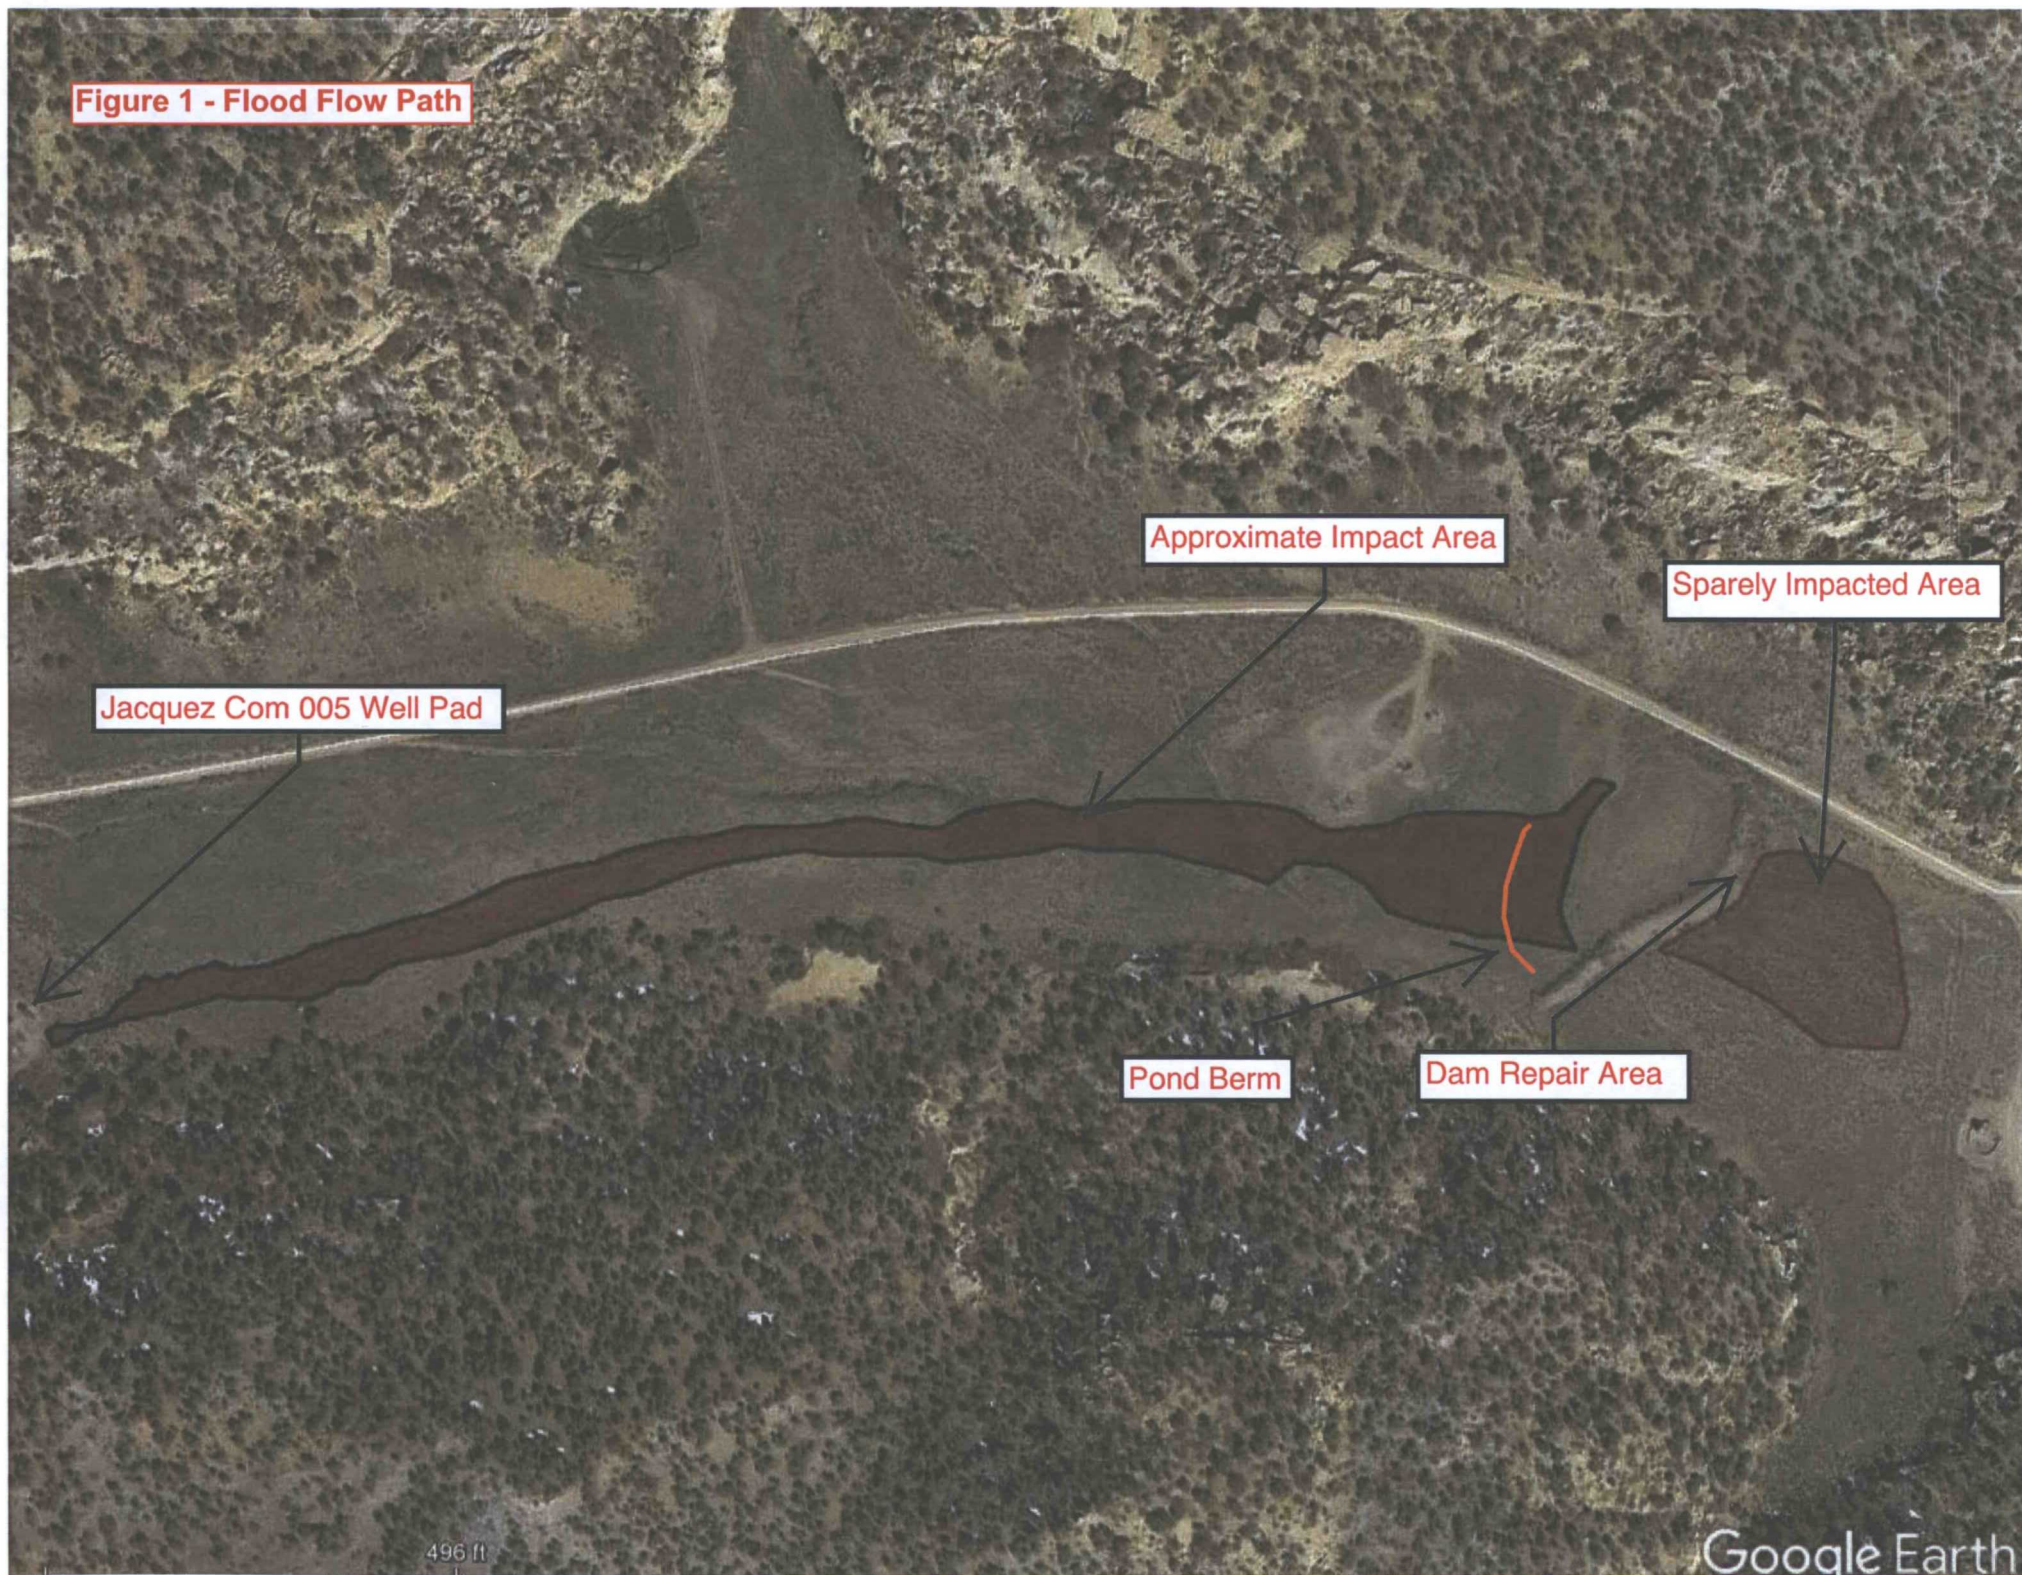
Figure 1 - Flood Flow Path

Mr. Velasquez has requested that all impacted soils and vegetation be removed from the location and floodwater flow path. The flow path is illustrated on Figure 1. Once the impacts have been removed, the area is to be backfilled with material from borrow location as specified by Mr. Velasquez. The Borrow Areas are illustrated on Figure 2. Both the remediated and borrow areas will then be reclaimed and seeded per the specified seed mix provided by Mr. Velasquez. Figure 3 illustrates the approved route to be used for importing from the borrow area.

To remove the impacts from the flood area, the soil and vegetation will be scrapped and collected to the extents of the impacts, plus an additional 1-2 feet lateral. The vertical extents of the impacts are not known and will vary. Current estimate is the impacts range from 4-6" deep. The impacted soil will be hauled to a landfarm for disposal. The area from the Jacquez Com 005 well pad to the livestock pond will be remediated in full. The area east of the pond will be remediated using foot traffic and hand tools to only remove the sparse and minimal impacts.
